City of Kennewick Reservoir Evaluation & Replacement

Presented by: Erik Peterson, PE & Ethan Alton, PE, SE
Peterson Structural Engineers

10.0 MG
Reservoir
Evaluation

6.0 MG
Reservoir
Planning & Design

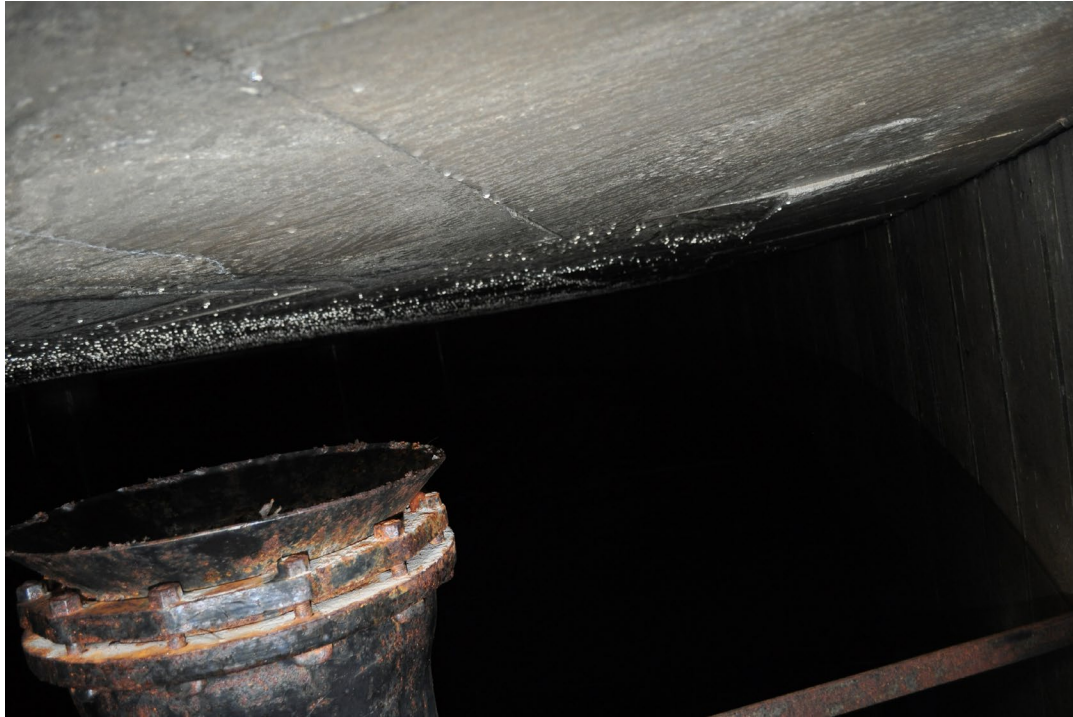
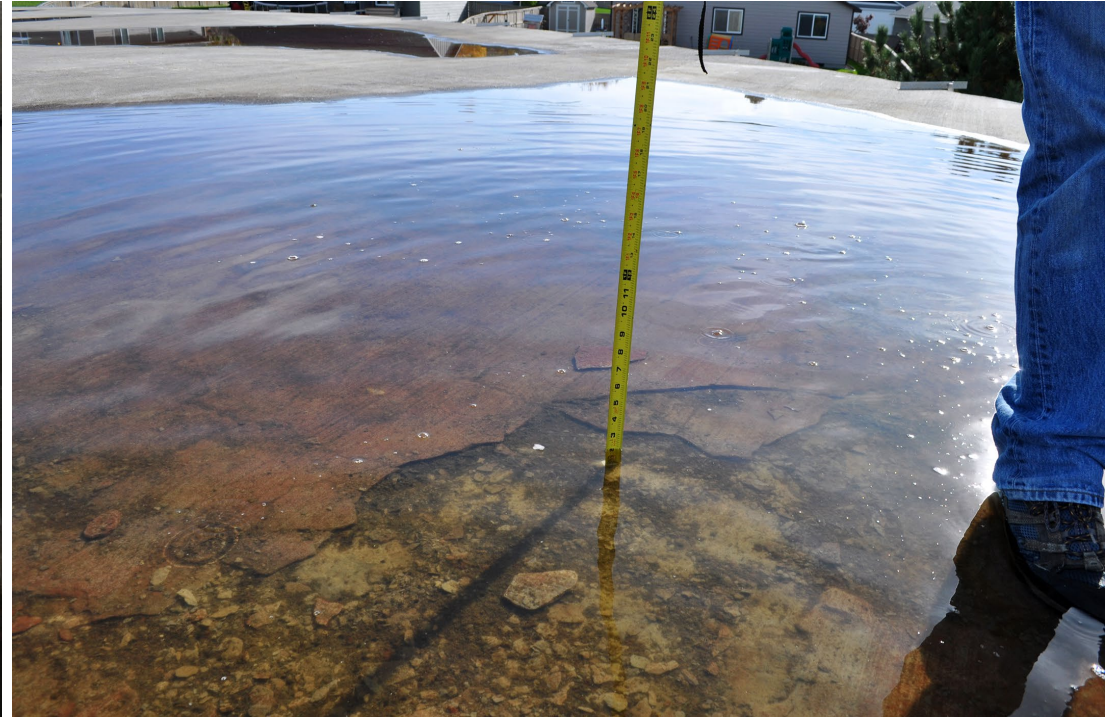
Primary Structural Issues

- Roof Slab Conditions the Primary Issues
- Ponding Caused by Concrete Creep

- Limited Options For Repair
- Carbon Fiber Only Partial Solution
- Adding Concrete Thickness Exacerbates Other Issues
- Creep is Permanent Deflection, Can be Arrested but Not Reversed

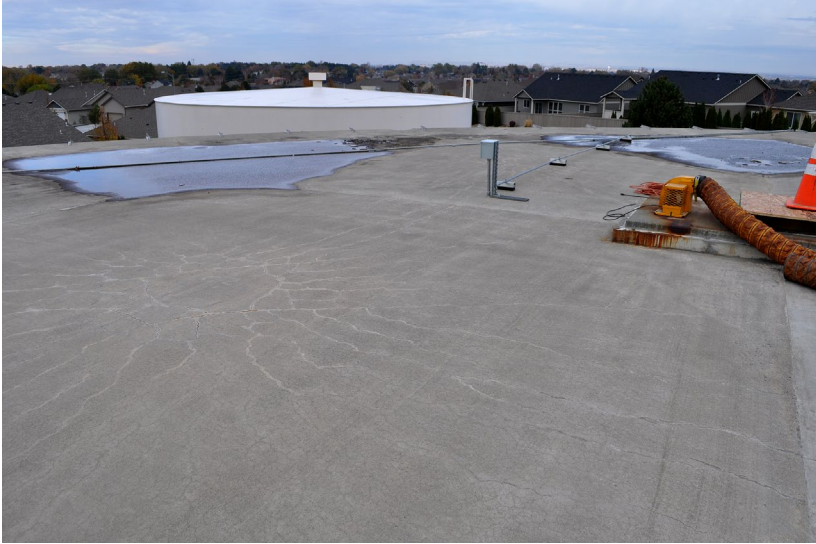
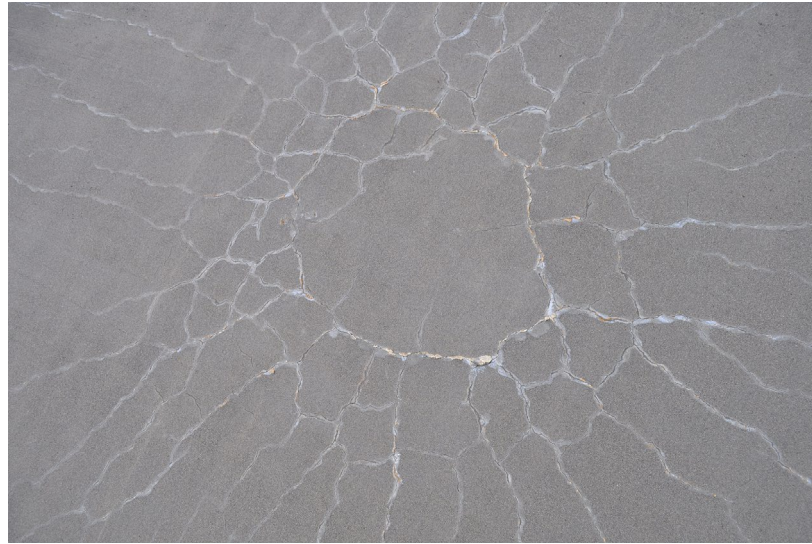
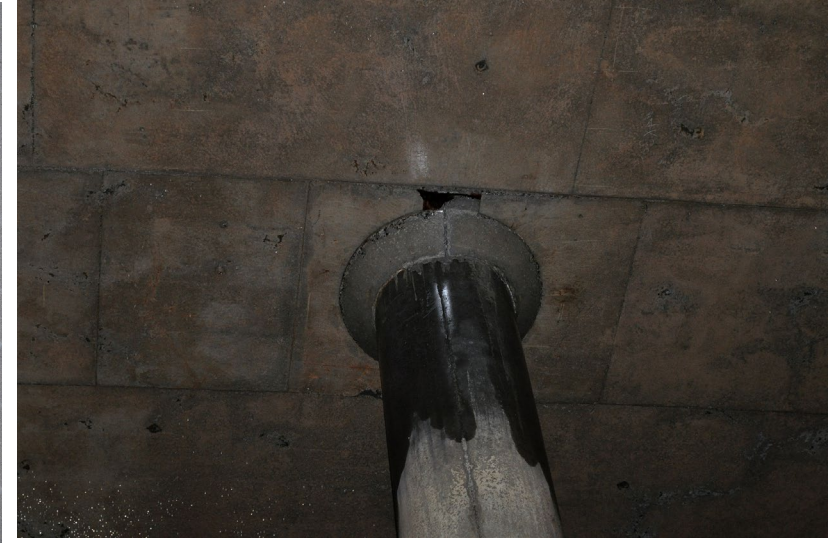
Primary Structural Issues

- Roof Slab Conditions the Primary Issues
- Column Punching Shear Failure

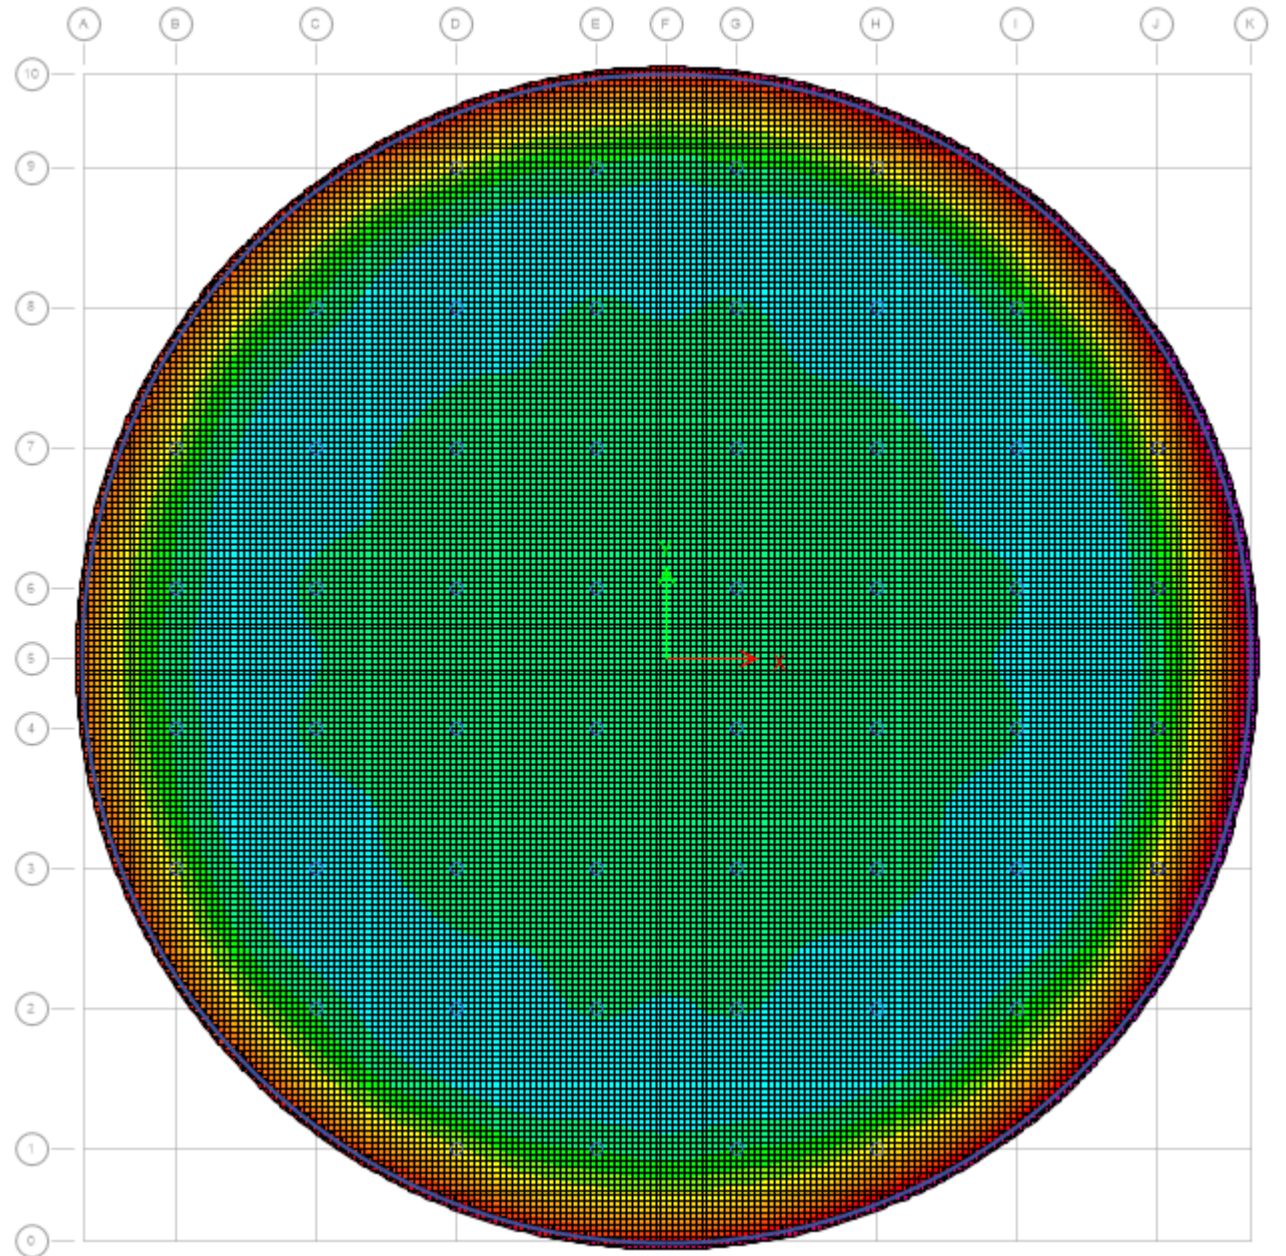
Mat Slab Design

- Modulus of Subgrade Reaction
- Initial value from Shannon and Wilson was lower than expected
 - Large area of influence leads to deeper stress bulb in soil
 - This site had deep silts
- Design team coordination and additional 24" mat of crushed rock below slab yielded a higher modulus
- CSI SAFE used to create a finite element model of the mat slab
- Final design was a 24" slab with #6 bars at 6" spacing at the top and bottom in both directions.

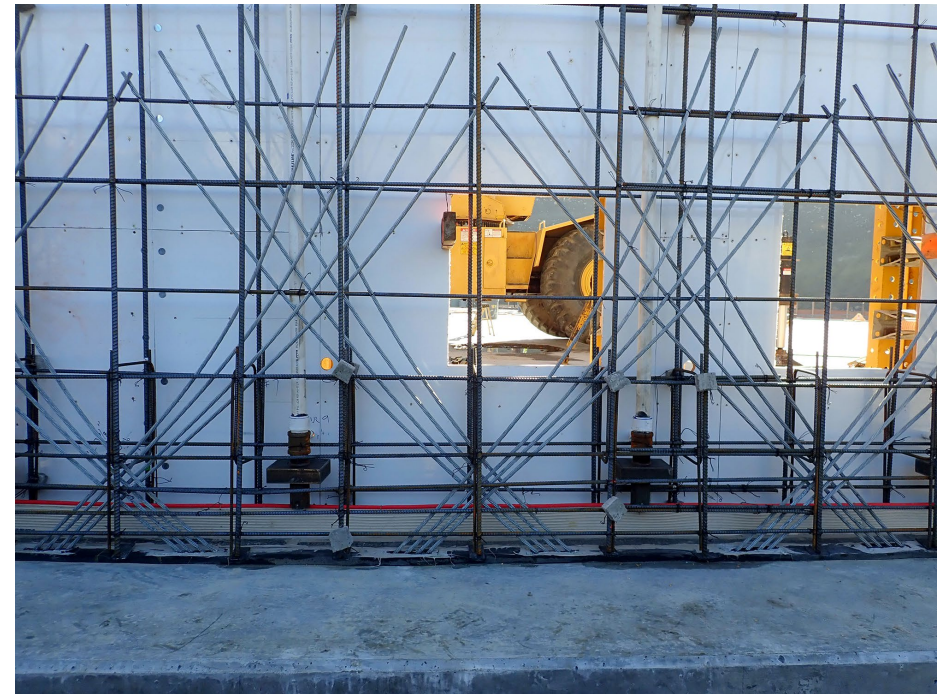
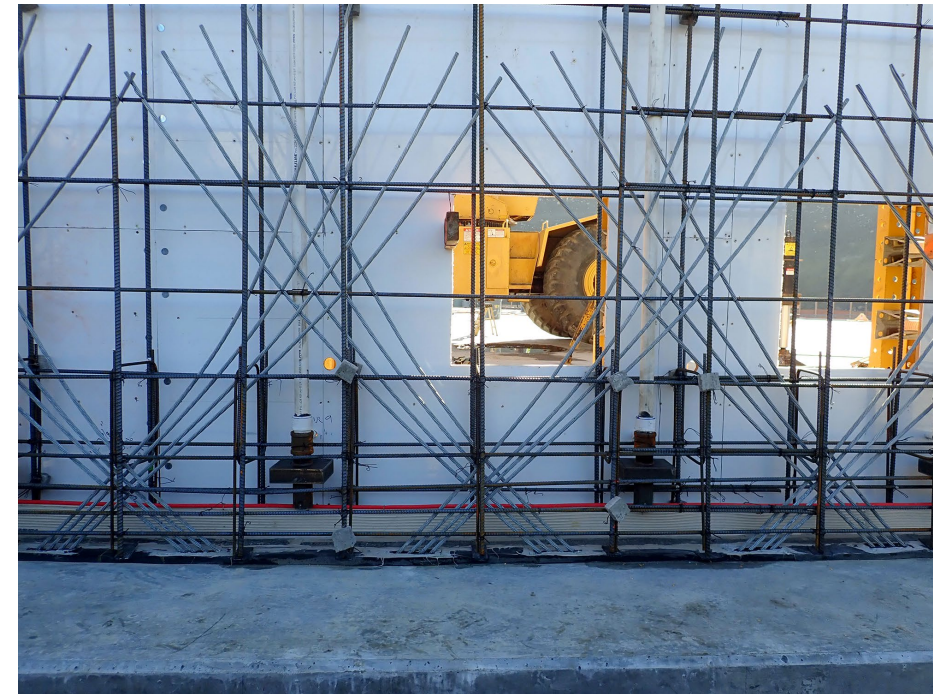
Anchored Flexible Wall Base

- Flexible base allows for higher ductility
- Wall, Roof, and Floor Slab with different fundamental periods
- Cables parallel to direction of seismic loads engage in tension

- Flexible base allows for higher ductility
- Wall, Roof, and Floor Slab with different fundamental periods
- Cables parallel to direction of seismic loads engage in tension

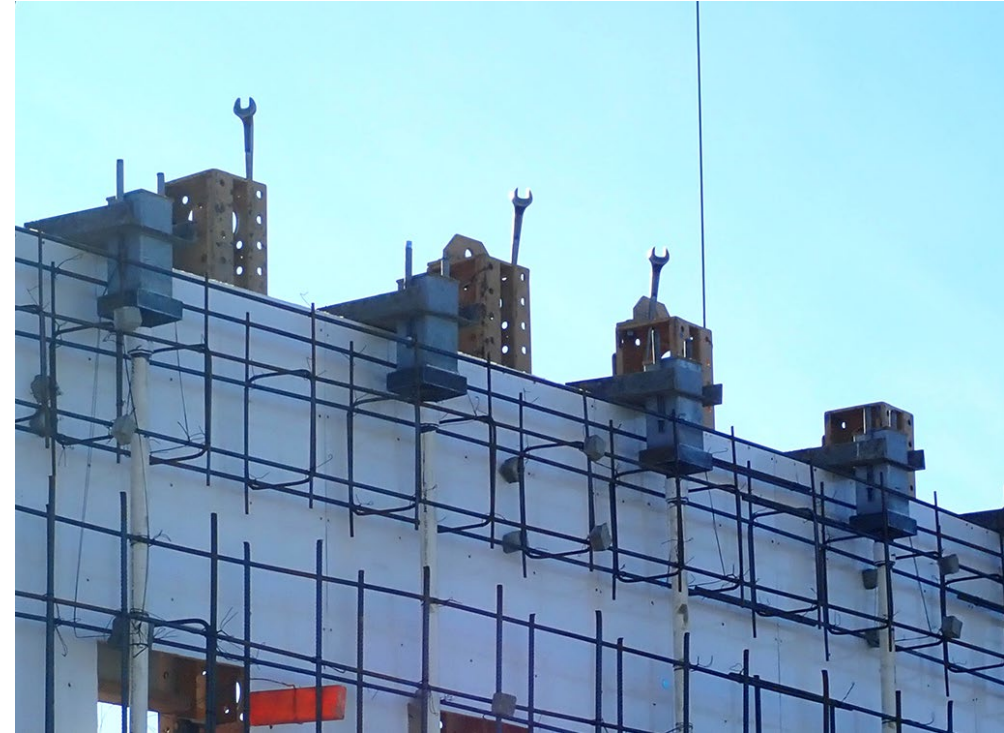
Top of Wall Connection

- Shear cans with bearing pads
- Allows for radial movement of the slab, but not for global translation
- Prevents out of plane loads on the wall
- Also acts as bearing plate for vertical tensioning

- Shear cans with bearing pads
- Allows for radial movement of the slab, but not for global translation
- Prevents out of plane loads on the wall
- Also acts as bearing plate for vertical tensioning

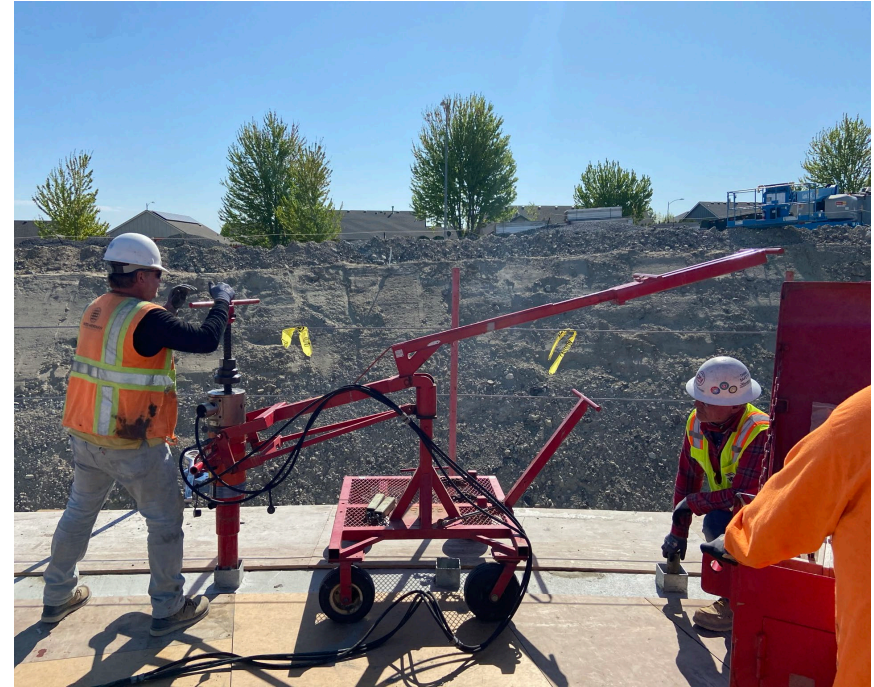
Vertical Prestressing

- Compresses wall vertically
- 1 3/8" diameter threadbars
- Approximately 4ft spacing
- 173,900lb tension
- Elongates 1.379"
- PVC tube with threadbar is filled with epoxy after tensioning

- Compresses wall vertically
- 1 3/8" diameter threadbars
- Approximately 4ft spacing
- 173,900lb tension
- Elongates 1.379"
- PVC tube with threadbar is filled with epoxy after tensioning

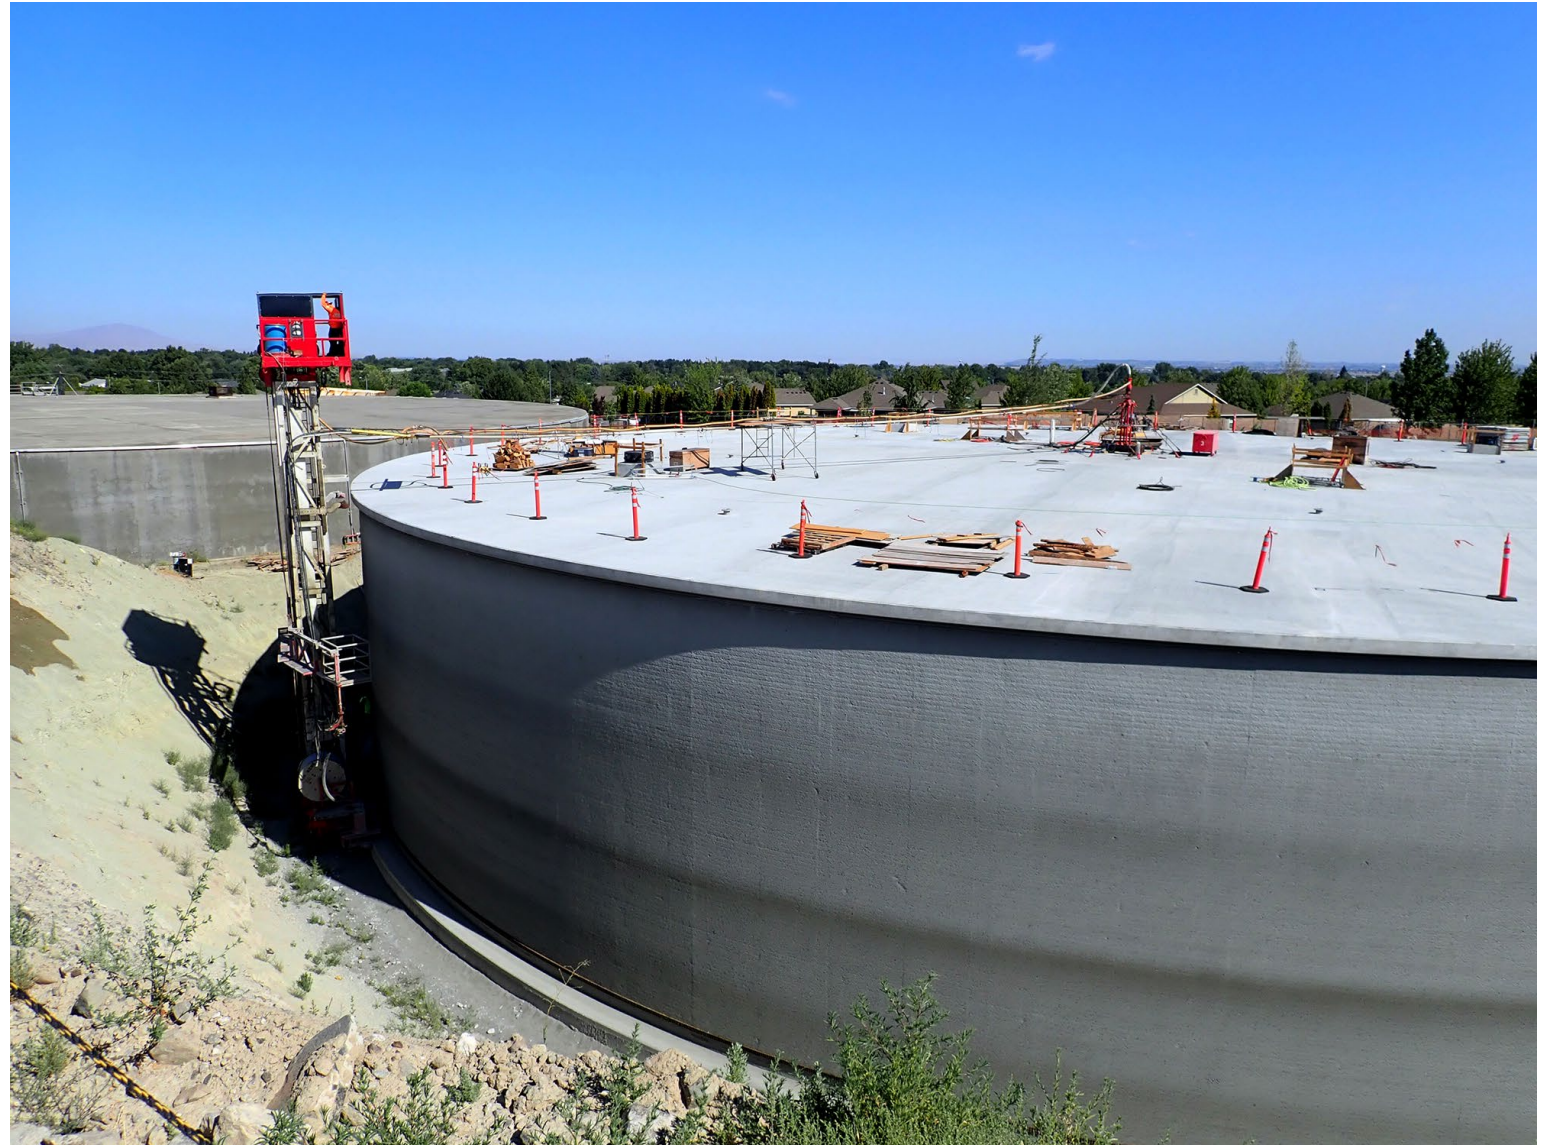
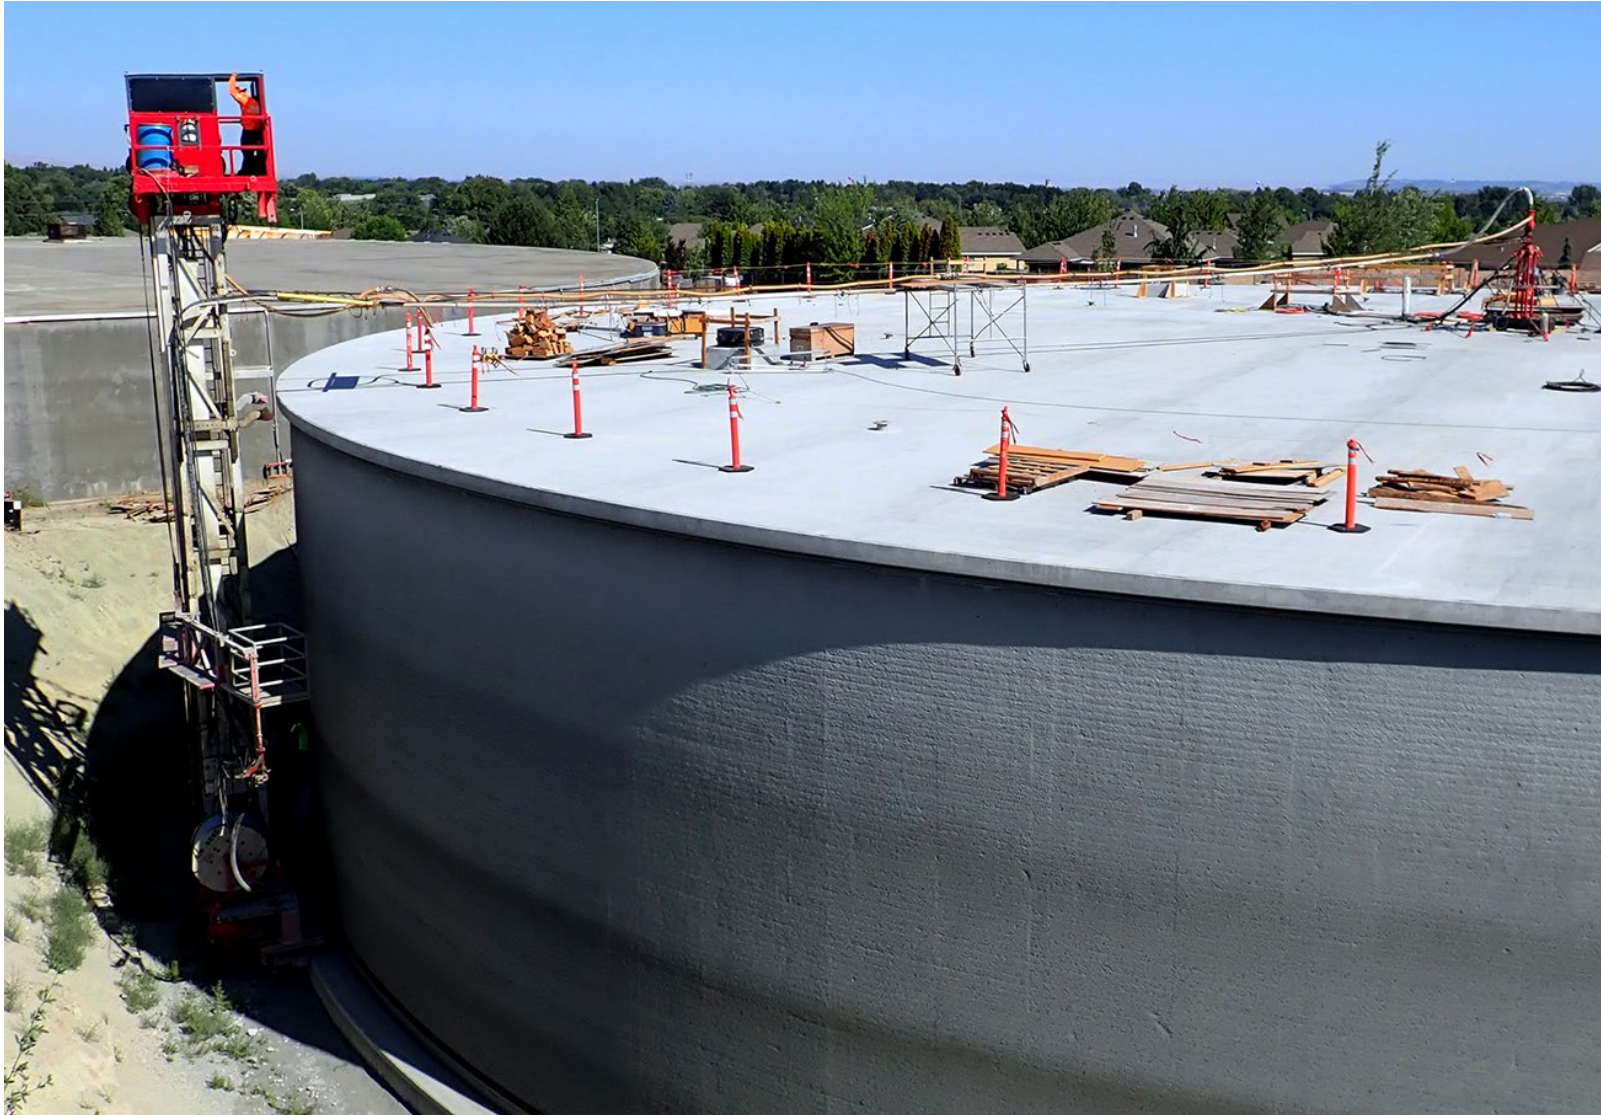
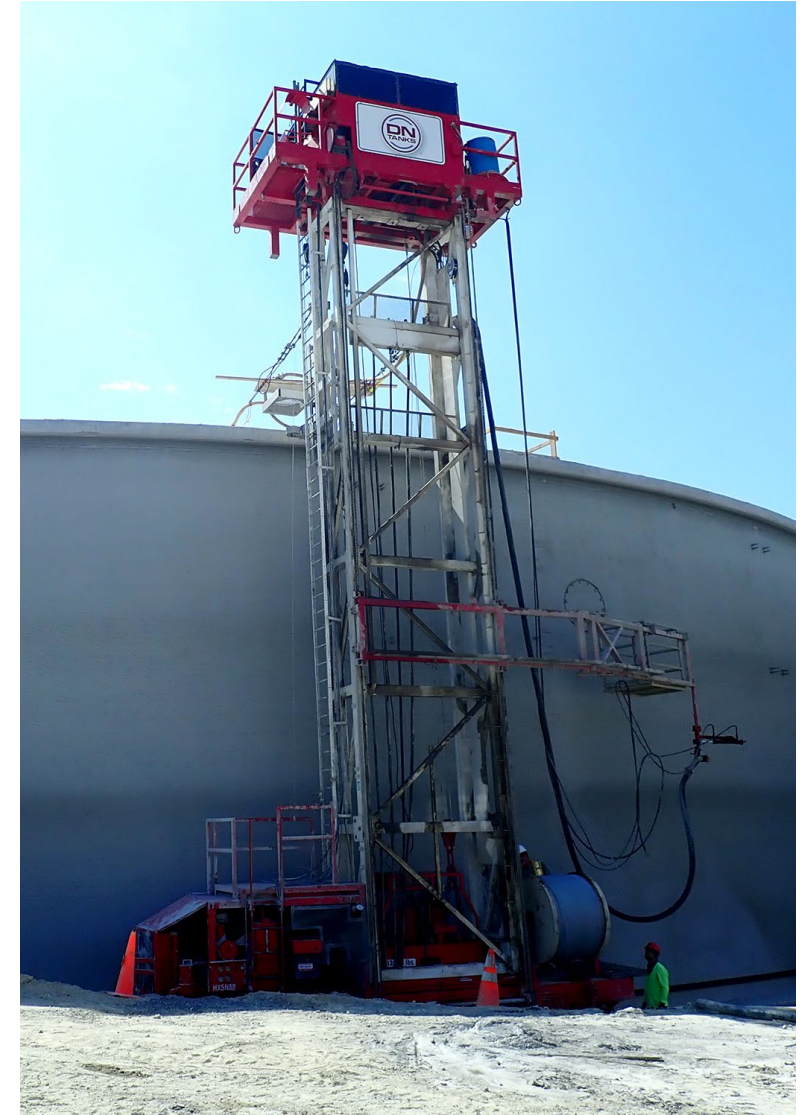
Horizontal Prestressing/Wrapping

- 3/8" diameter cables
- Tensioned to 14,950lb
- Spacing varies.
Tightest spacing near the bottom, and increased spacing near top
- Shotcrete between each layer of wrapping
- Applied by DN Tank's specialized machine

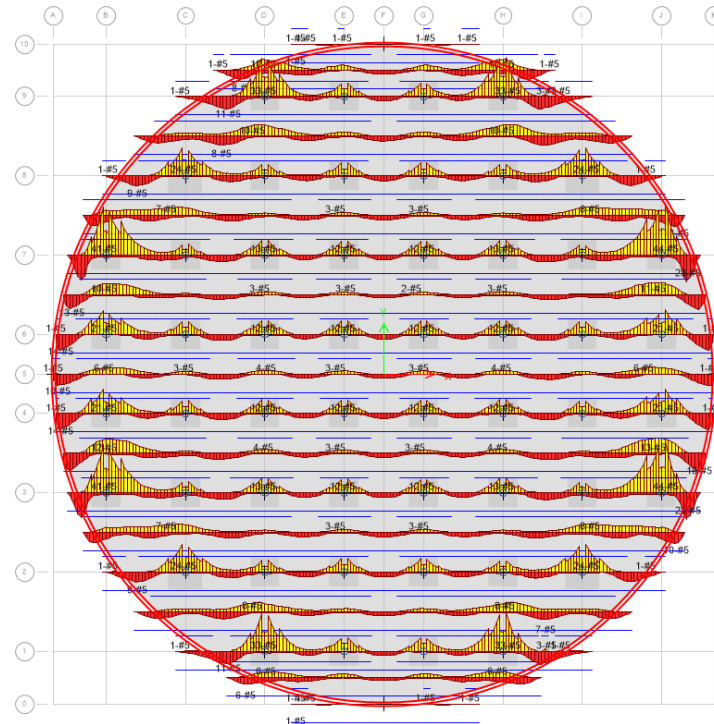
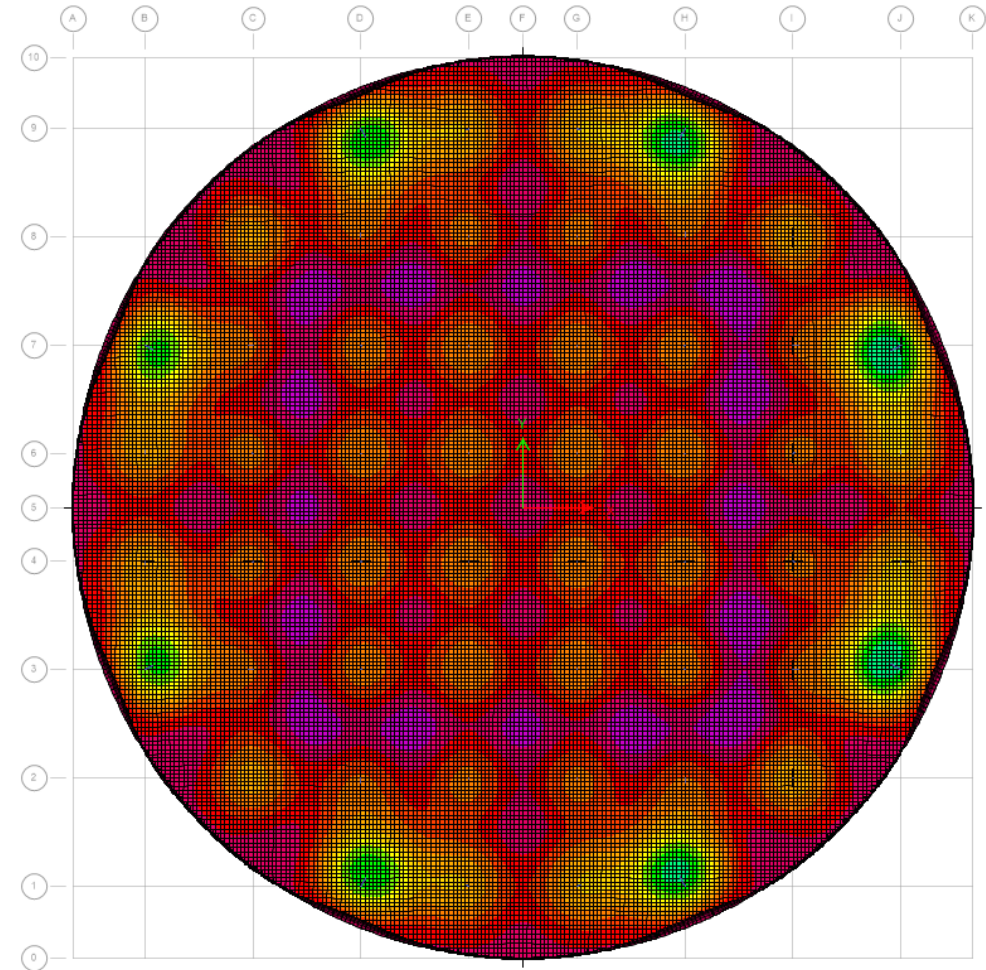
Roof Slab Design

- 2 way flat slab spanning between a square grid of columns and the core wall
- Designed using CSI SAFE Software
- Iterative design with floor slab
- 10" slab with #5 spaced at 8" over column strips and 12" at middle strips

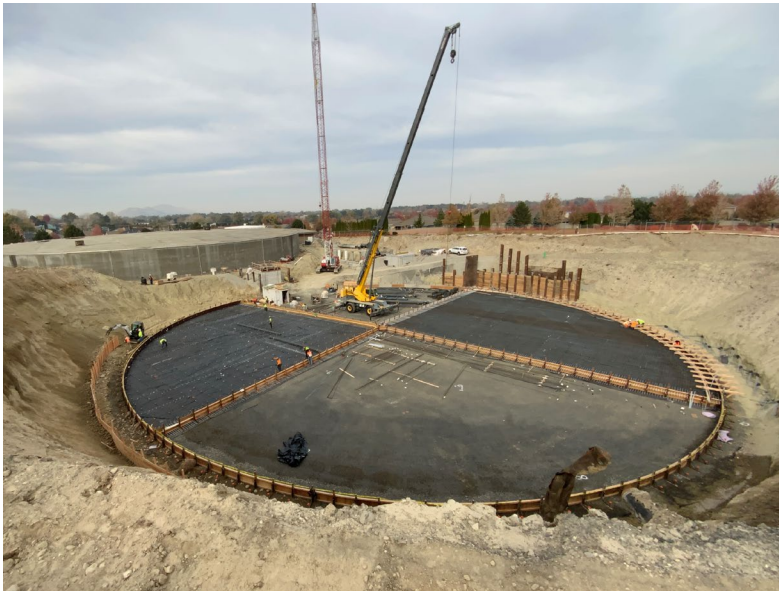
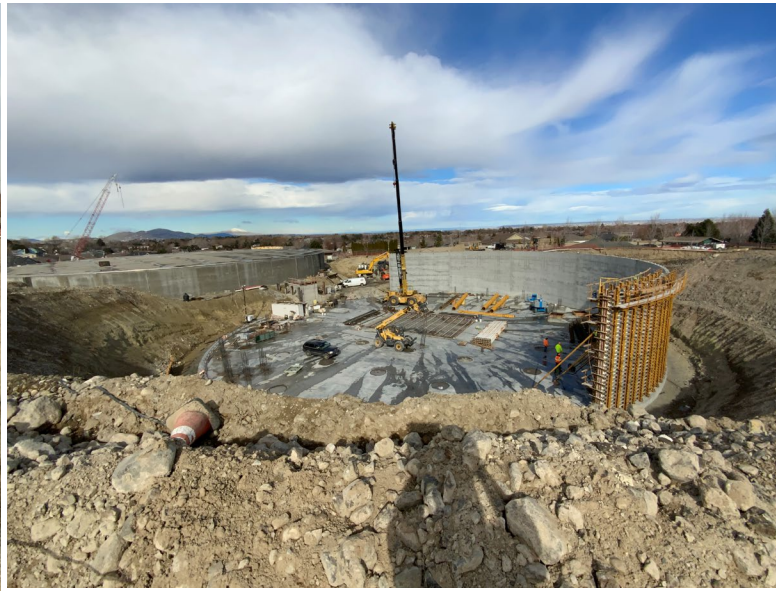
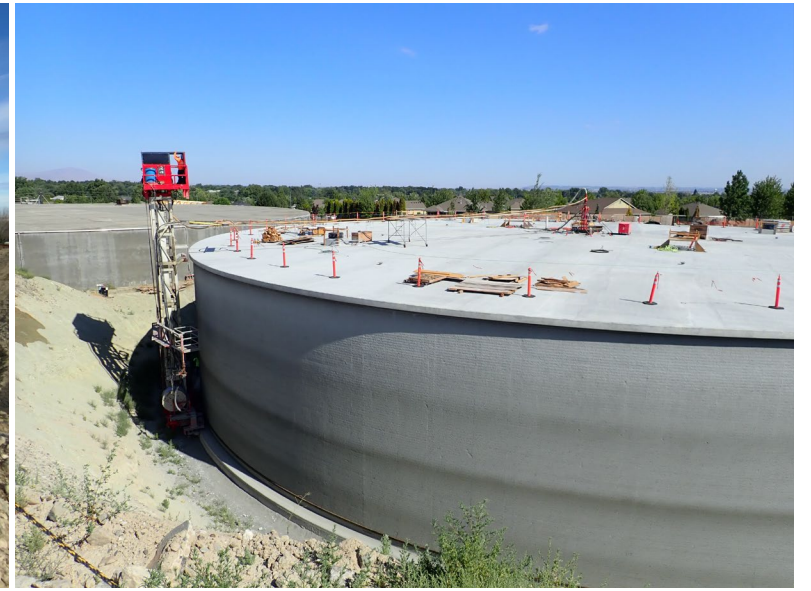
Construction

PSE PERFORMED 7 OBSERVATIONS

- Floor slab reinforcing
- Wall reinforcing
- Column reinforcing
- Vertical stressing
- Roof slab reinforcing
- Wall wrapping
- Final observation
