Rehabilitation Options for Aging Concrete Water Storage Reservoirs

Gray & Osborne, Inc.
CONSULTING ENGINEERS

Case Study - Background

- ▶ Yakima 1st Level Reservoir
- ▶ 6 MG buried concrete tank constructed 1971
- ▶ No significant upgrades since original construction
- ▶ Known concrete damage at floor
- ▶ Known leakage from reservoir

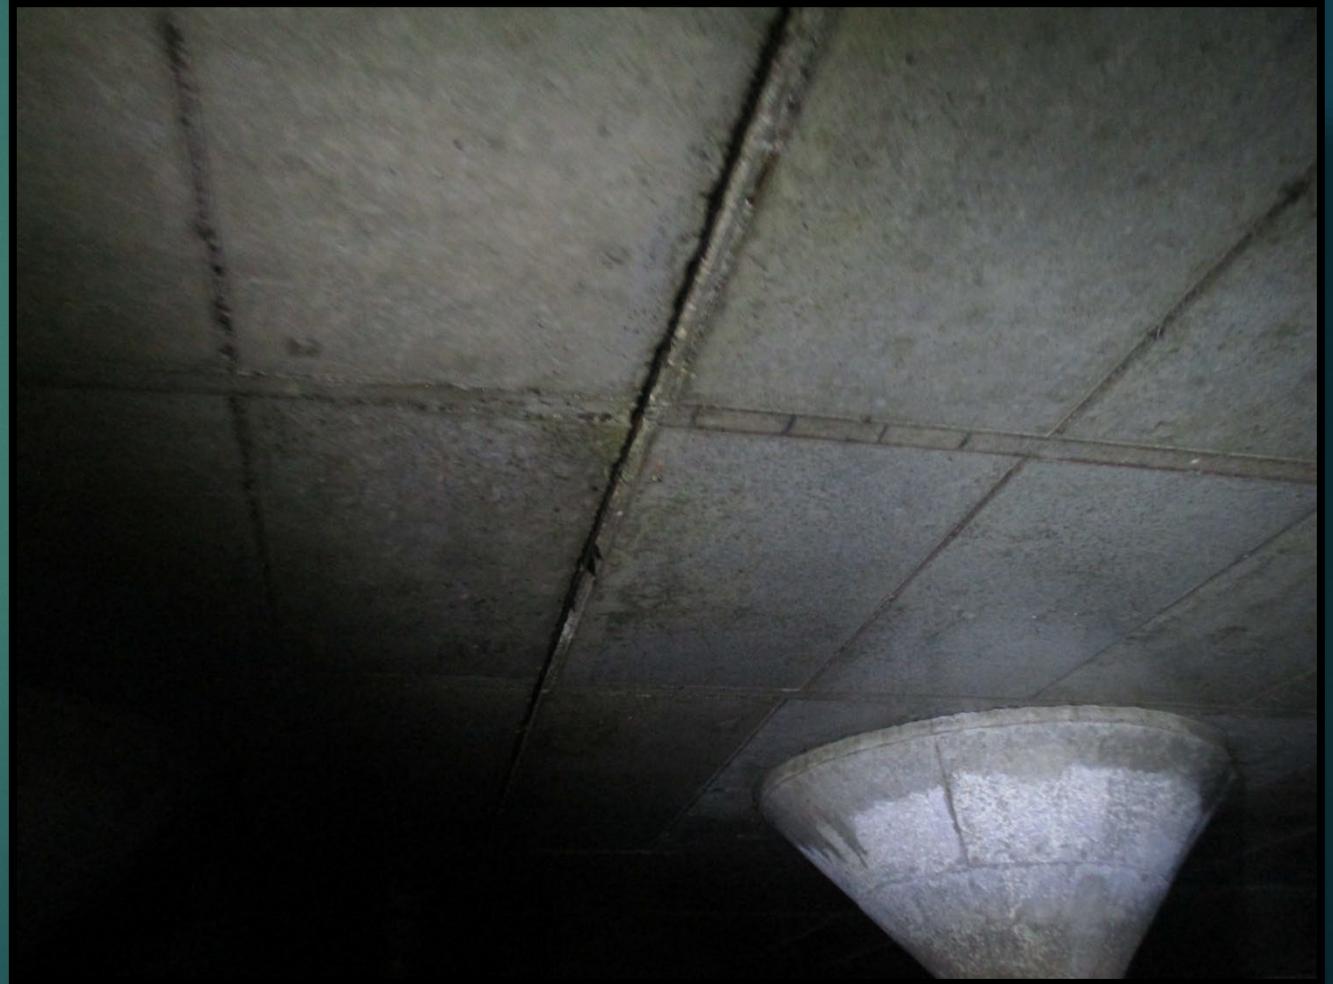
- ▶ Raft allows up-close inspection of underside of roof

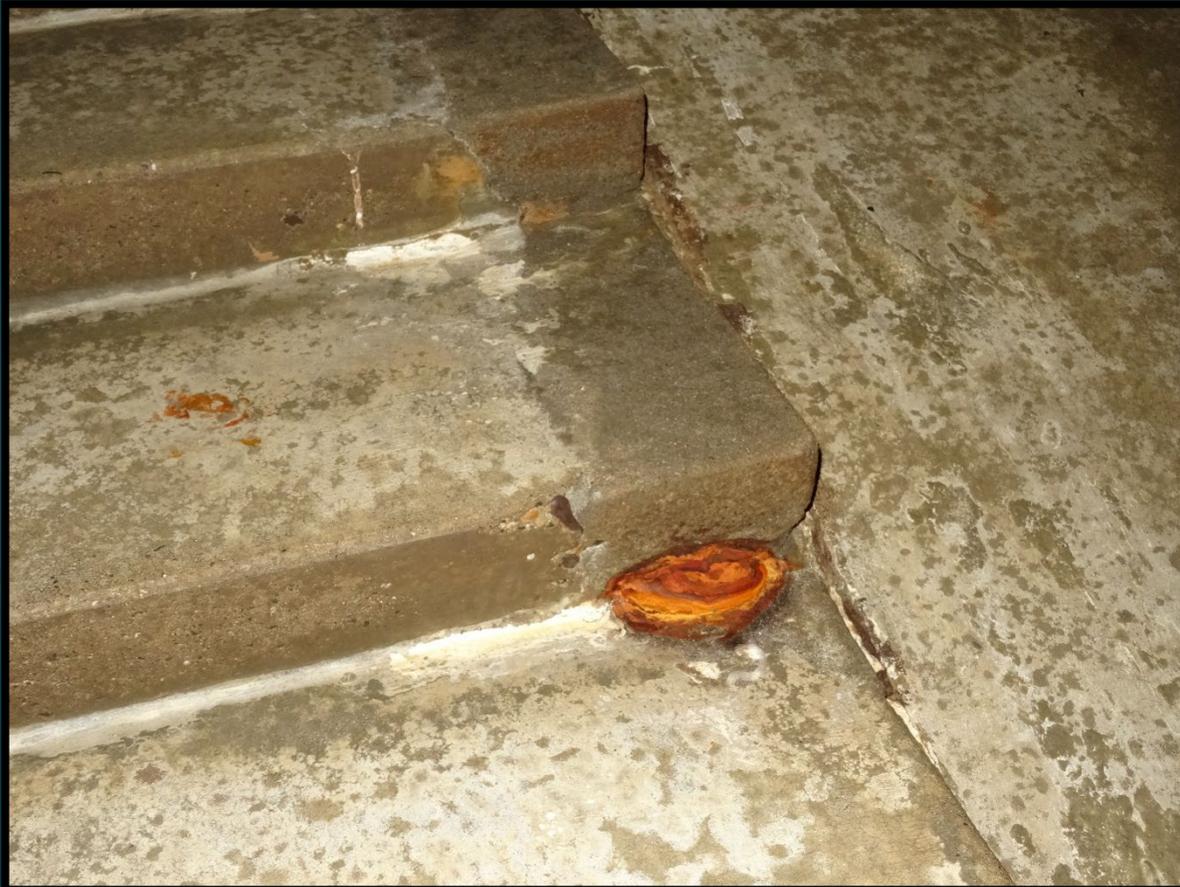
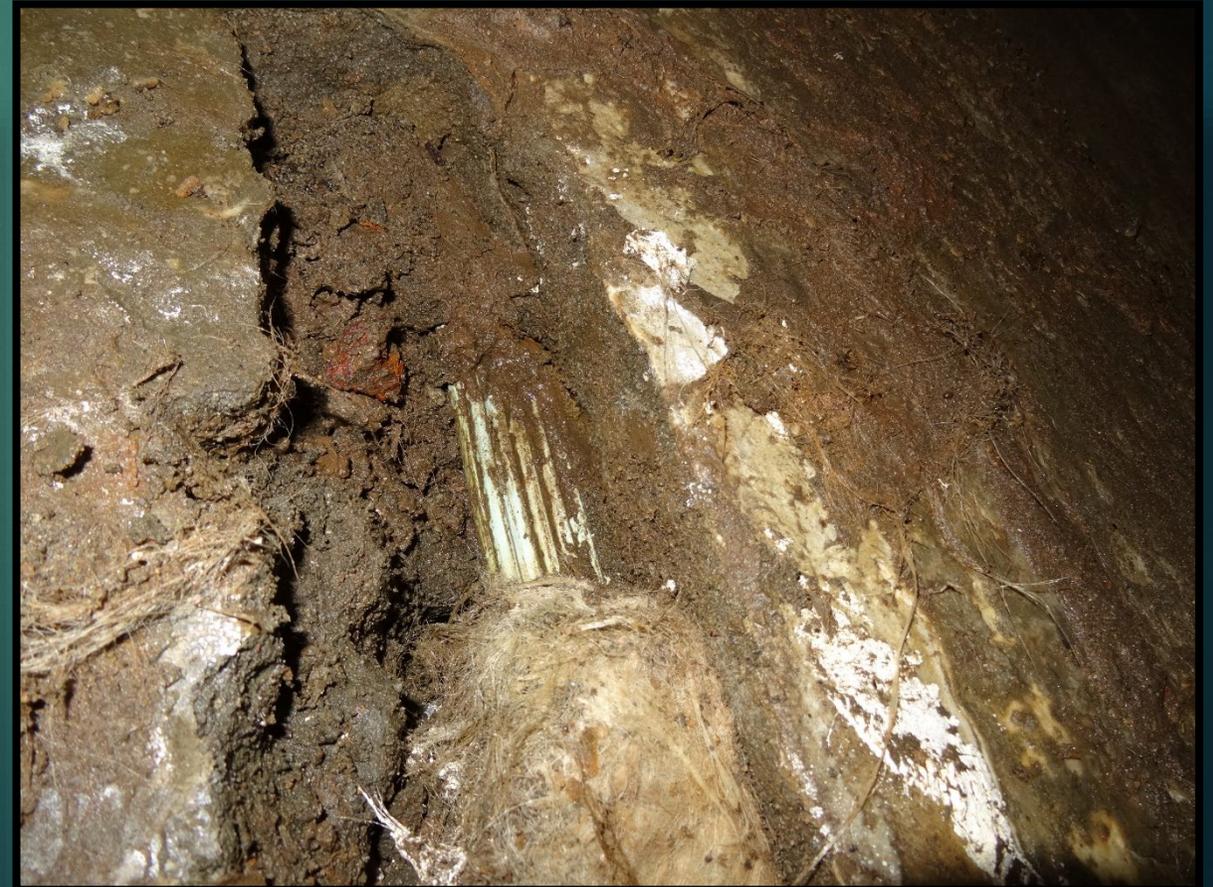
Failure Types - Concrete deterioration – at surface or extends deeper?

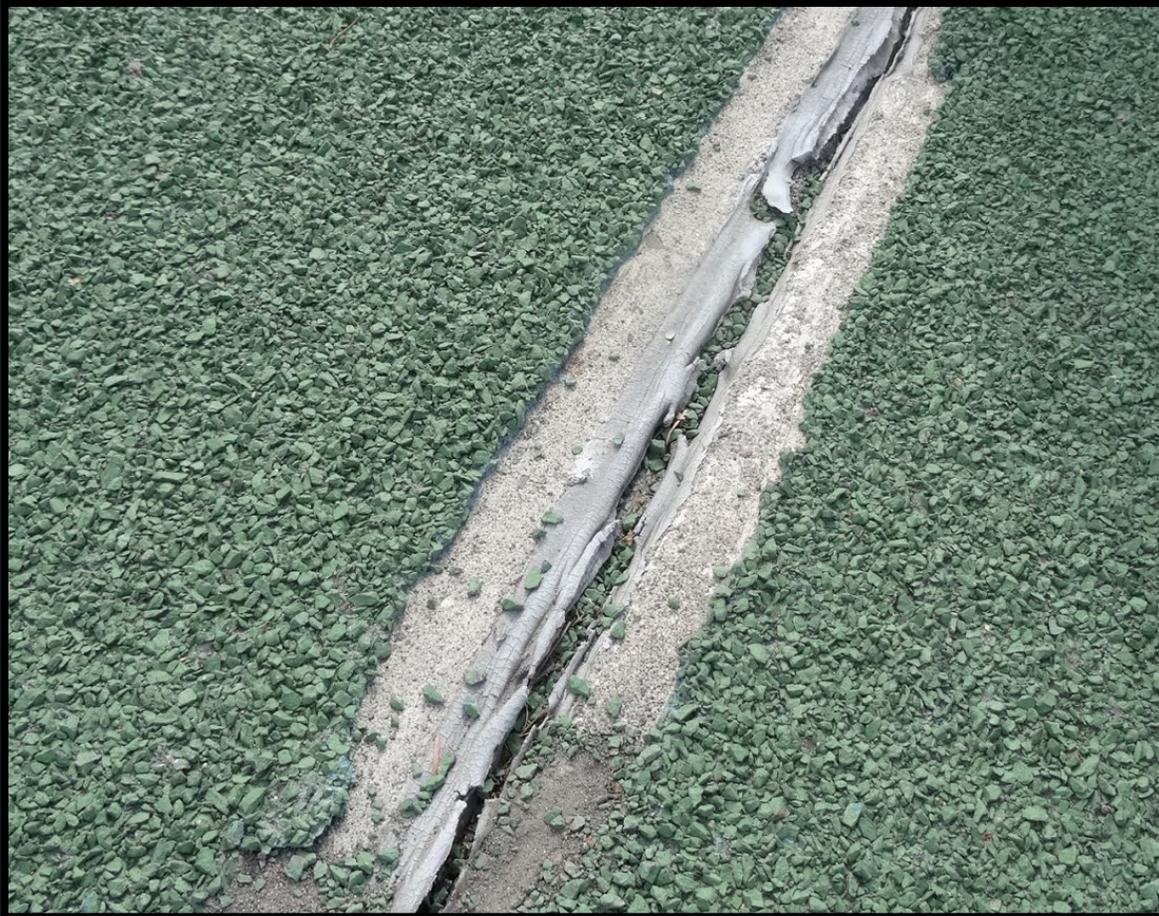
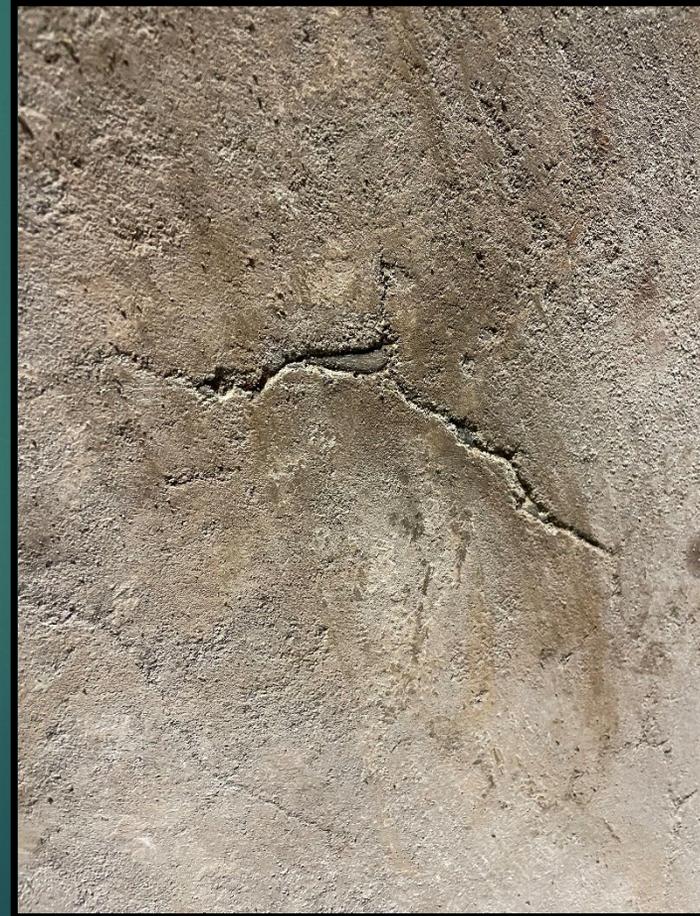
Failure Types – joints and cracks

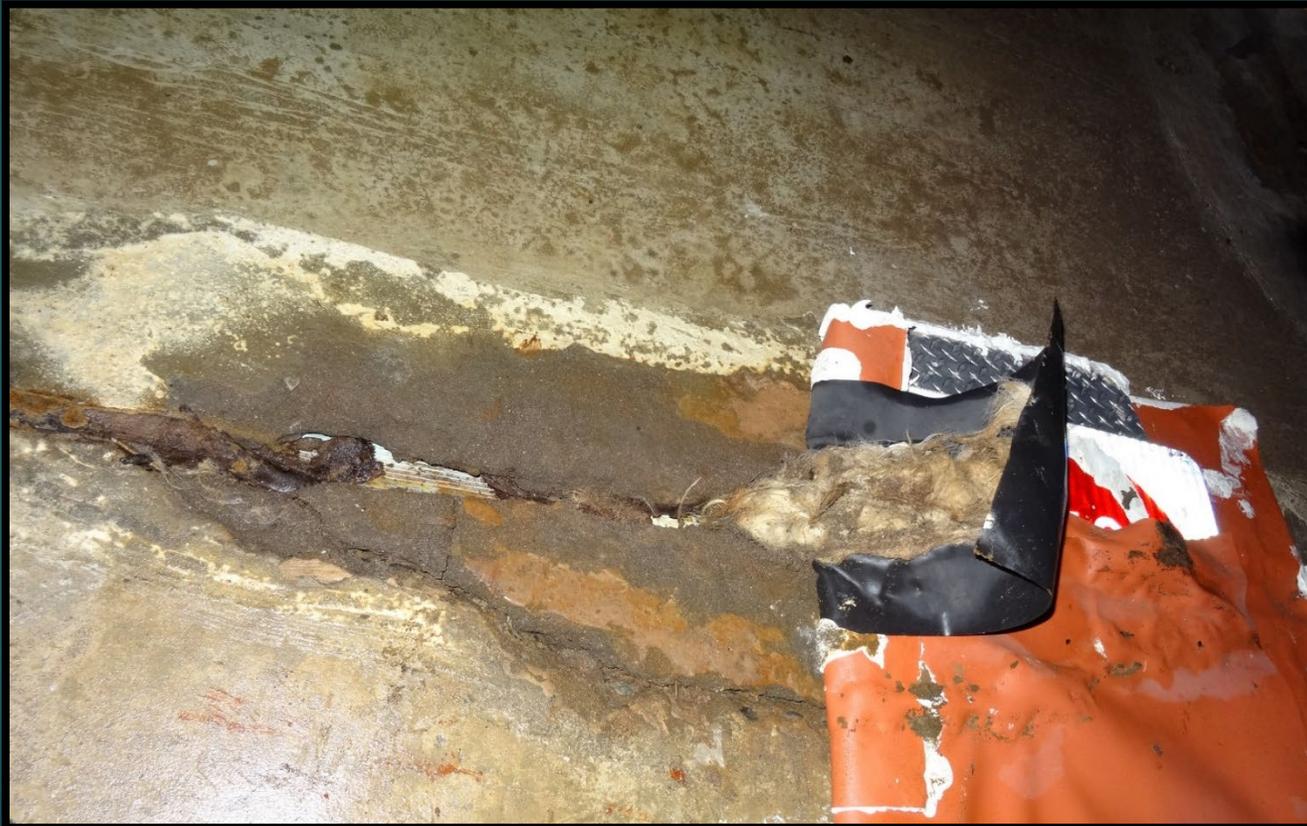
Failure Types - active leakage at floor joints

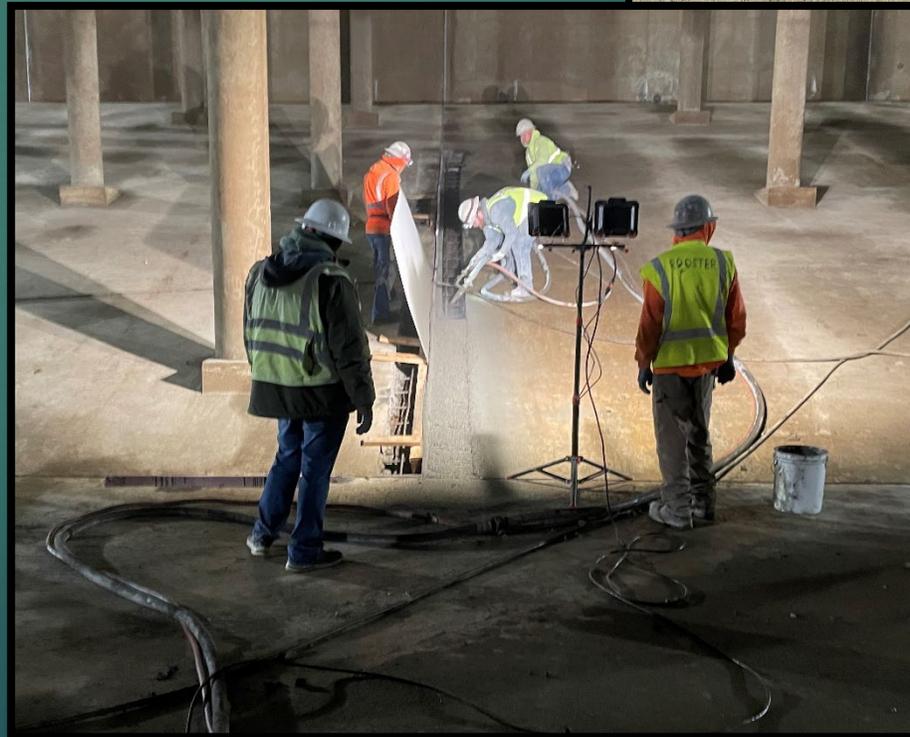
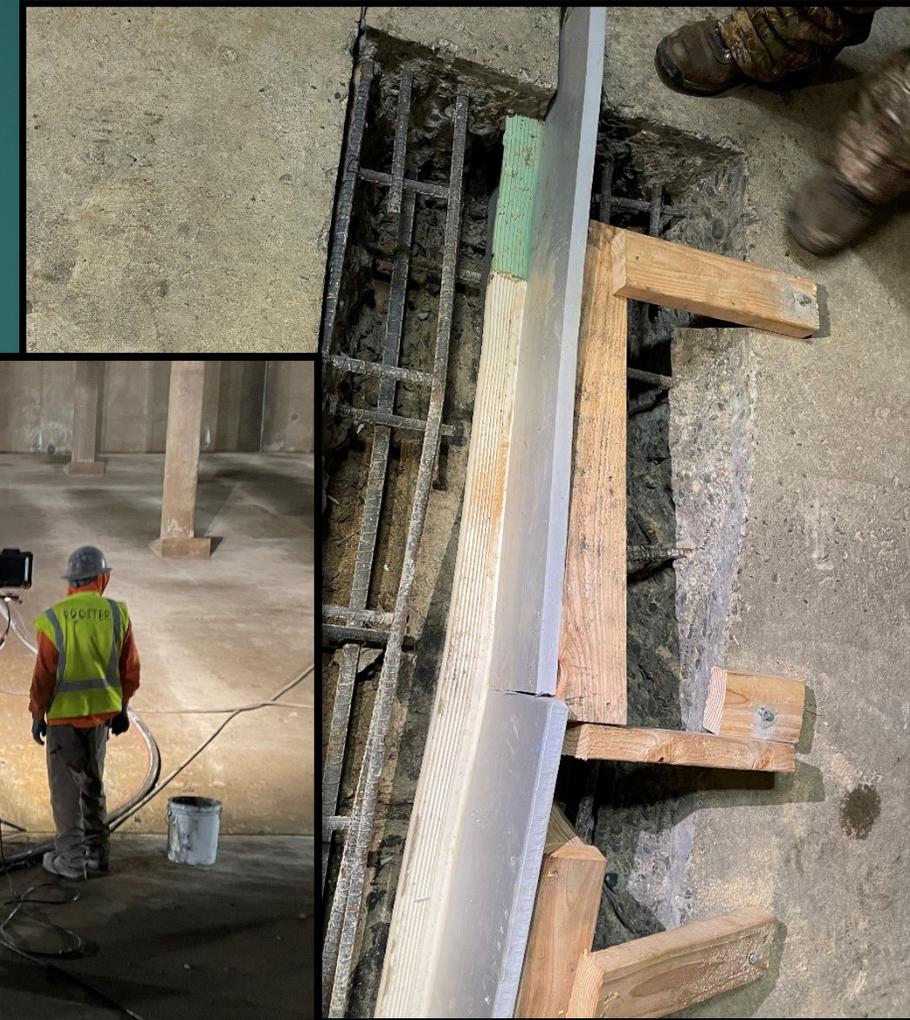
Shotcrete:

- ▶ Works well for walls and sloped slabs
- ▶ Significant setup – not efficient for small areas
- ▶ Can be installed to range of depths
- ▶ Requires experienced crew
- ▶ Requires tight control of concrete mix

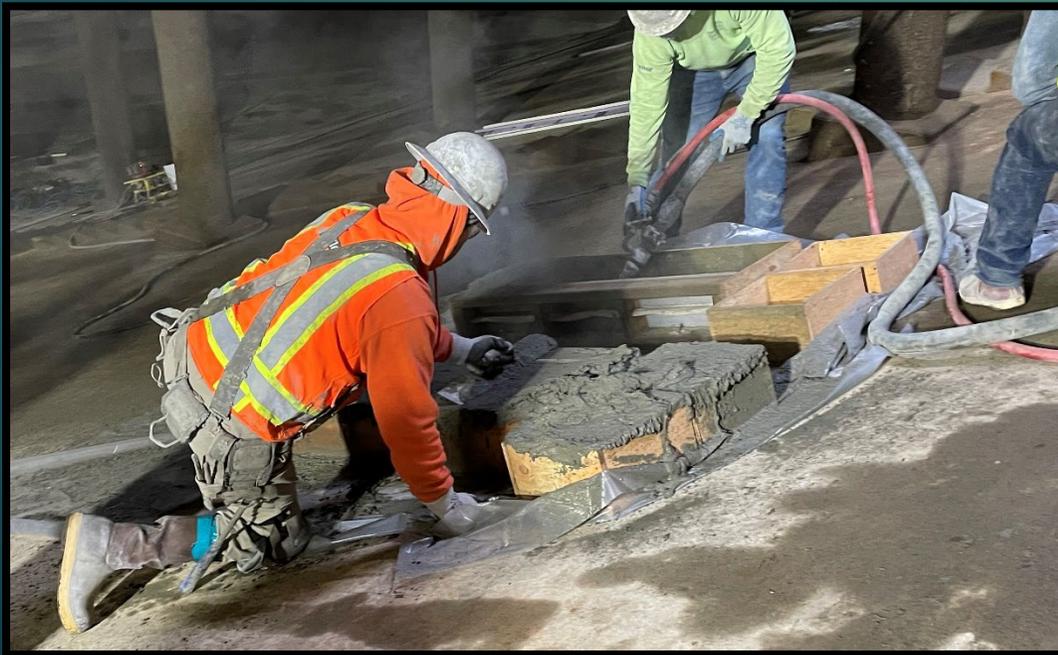
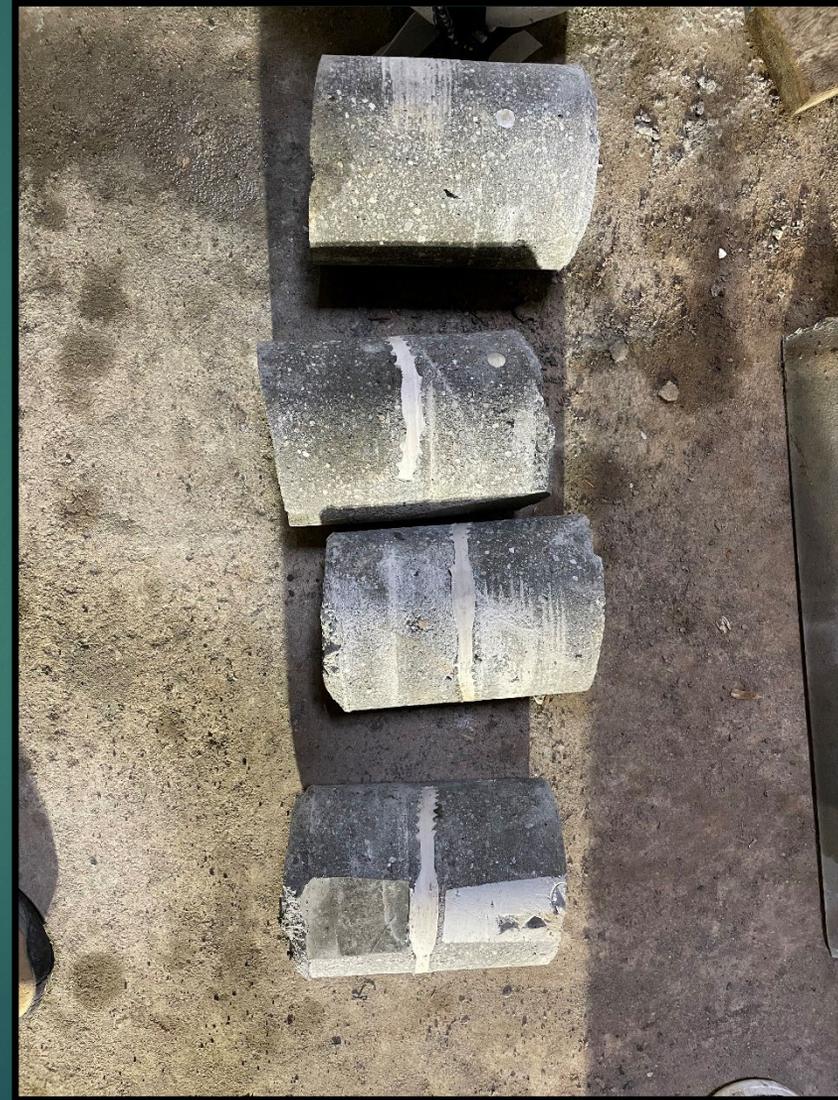
- ▶ Test panels and cores to verify consolidation and to perform strength testing

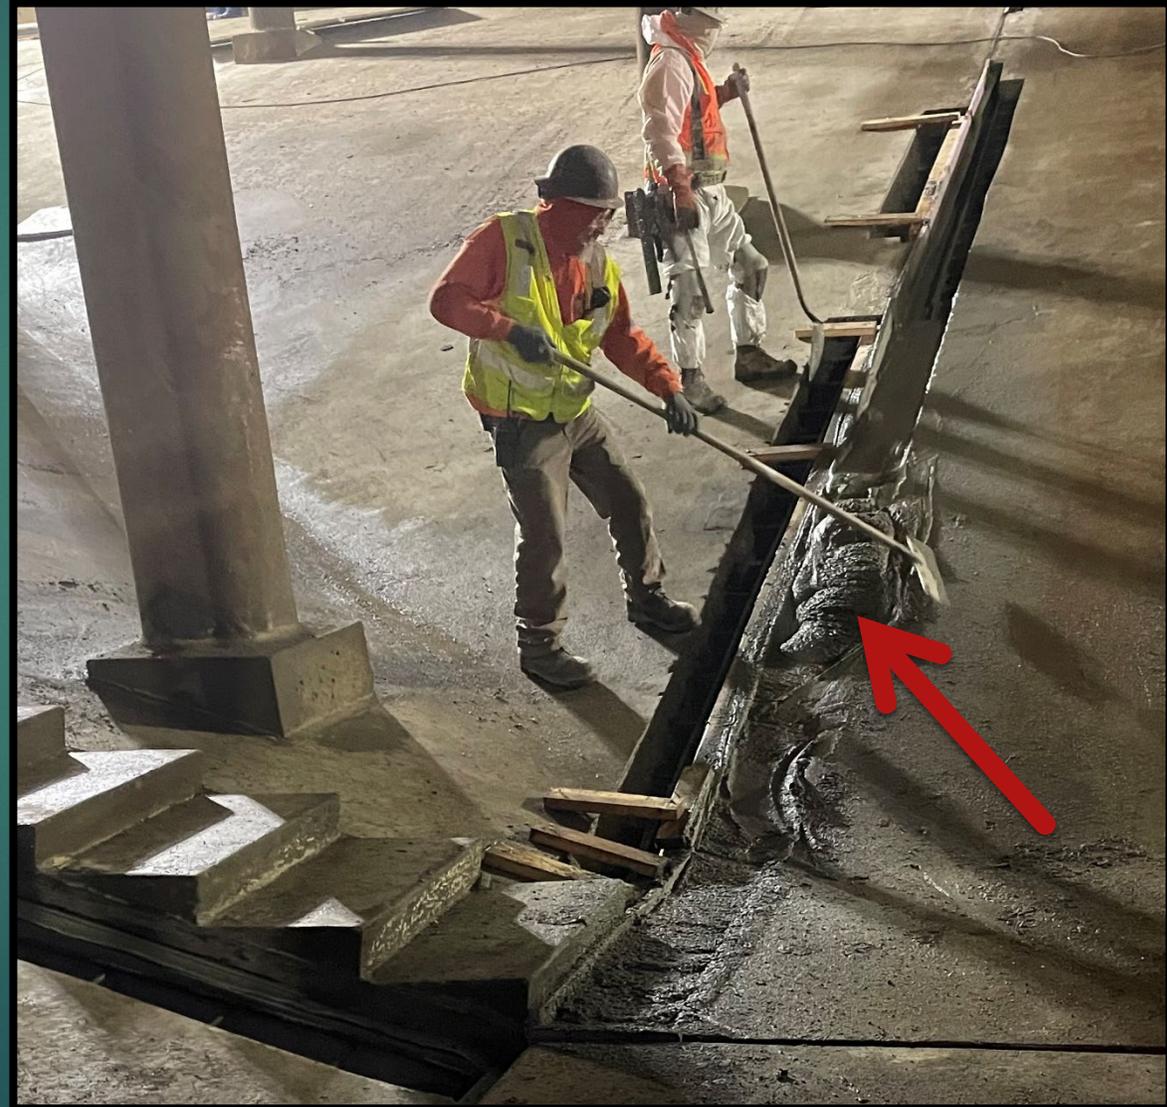
- ▶ Example of shotcrete mix that was too fluid
- ▶ Long supply line

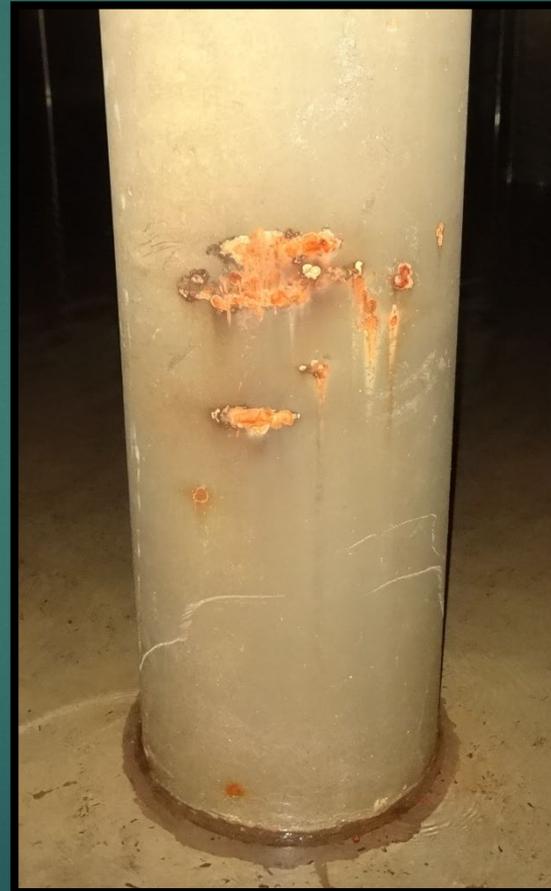
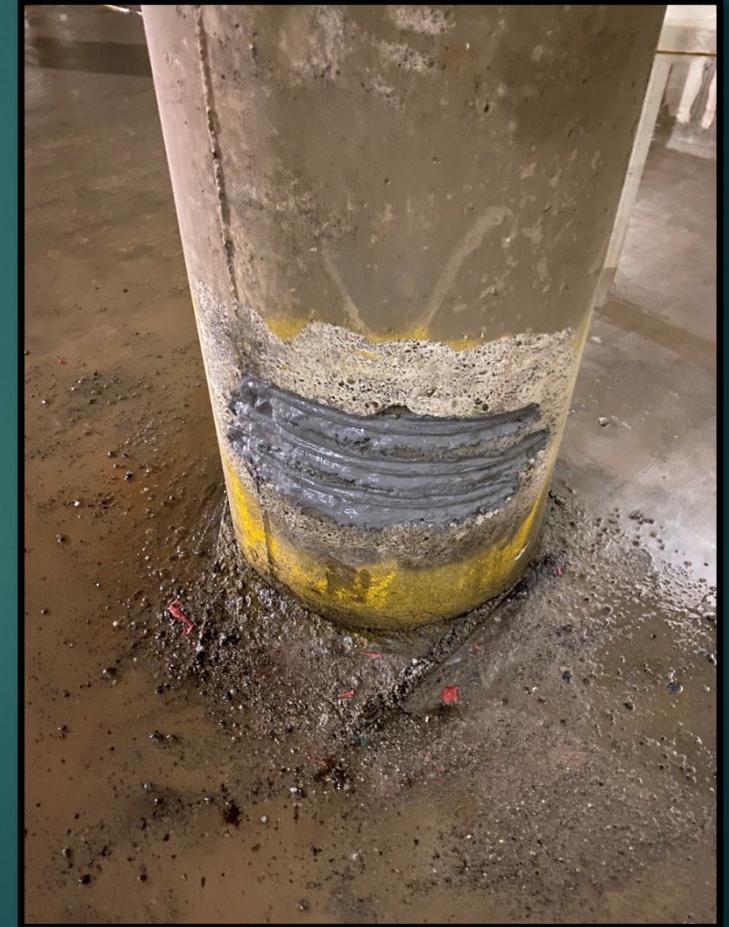
- ▶ Repair of exposed rebar
- ▶ Prep and coat rebar with primer containing corrosion inhibitor prior to grout repair

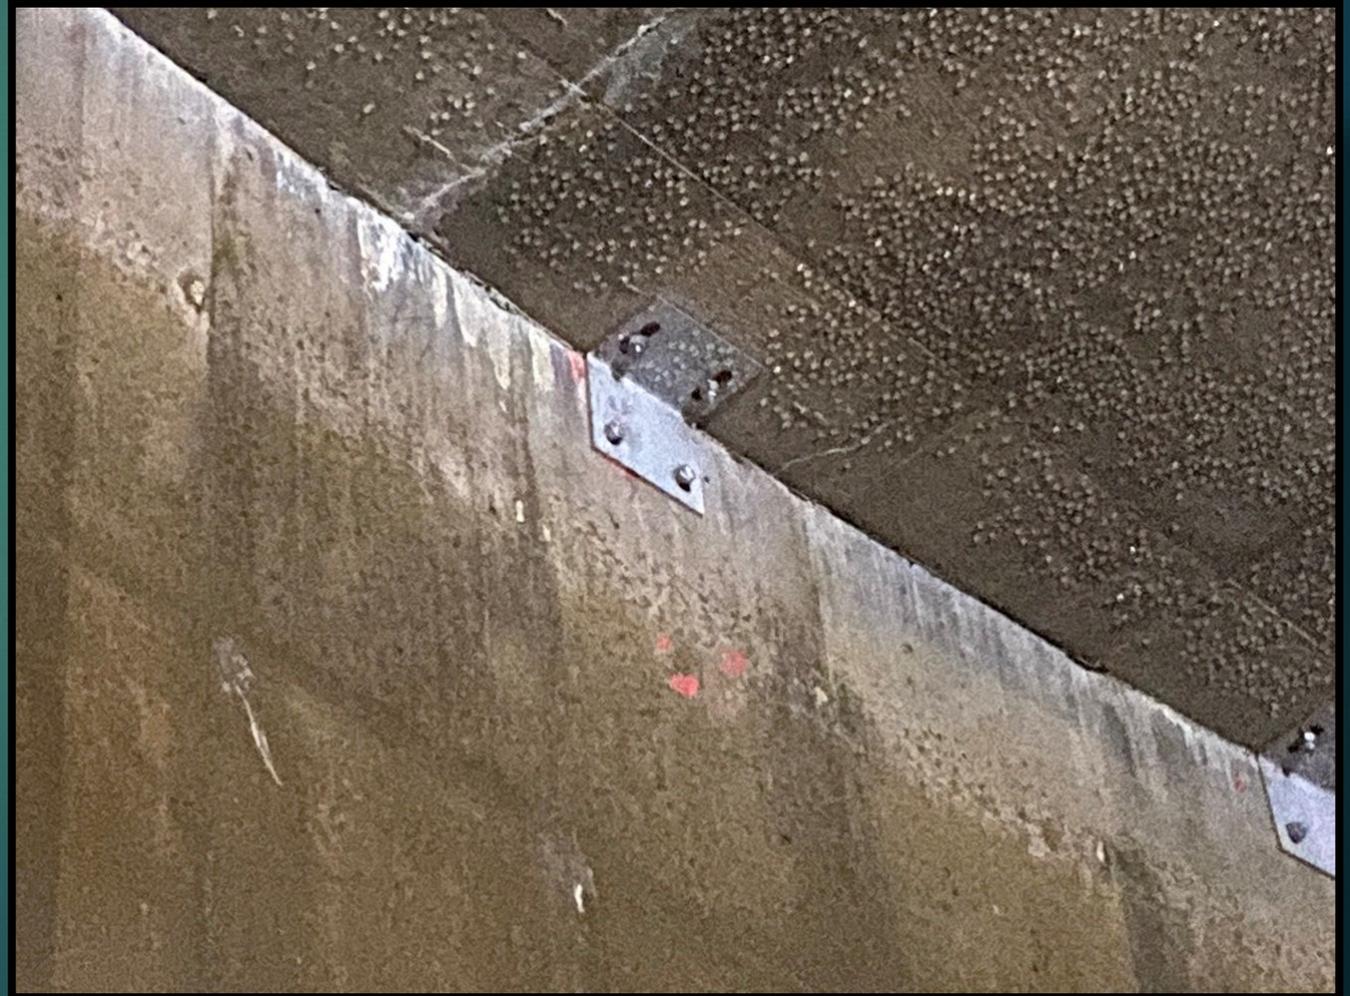
- ▶ Prestressed circular concrete reservoirs –
roof to slab connection
– radial and tangential effects

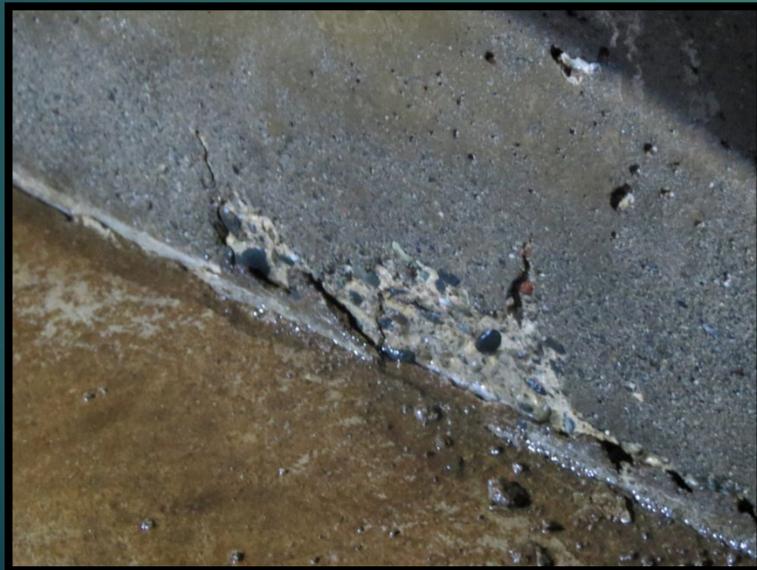
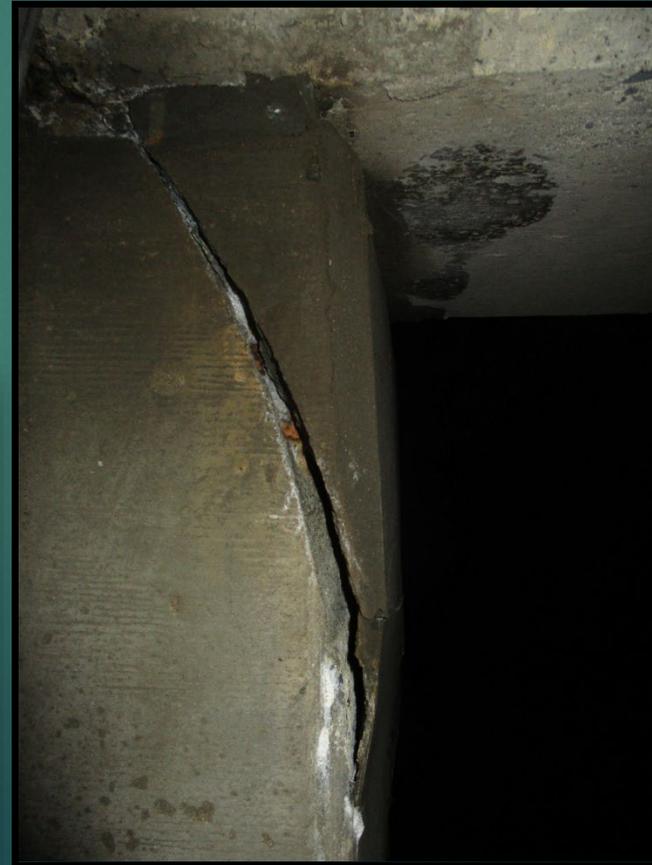
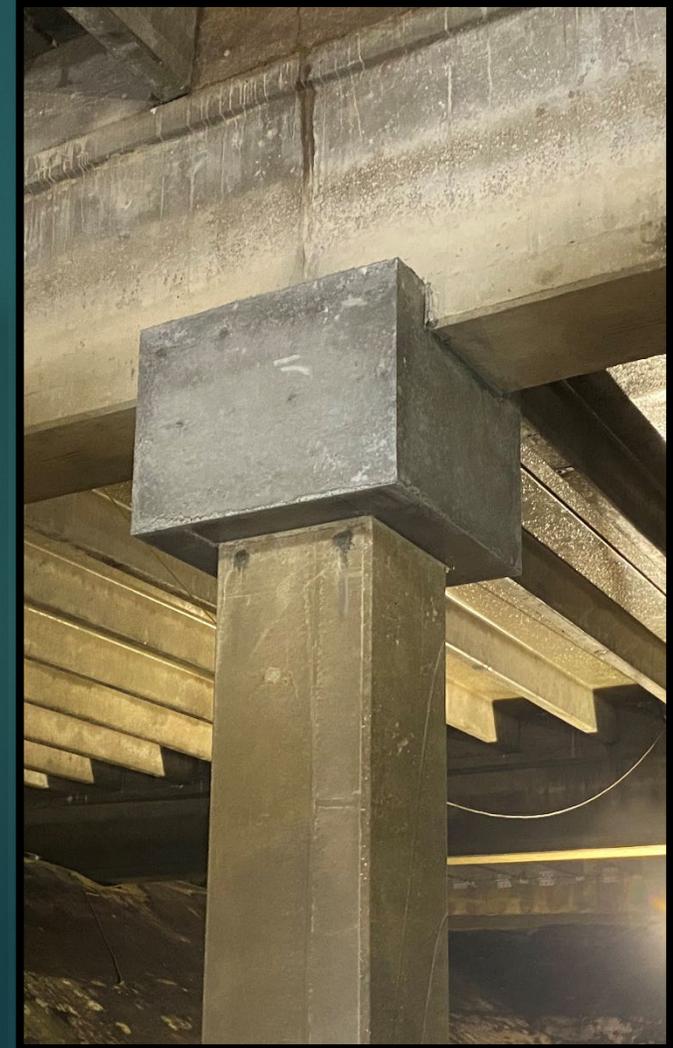
- ▶ Temperature expansion/contraction and restraint cracking
- ▶ Design repairs to address problematic restraint

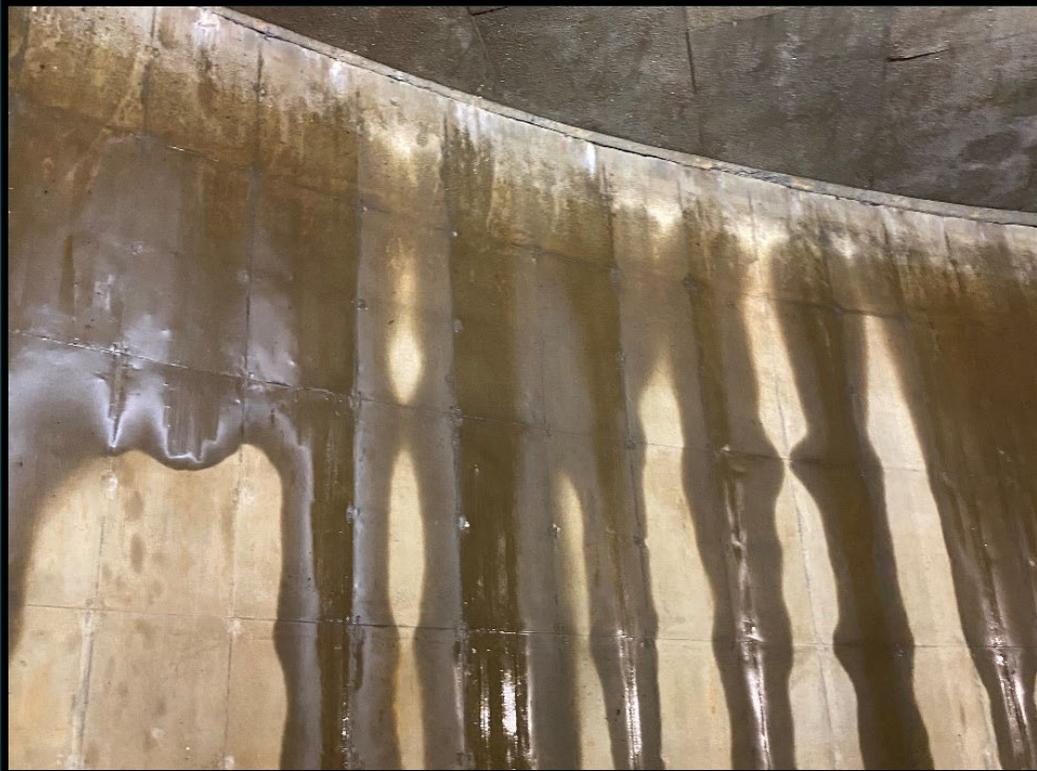
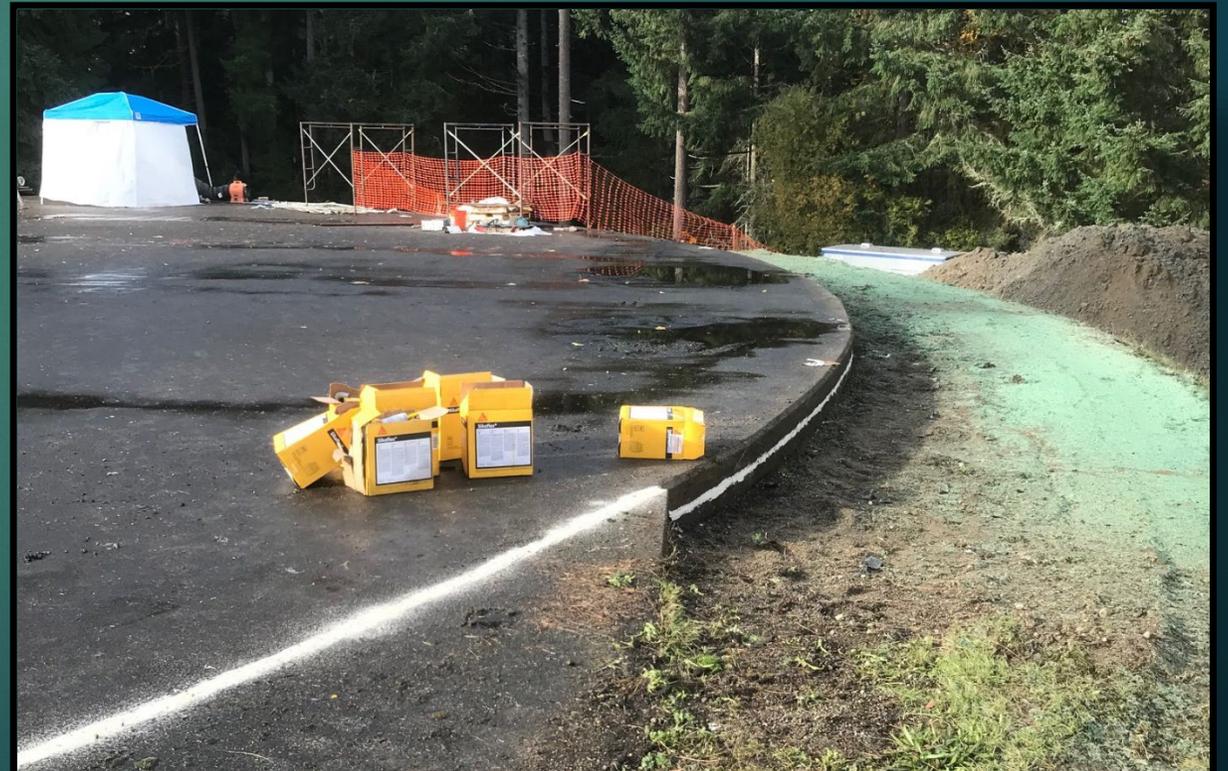
- ▶ Groundwater/Surface water intrusion example

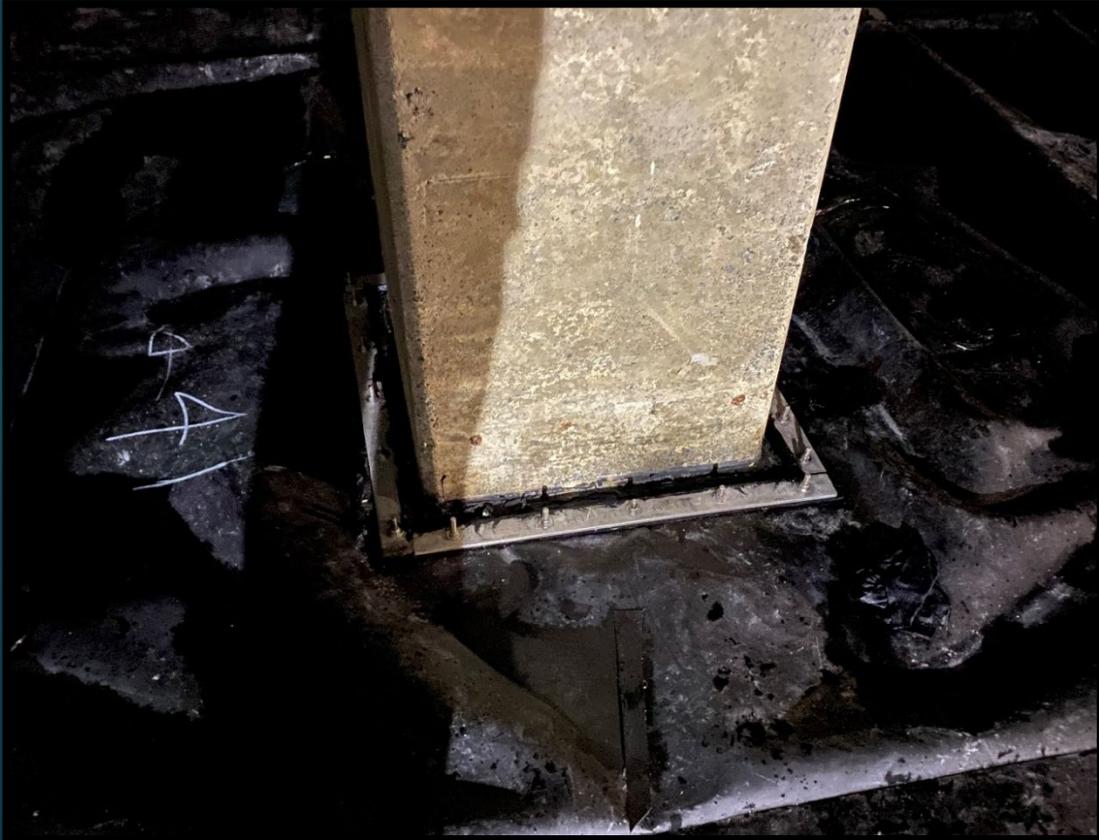
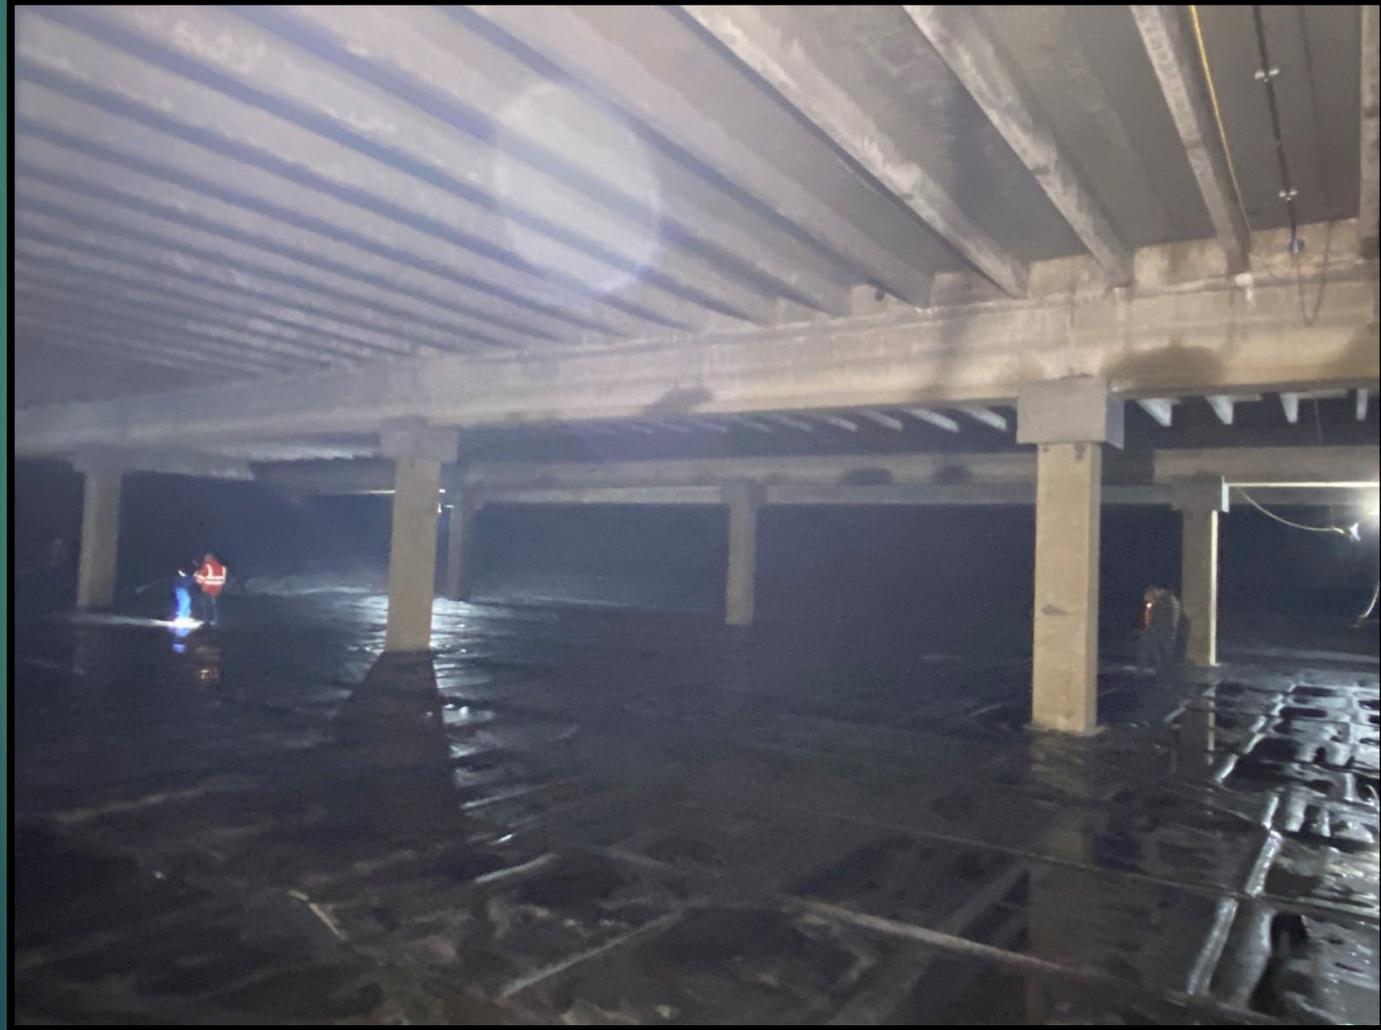
- ▶ Liner to address watertightness

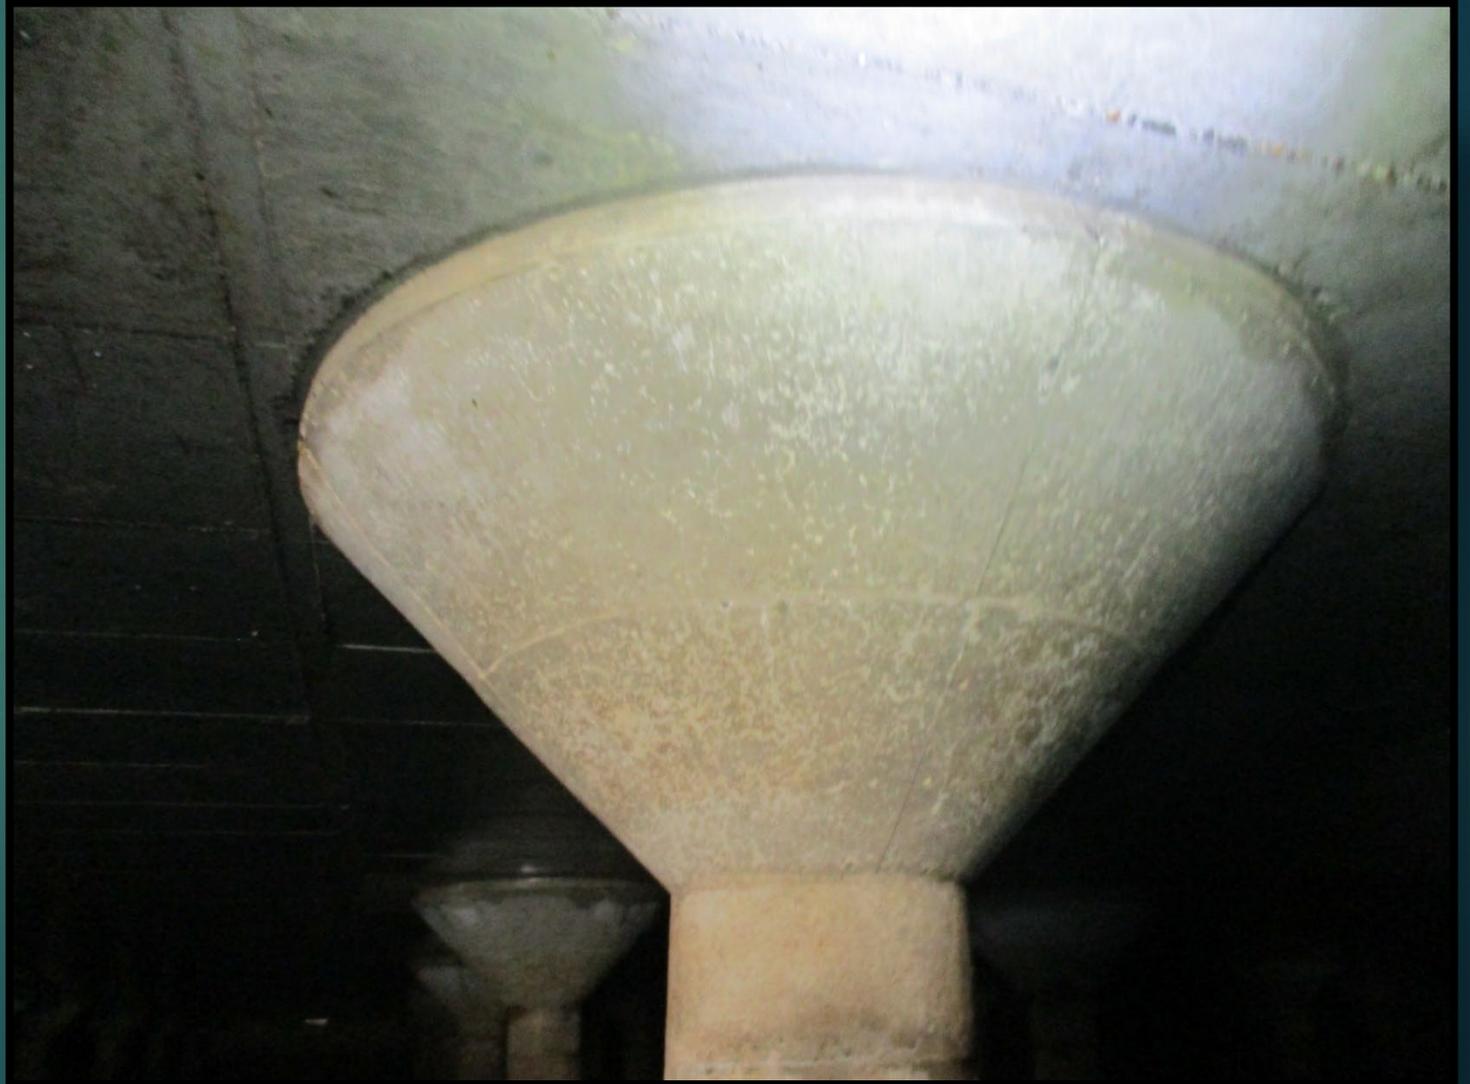
- ▶ Check roof slab to column connection
- ▶ Deformation compatibility

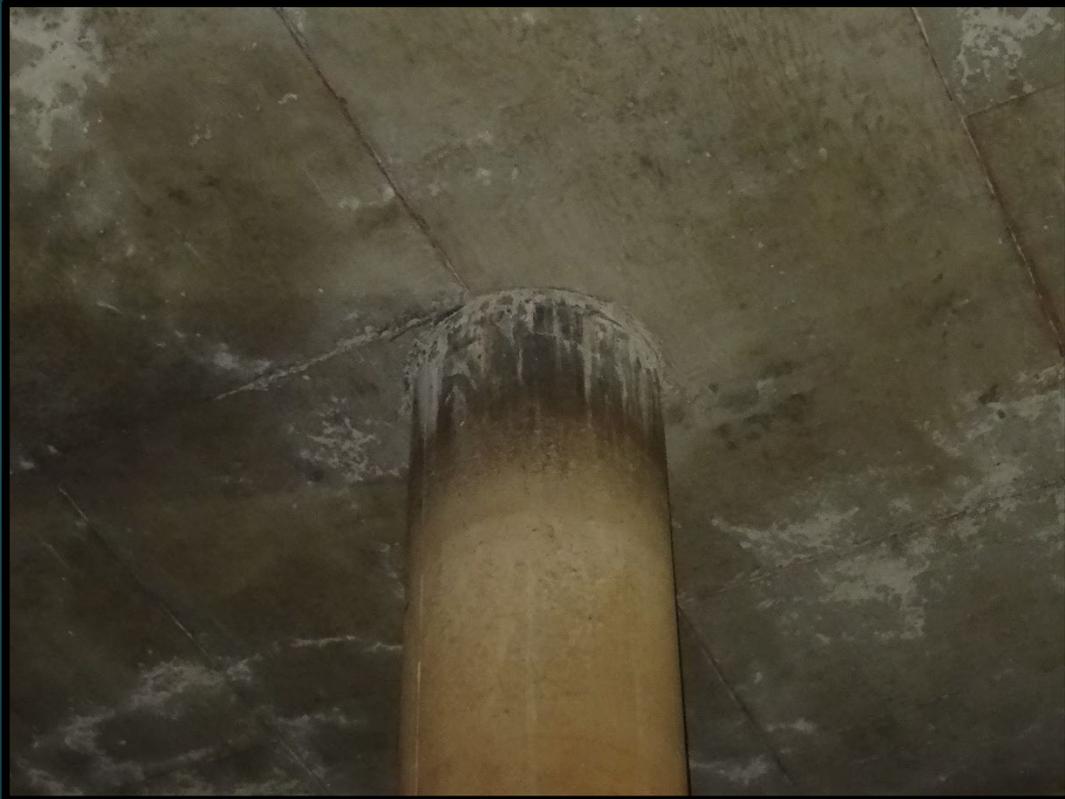
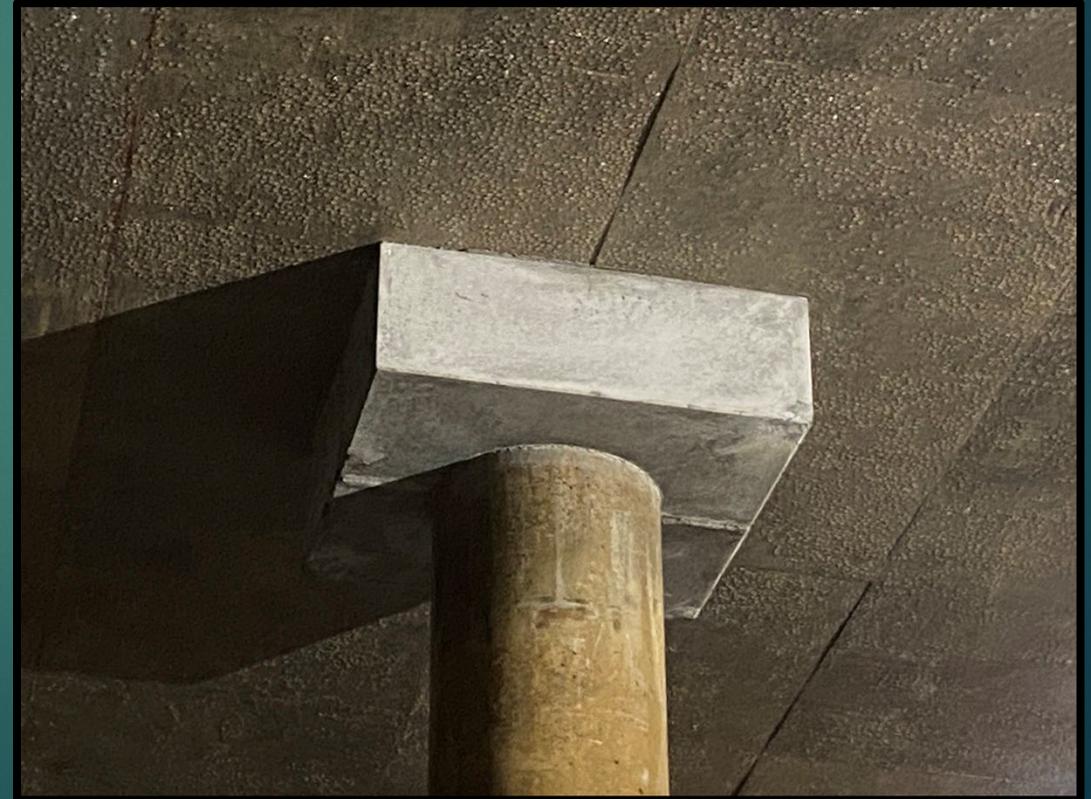
- ▶ Example of seismic retrofit at joint between roof slab and column
