Rehabilitation Options for Aging Concrete Water Storage Reservoirs

Gray & Osborne, Inc.
CONSULTING ENGINEERS

Case Study - Background

- ▶ Yakima 1st Level Reservoir
- ▶ 6 MG buried concrete tank constructed 1971
- ▶ No significant upgrades since original construction
- ▶ Known concrete damage at floor
- ▶ Known leakage from reservoir

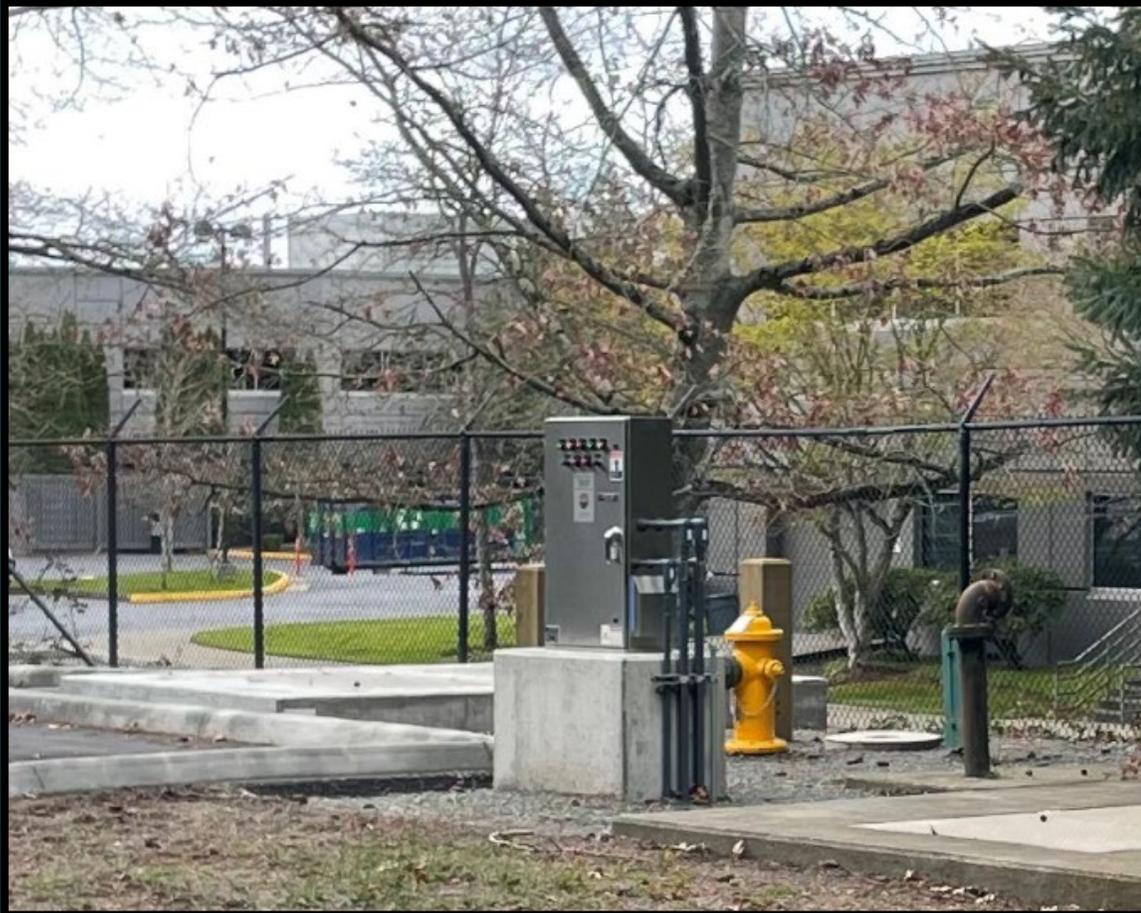
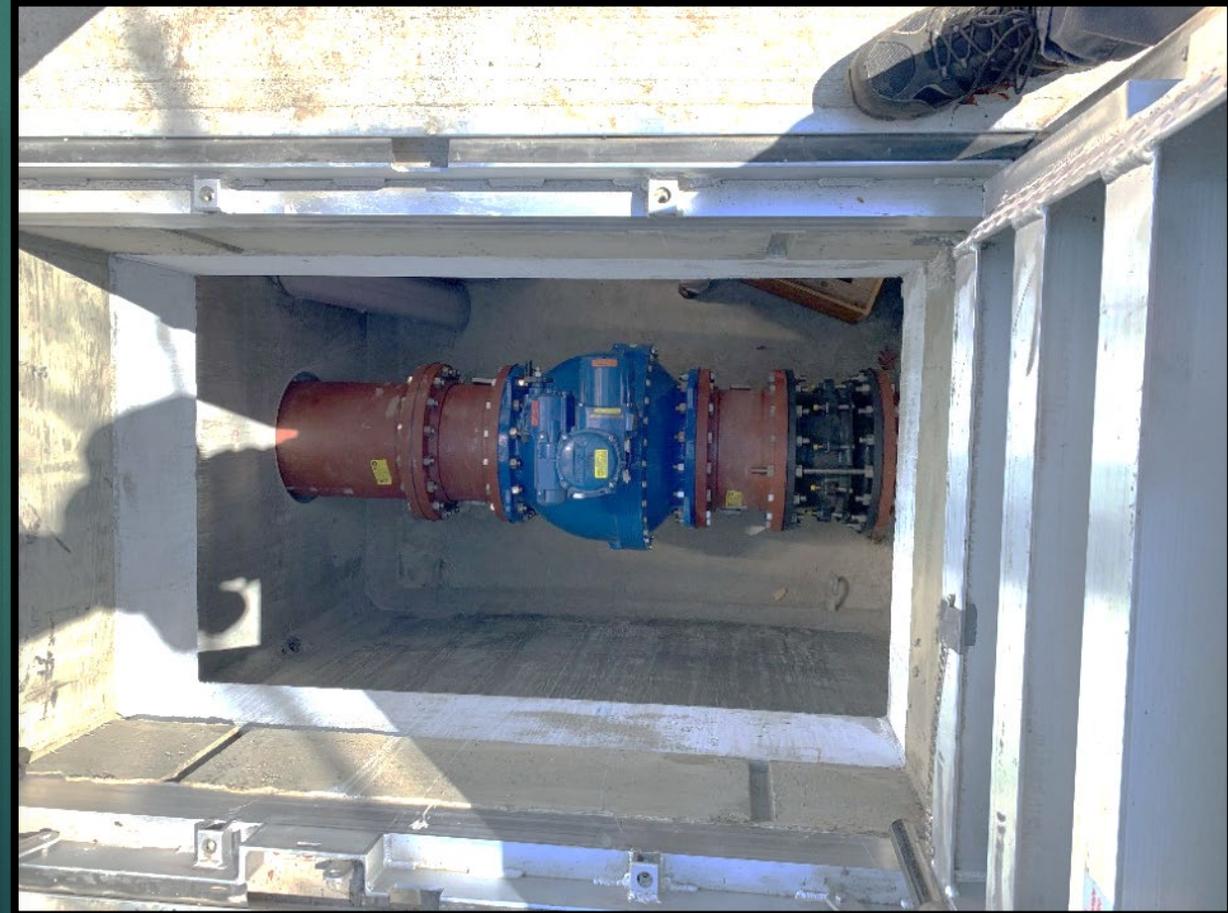
- ▶ Seismic sensor and valves

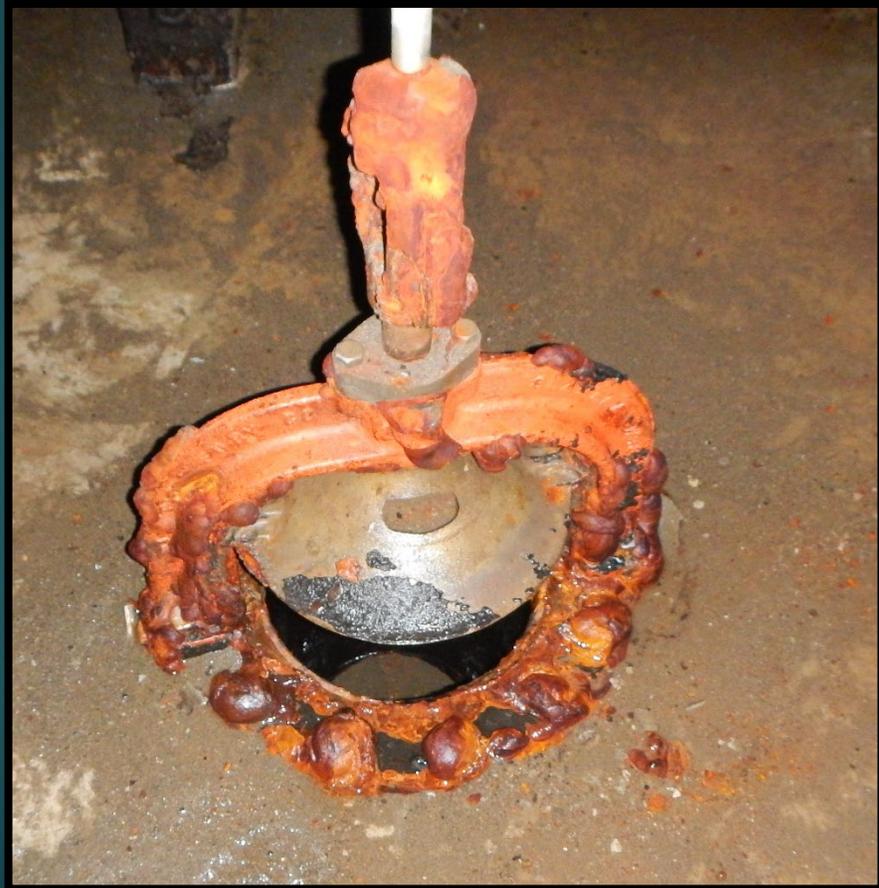
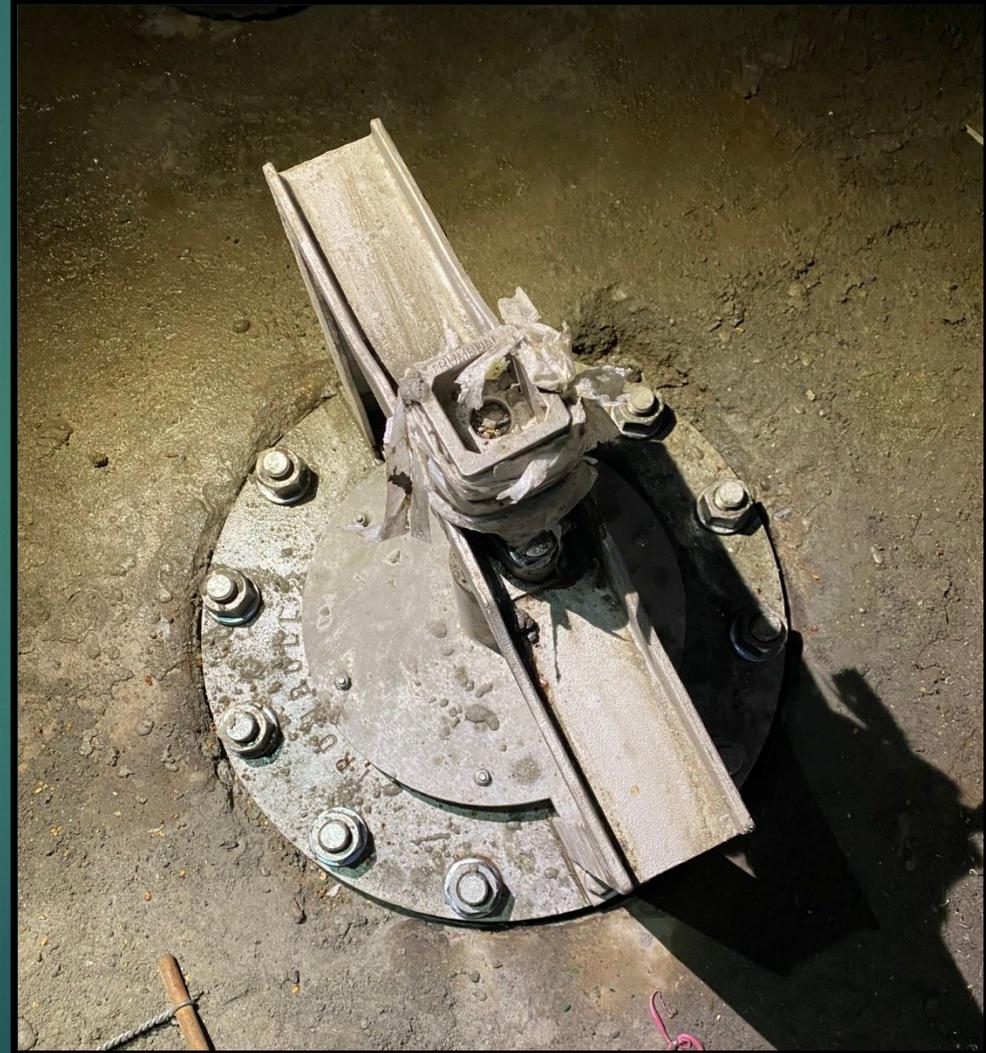
- ▶ Drain Valves

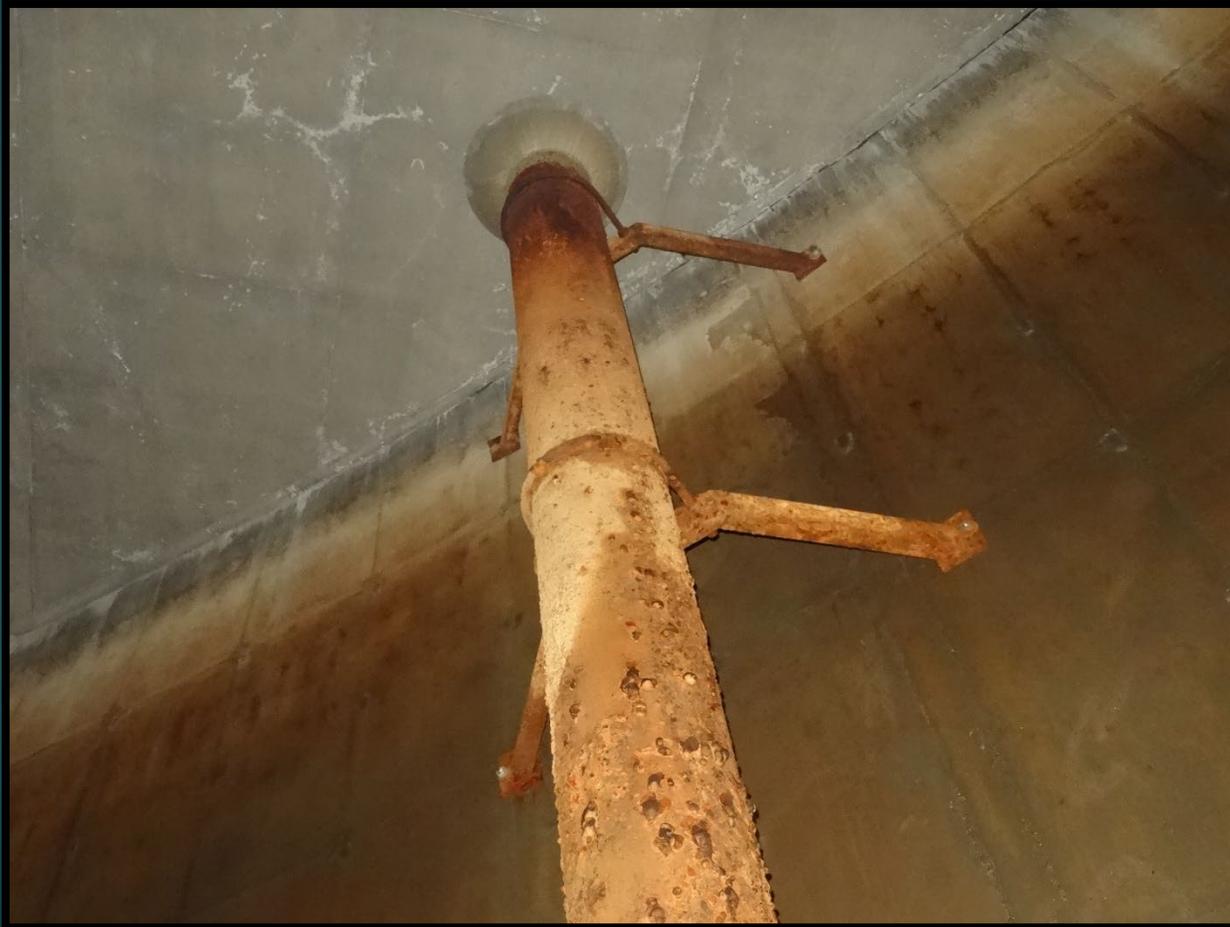
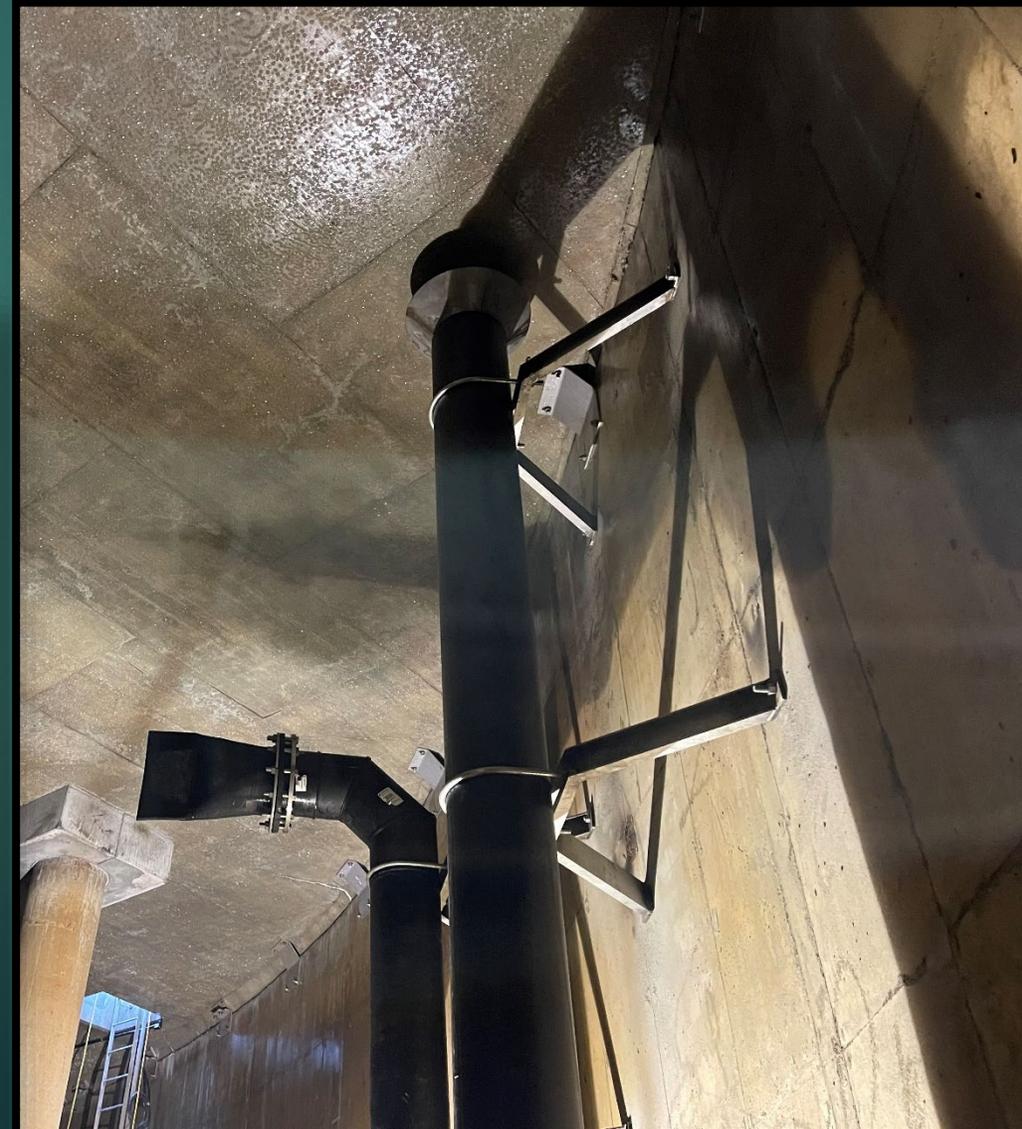
► Overflow Piping

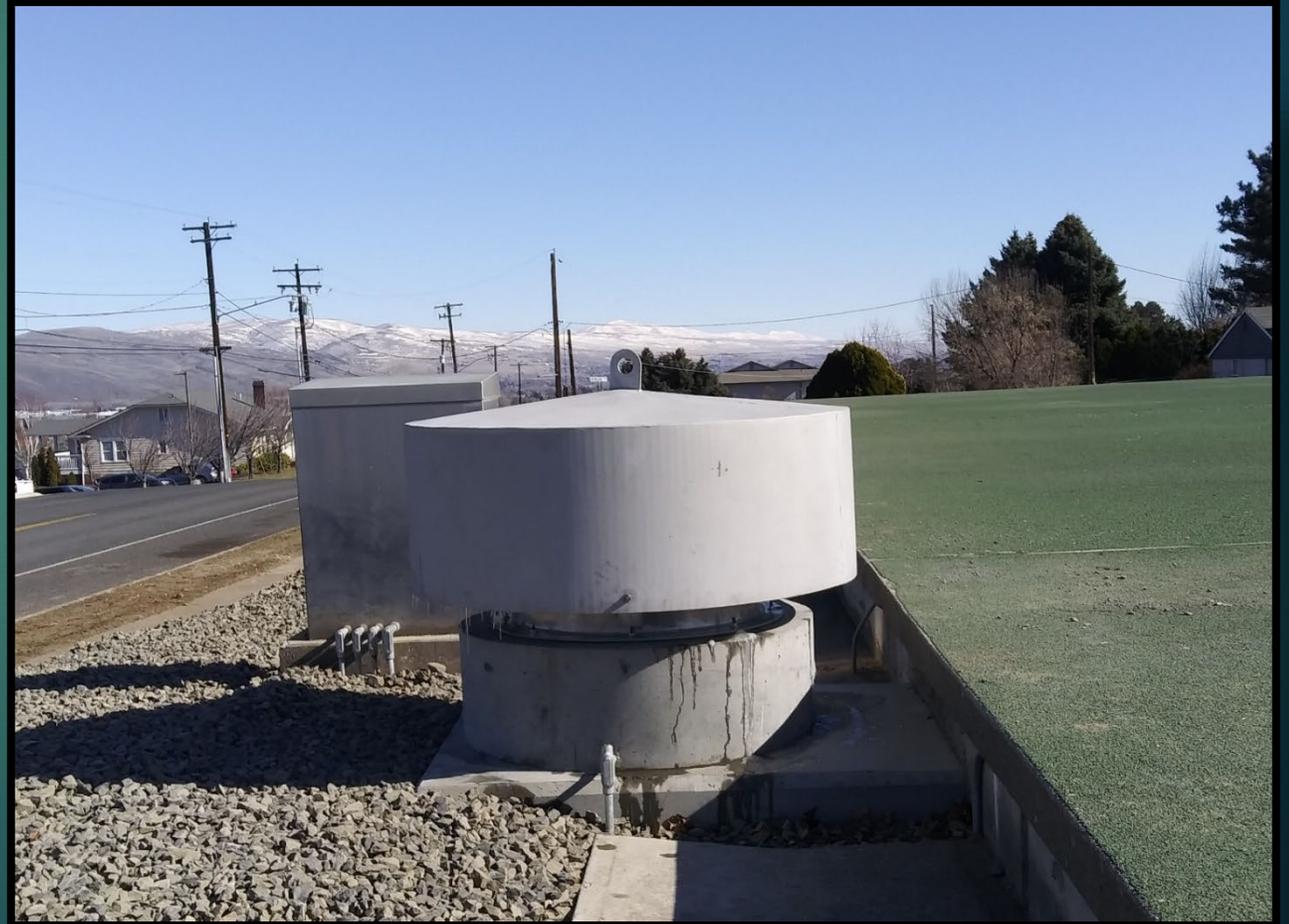
Roof Vent:

- ▶ Existing vents were undersized
- ▶ City opted for locating at side of reservoir rather than on roof

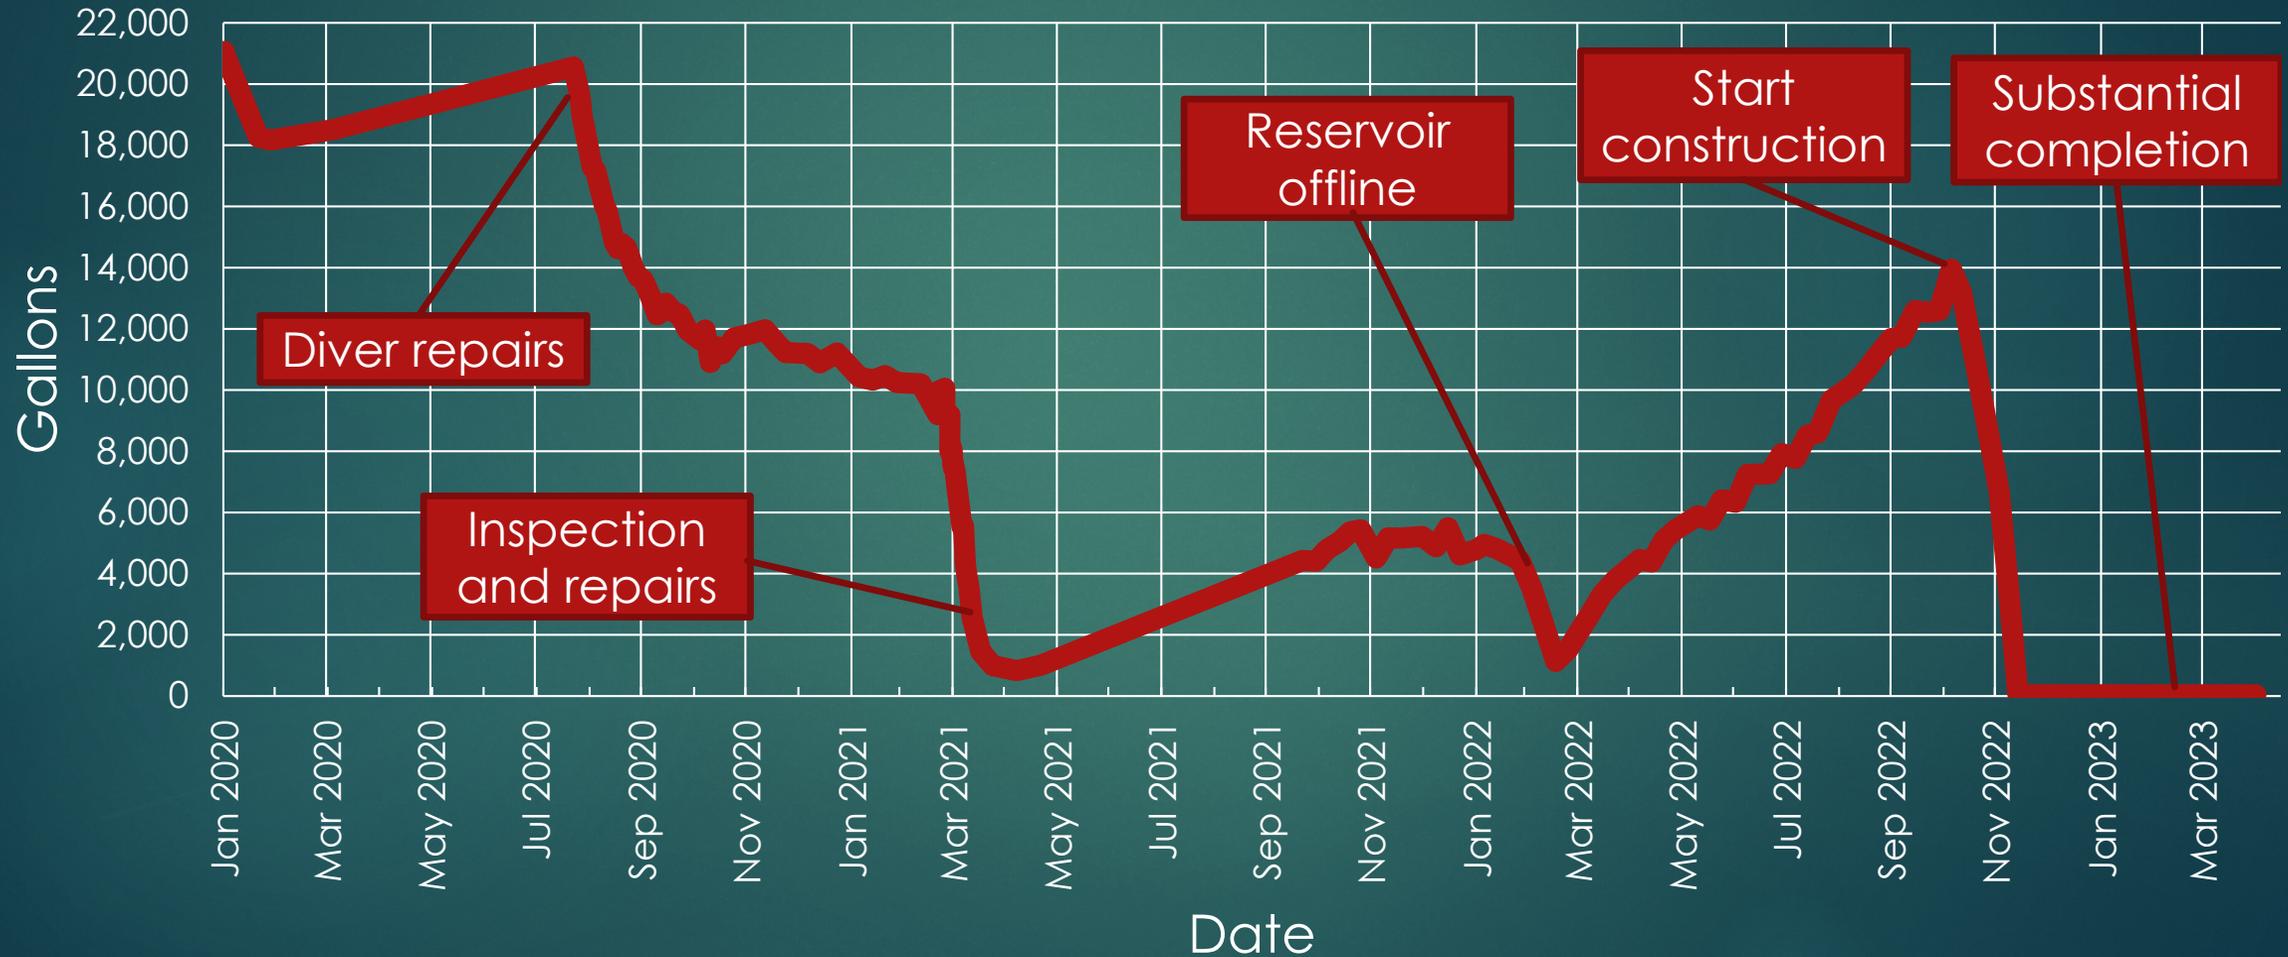
Leakage History and Current Status

Sump Pump Discharge (gpd)
