Improving System Resiliency One Critical Valve at a Time

Portland Water Bureau
PNWS AWWA 2024
Section Conference

Critical Valve Replacements

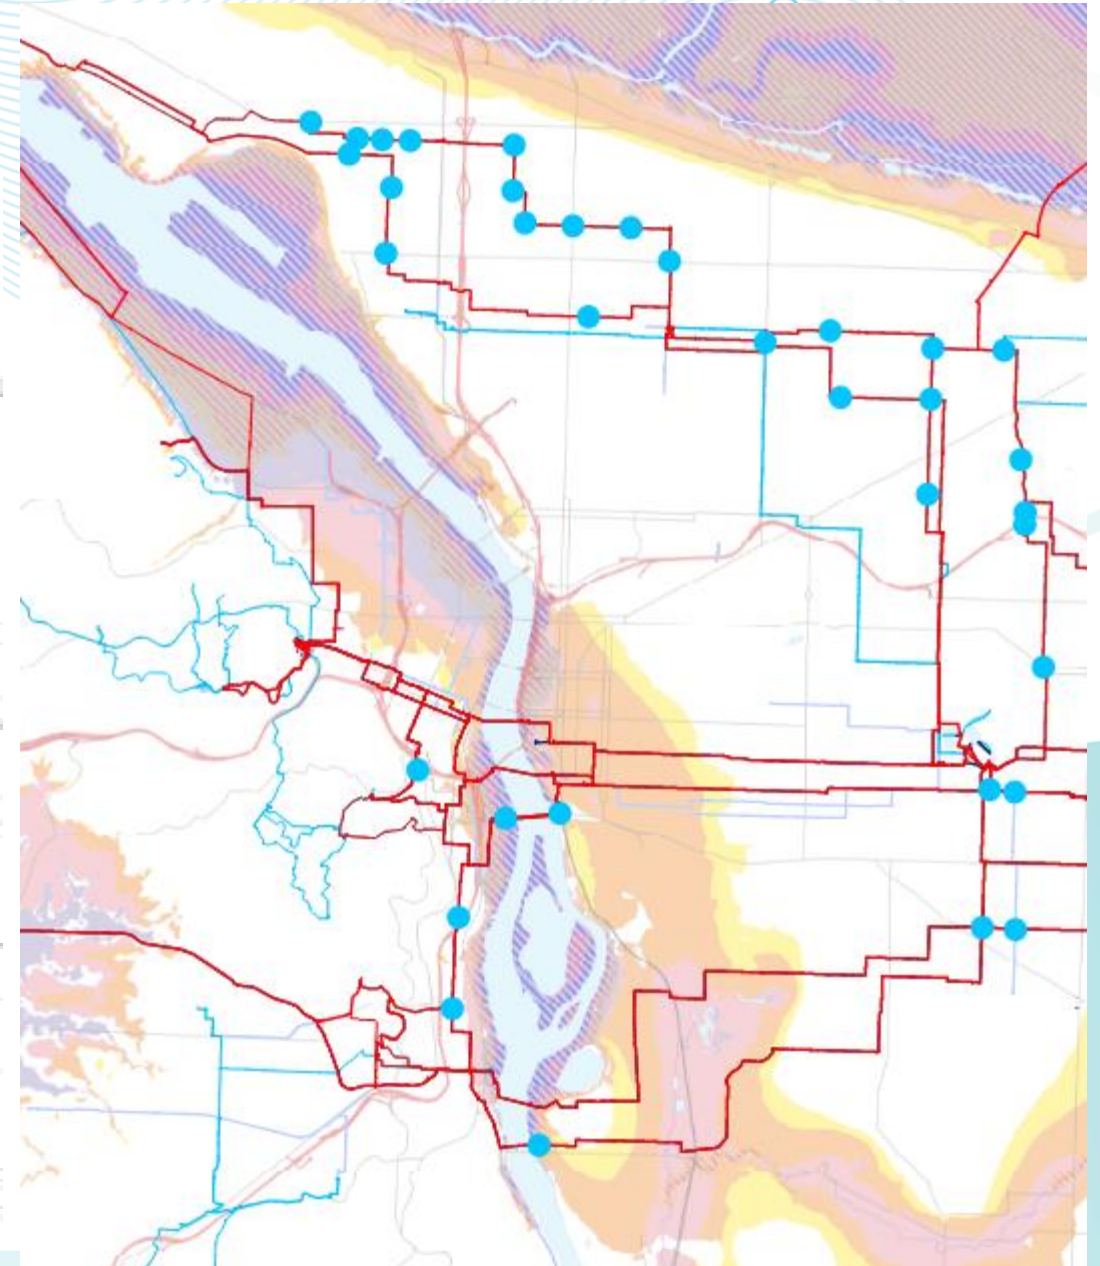
Large Valves + Liquefaction + Lateral Spread

- Horizontal Valve on Backbone
- Horizontal Valve
- Other Valve on Backbone
- Other Valve
- Butterfly Valve on Backbone
- Butterfly Valve
- Backbone
- Transmission Main
- Distribution/Transport Main
- Distribution Main

Lateral Spread

- 10-83 Feet
- 5-10 Feet
- 1-5 Feet
- 0.5-1 Feet

Liquefaction

- Very High
- High
- Moderate
- Low

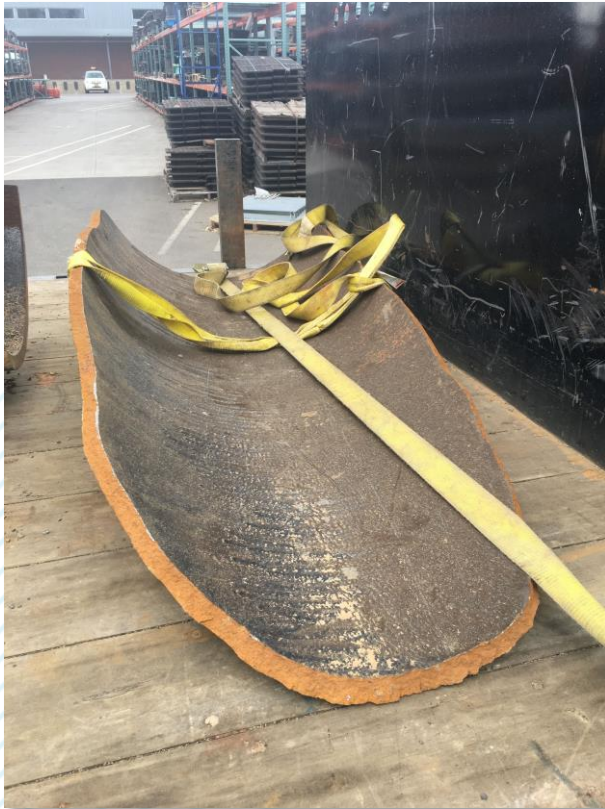
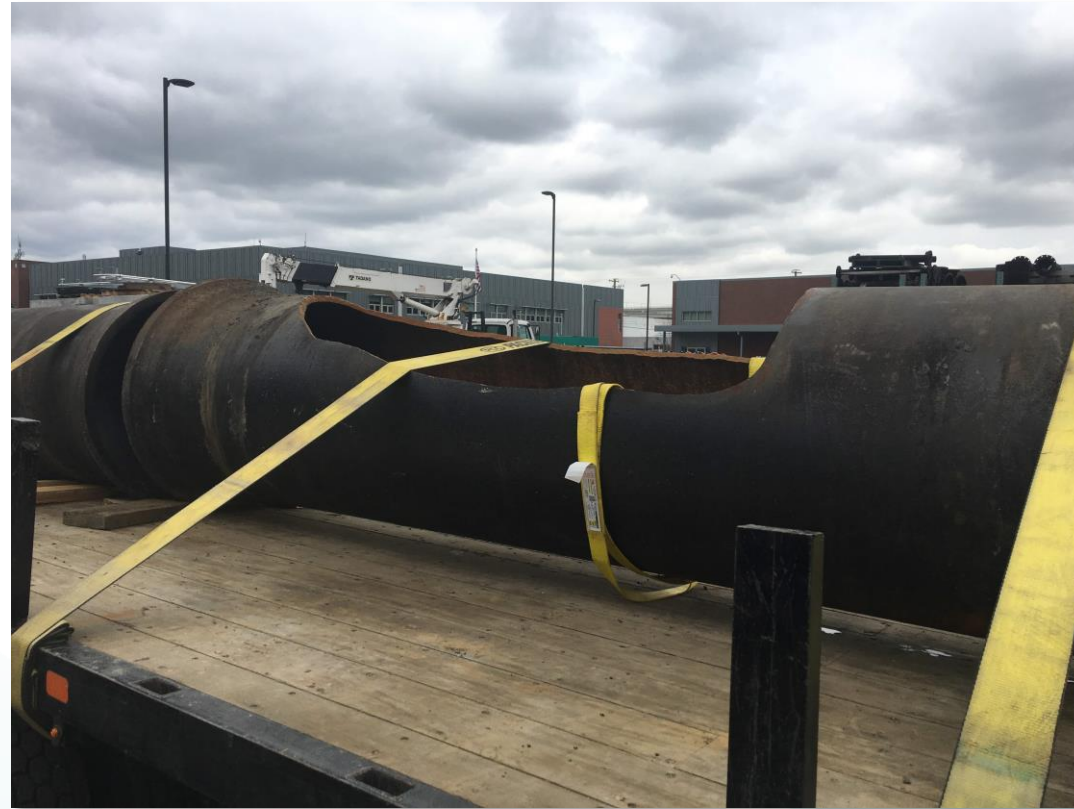
30-inch Broken CI Pipe

- Installed in 1915
- Supplies Vernon Tank Site
- Carries up to 9500 gpm
- Contributes to the supply of 100,000+ customers

The Portland Water Bureau on March 16, 2019 reported the break of a 30-inch water main at 23rd and Skidmore in Northeast Portland. The break of the cast-iron pipe sent a million of gallons of water onto nearby streets, prompting the closure of an area from NE 21st Avenue to NE 30th Avenue, and from NE Alameda to Rosa Parks Way. The break occurred about 11:30 a.m. The Bureau's press release is [here](#). [Portland Water Bureau Press Release on Water Main Break](#) (282.97 KB)

Although the Water Bureau reports about 200 breaks a year in pipes ranging from 2-inches to 24 inches, this incident was more significant because of the size of the pipe and volume of water it unleashed.
