# Proactive Pipeline Management:

Gresham's Innovative Approach to Watermain Assessment  
using Non-linear Vibroacoustics

**Cameron Lee**

2025 PNWS – AWWWS Conference, Boise, Idaho  
May 8<sup>th</sup>, 2025

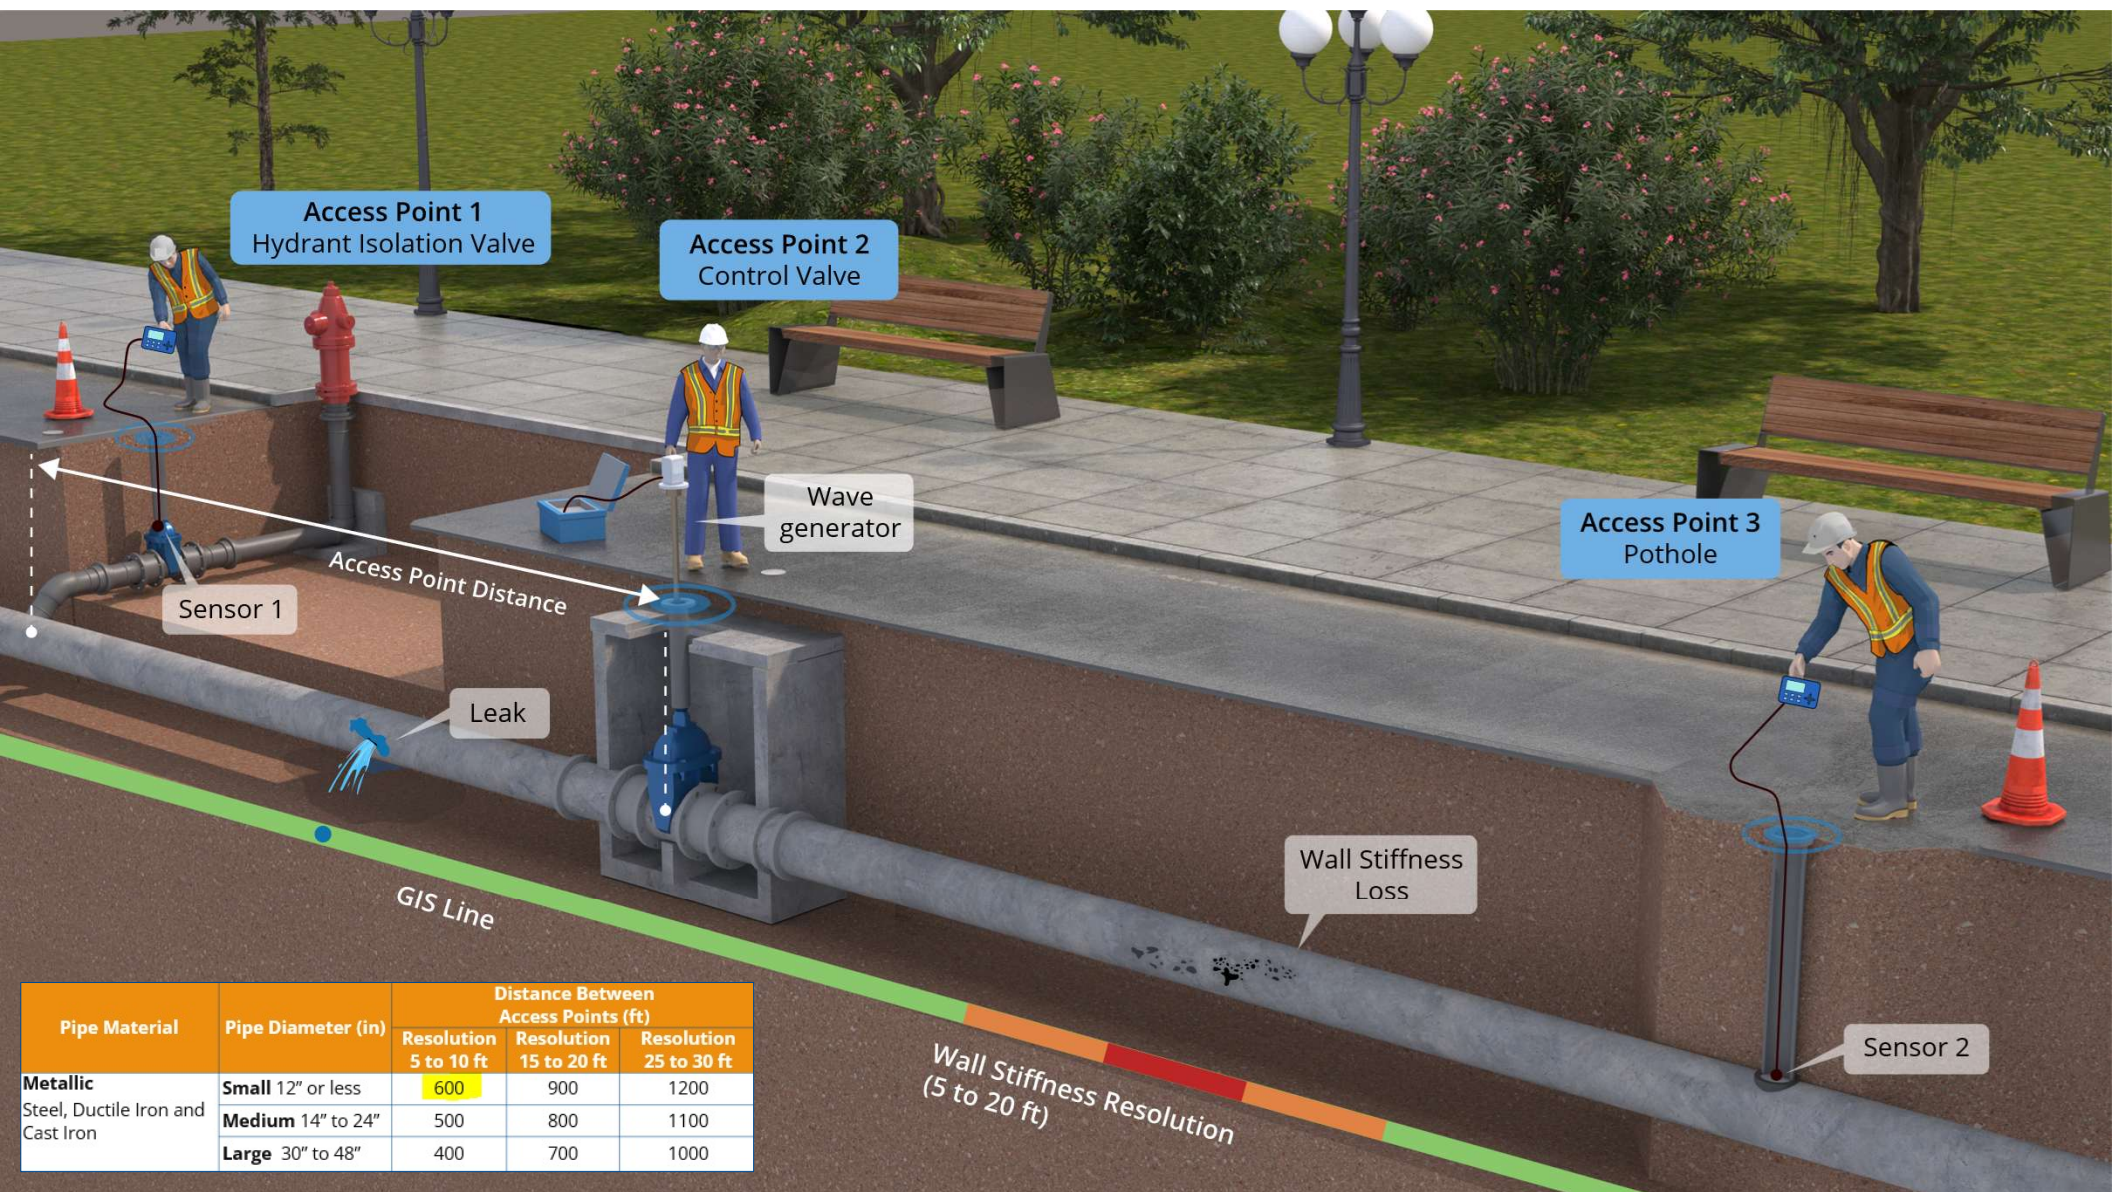
# Dynamic Response Imaging

Vibroacoustic based Non-Invasive Pipeline Inspection

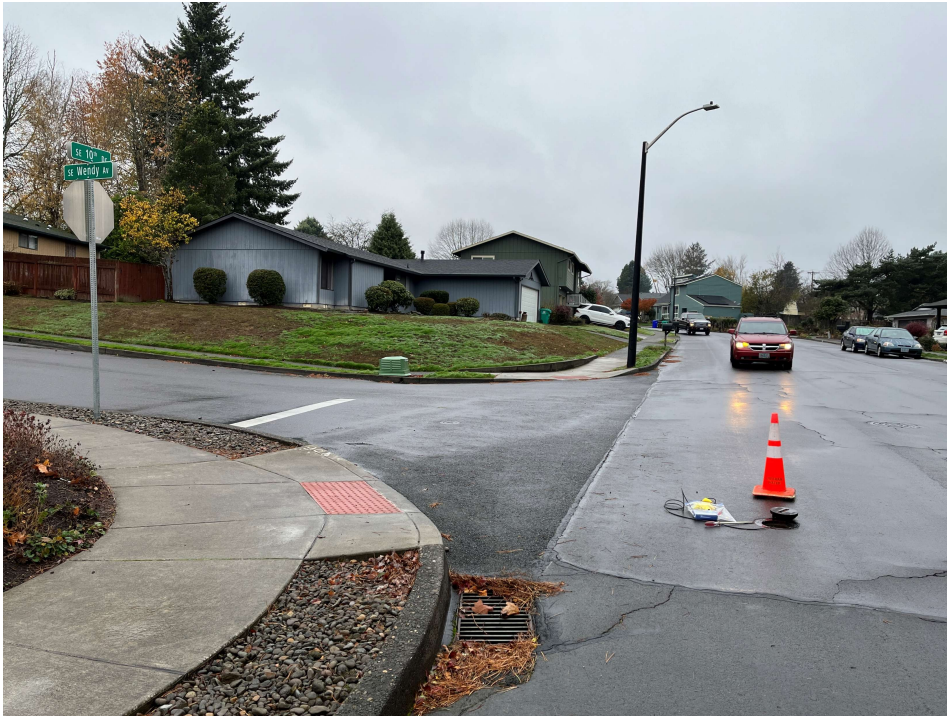
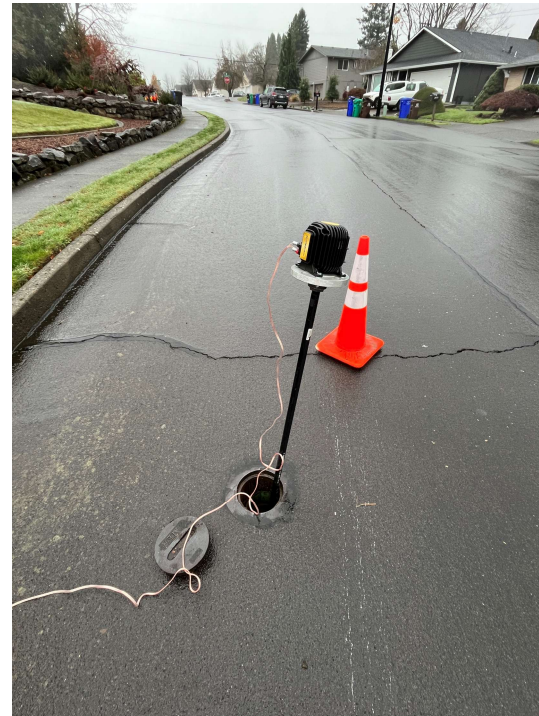
# Pilot Project

## Field Work

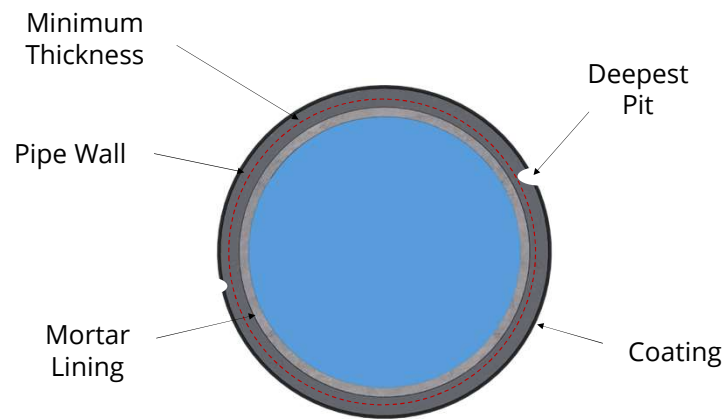
## Validation Process

The stiffness of a 'hoop' is driven by the lowest circumferential thickness.

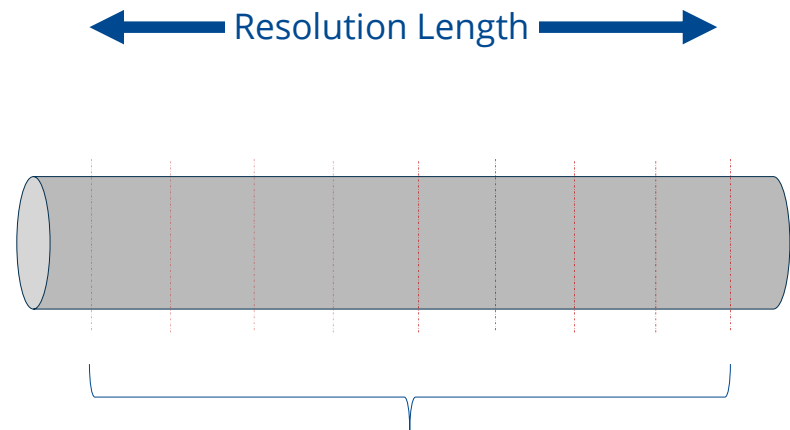
DRI Thickness  $\approx$  Minimum circumferential thickness averaged over the resolution length

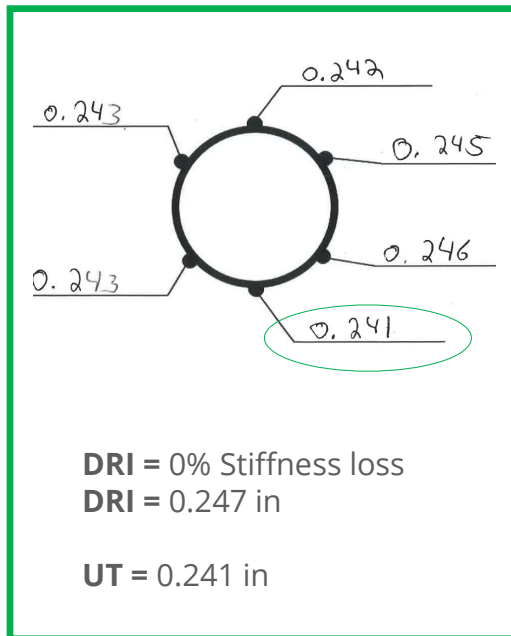
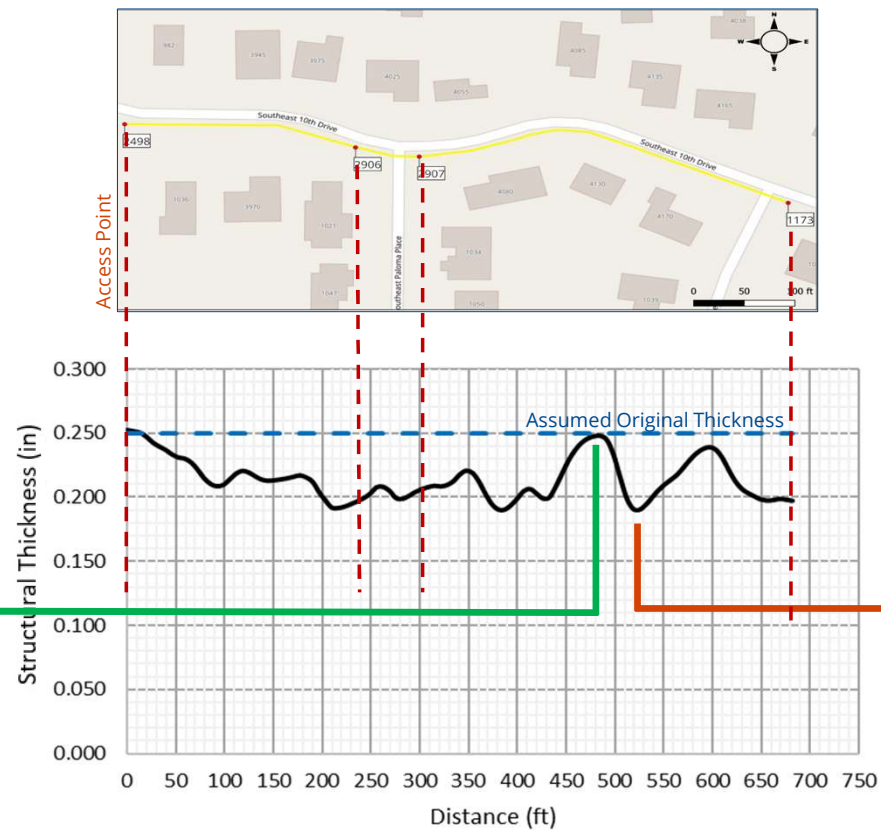
## Validation Results: SE 10<sup>th</sup> Dr, 6-inch Ductile Iron

### Daylight - Slice

**DRI = 24% Stiffness Loss**  
**DRI = 0.189 in**  
**UT = 0.187 in**

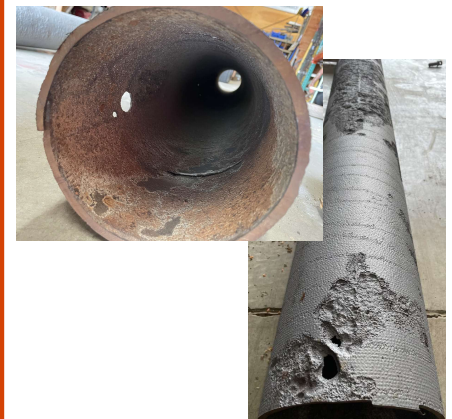
### Pipe Stick Removed

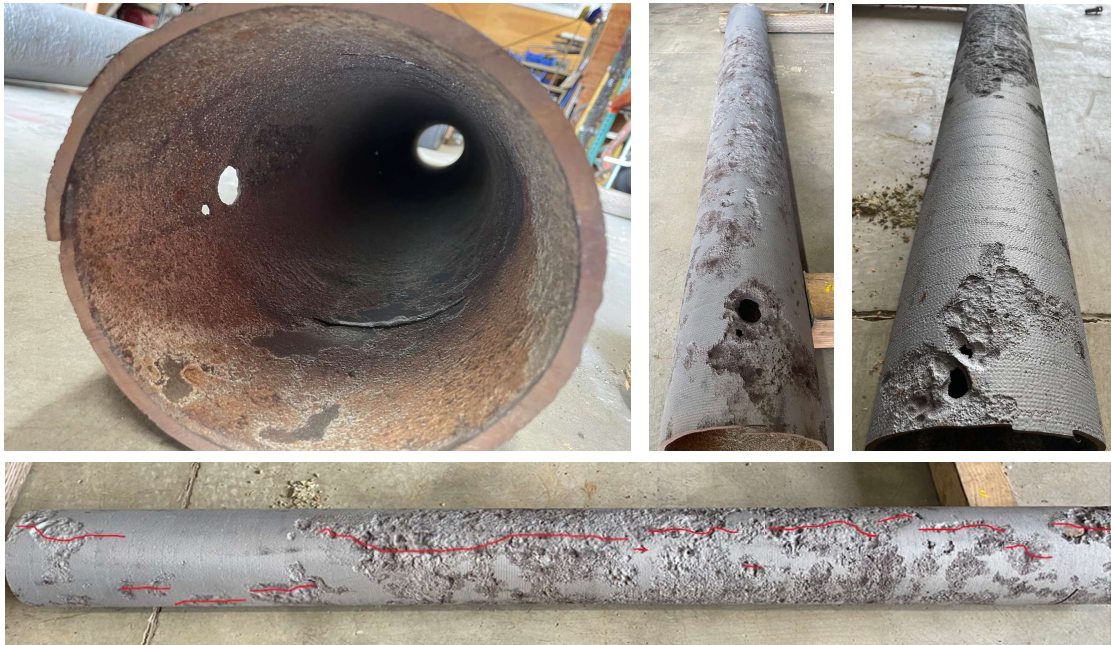
Validation – SE 10<sup>th</sup> Drive 6in Ductile Iron

↓ “Slice” every 6 in

— Minimum Circumferential Wall thickness

Avg minimum (Red) = 0.187 in

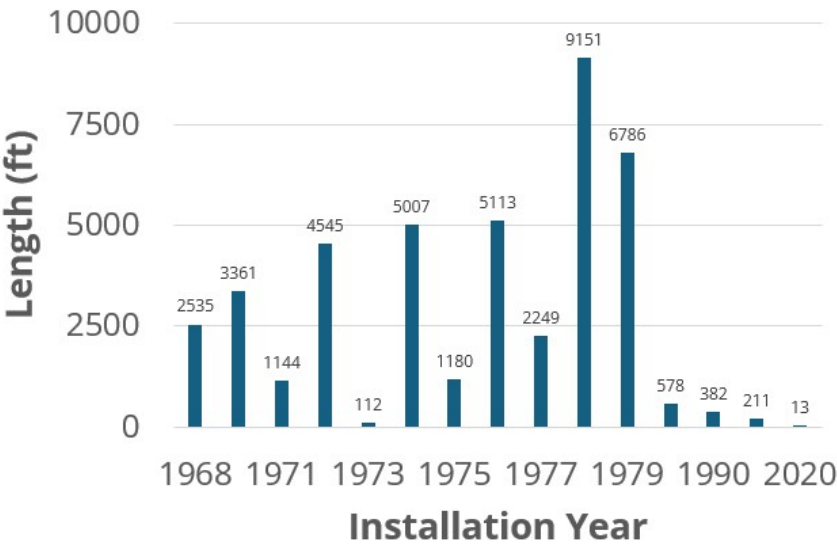
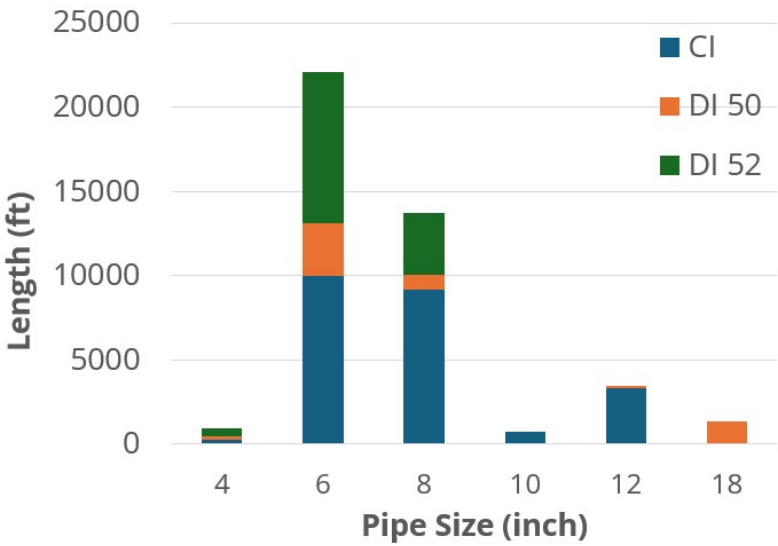
7.7 miles collected over 6 field days (2 crews)

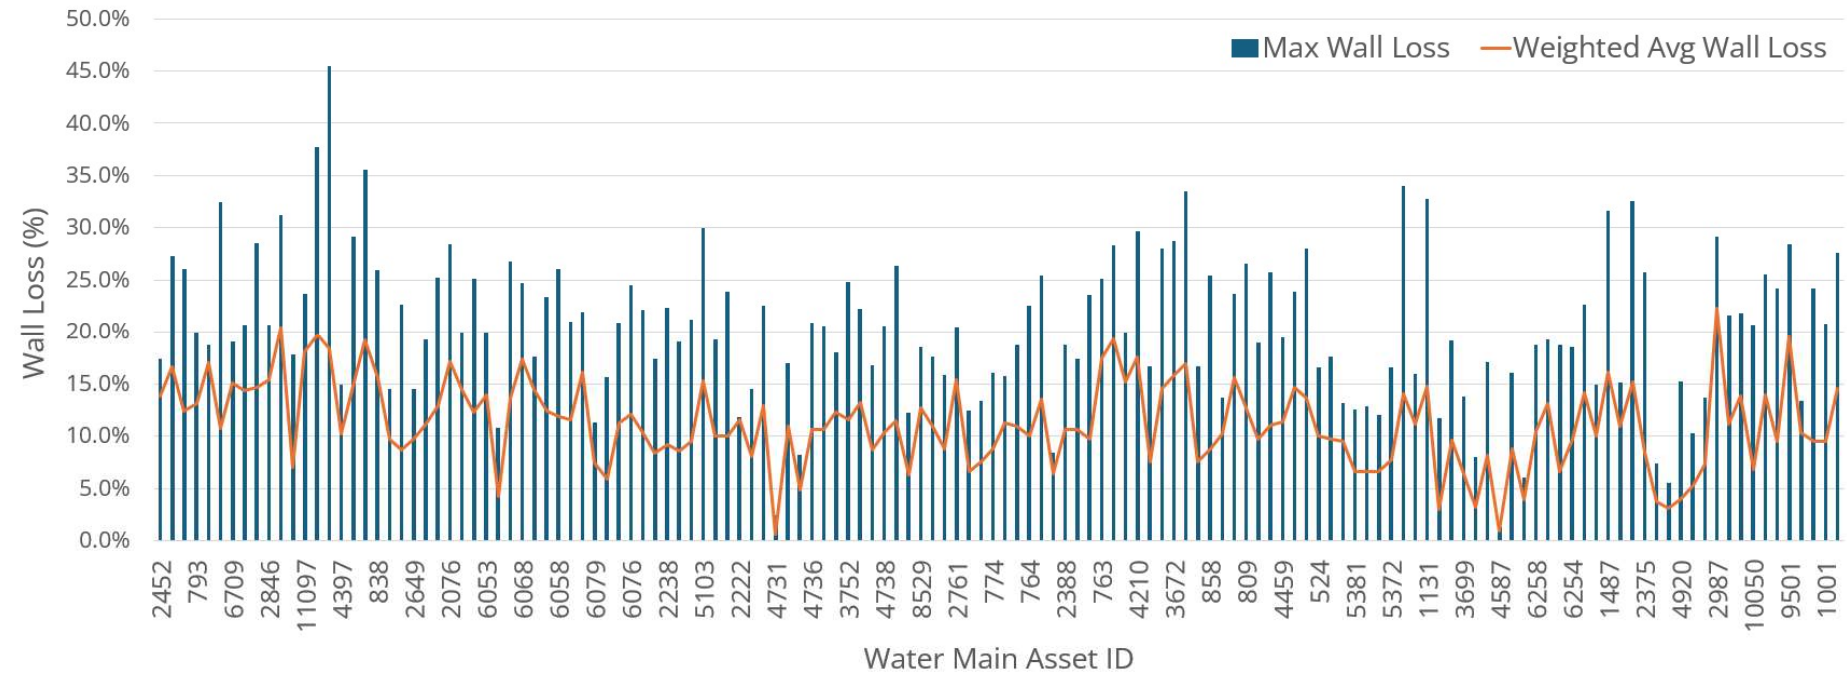
## Wall Loss by Asset ID

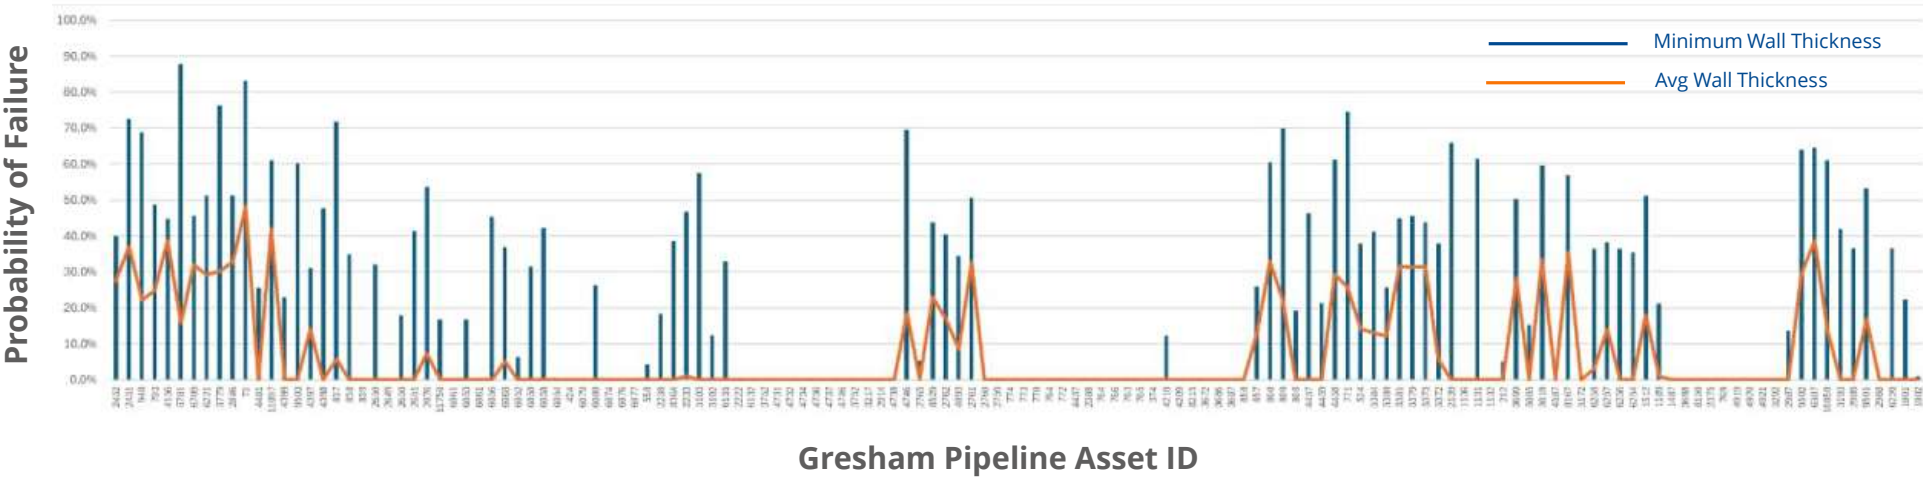
## Factor of Safety and Current Probability of Failure

Factor of Safety (FOS)

$$FOS = \frac{\sigma_{Yield}}{\sigma_{Total Hoop Stresses}}$$

FOS ≤ 1 = 100% (pipe is at or below yield limit)

FOS ≥ 2 = 0%

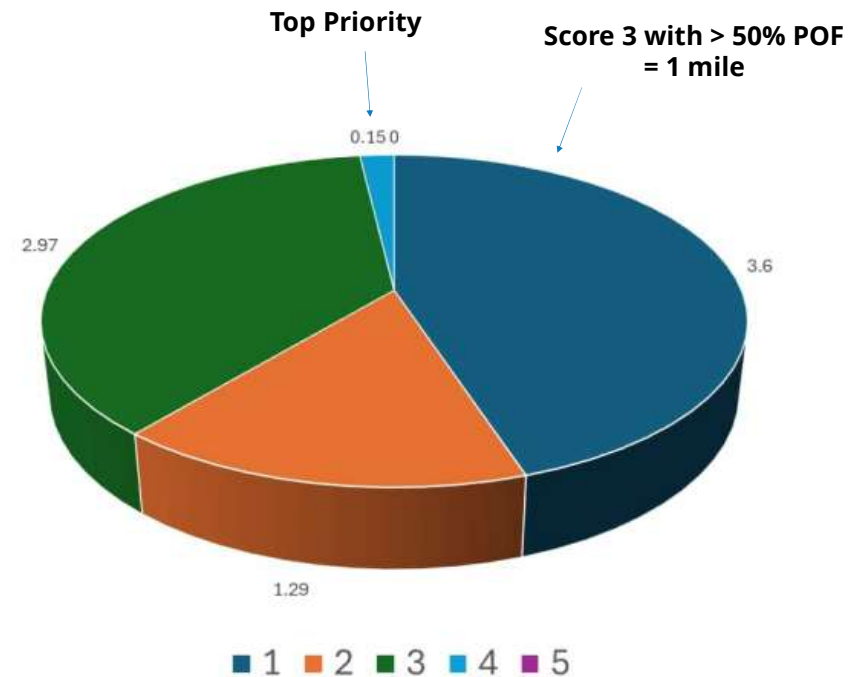
## Likelihood of Failure (LOF) 1 to 5

- Score (1 to 4) based on Remaining Useful Life (RUL) Estimate
  - RUL = time to reach  $FOS \leq 1$
  - RUL assumes straight line deterioration
- Bonus point for segments w break or leak

RUL (Years)	Likelihood of Failure <sup>1</sup>
50-100	1
40-49	2
1-39	3
0	4
0 (with history of main break)	5
