Three Earthquakes: Haiti, Chile, and Calexico

Don Ballantyne
MMI Engineering
Federal Way, Washington

Pacific Northwest Section of the AWWA
May 14, 2010

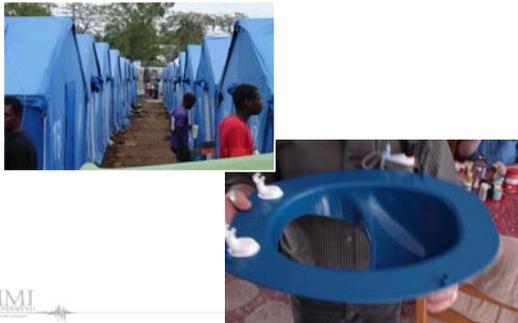
Waste Disposal

- Septic systems (10-30%) – large modern buildings
- Cesspools/Latrines (30%)
- Balance to drainage system
- Only WWTP in country at National Hospital and was inoperable before earthquake

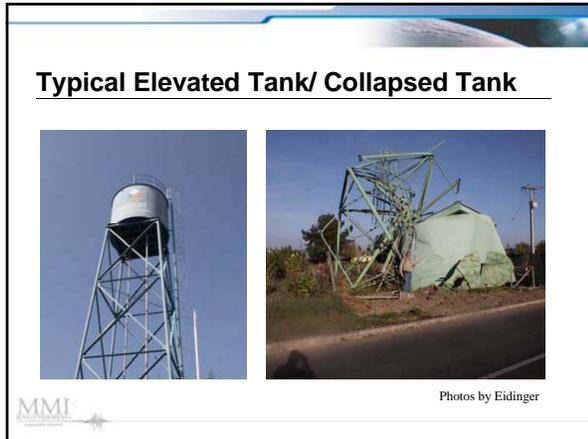
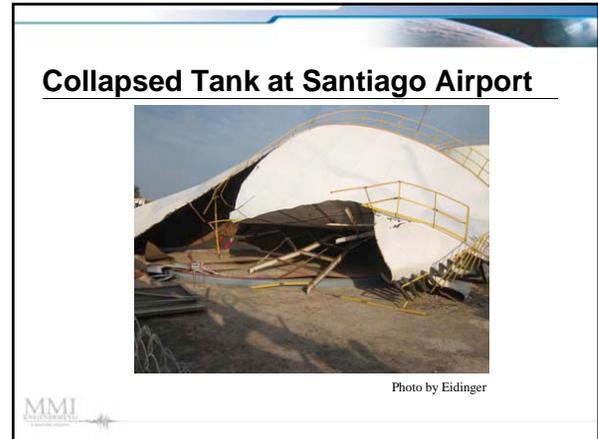
Rural Water Systems

- Groundwater with submersible pumps
- Small steel elevated tanks ~ 10,000 gallons
 - 73 tanks of 420 exposed to strong shaking collapsed
 - PVC distribution
