# Gabbert Reservoir Seismic Upgrade Project

Tom Boland, P.E.

May 9, 2014

# Existing 200,000 gallon Gabbert Reservoir

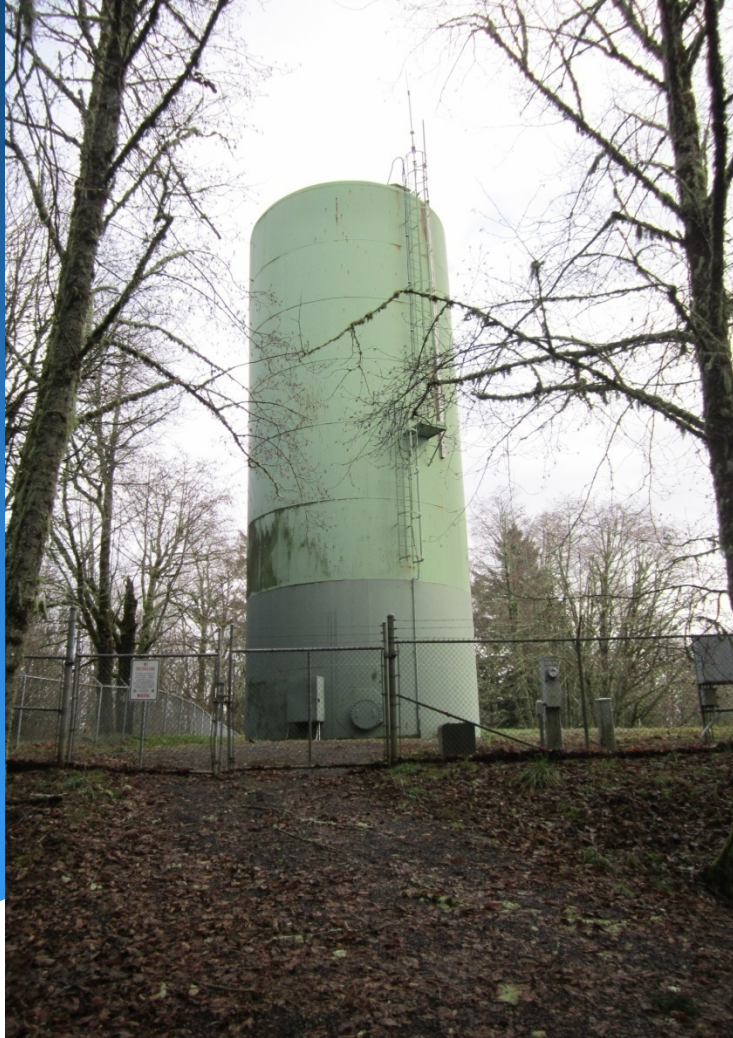
- Welded steel standpipe, constructed 1969
- Diameter = 24 ft
- Water Depth to Overflow = 60 ft
- Serves 130 customers in City's highest service level
- Supplied by Gabbert Pump Station

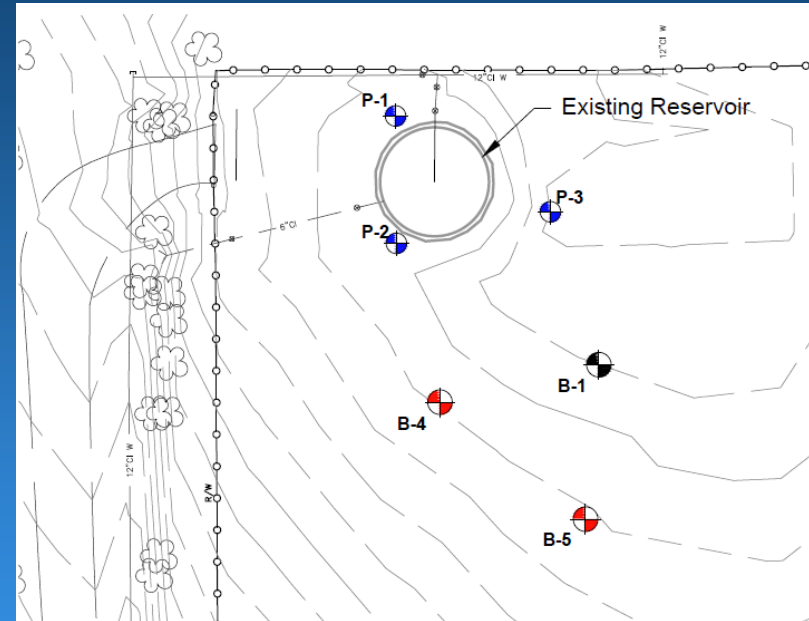
- Soft Soils in Upper 25 feet
- High Plasticity Soils
- No Shallow Groundwater

- Basalt at 40 to 65 feet deep

**Primary concern: Seismic induced settlement**

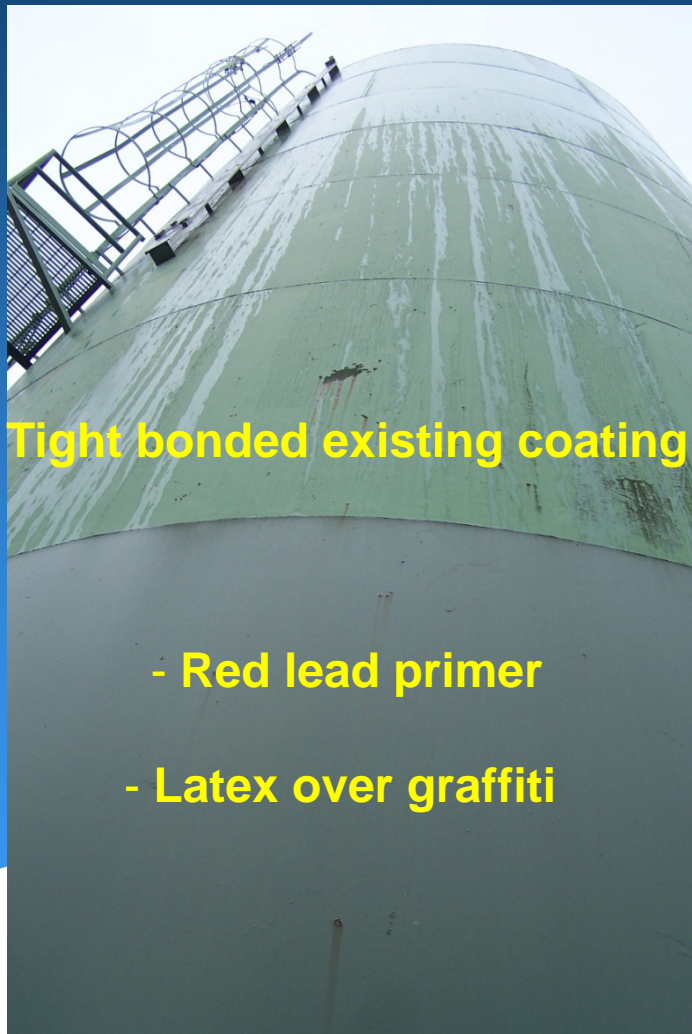
**Tight bonded existing coating**

**- Red lead primer**

**- Latex over graffiti**

**Upper 44 feet & roof – overcoat & encapsulate**

- Hydroblast
- Hand tool cleaning (SSPC-SP2)
- Power tool cleaning (SSPC-SP3)
- Epoxy spot sealer/primer & full prime
- Urethane topcoat

**Lower 16 feet – remove & coat**

- Latex paint over graffiti
- Remove w/Abbrasive Blast (SSP-SP6)
- Existing lead primer – full containment
- Epoxy primer& intermediate coat
- Urethane topcoat

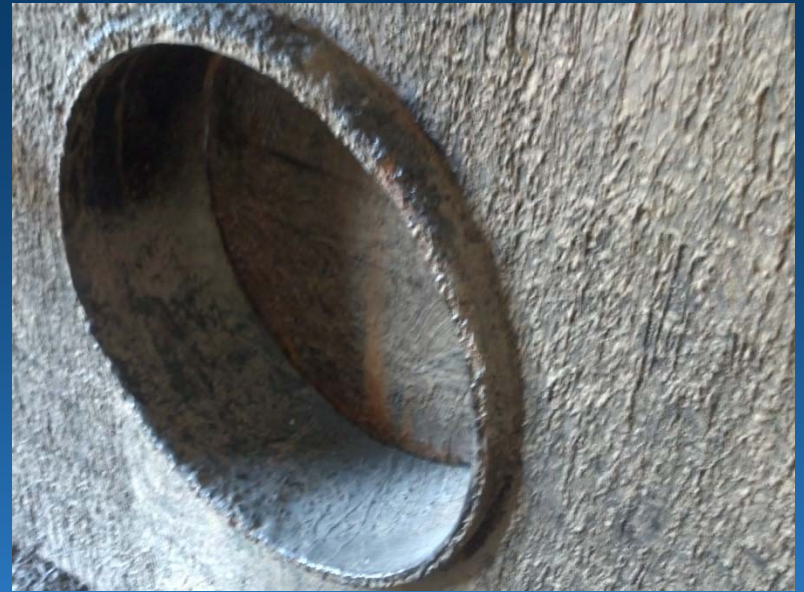
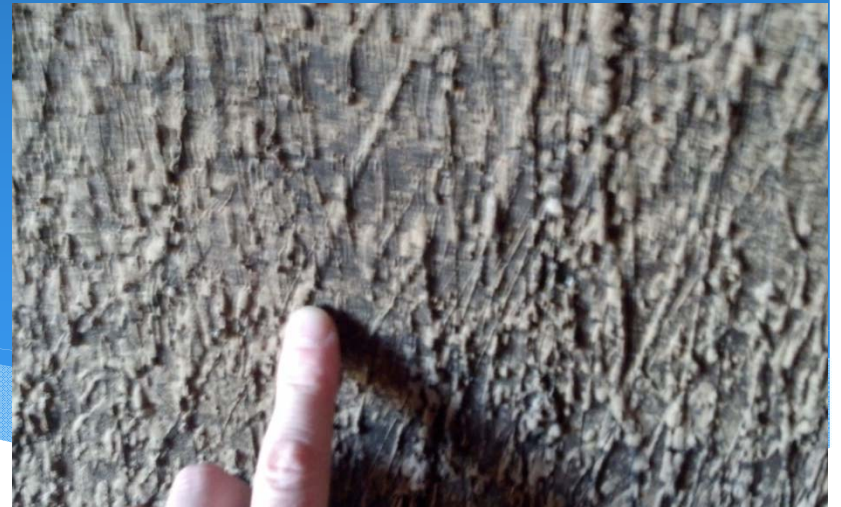
Existing Coal Tar – remove & coat

- No lead
- Remove w/ abrasive blast  
(SSPC-SP10)
- Epoxy primer, intermediate & topcoats
- Zinc rich epoxy primer – above water level
