Condition Assessment: City of Bellingham Supply System

2015 PNWS-AWWA Conference

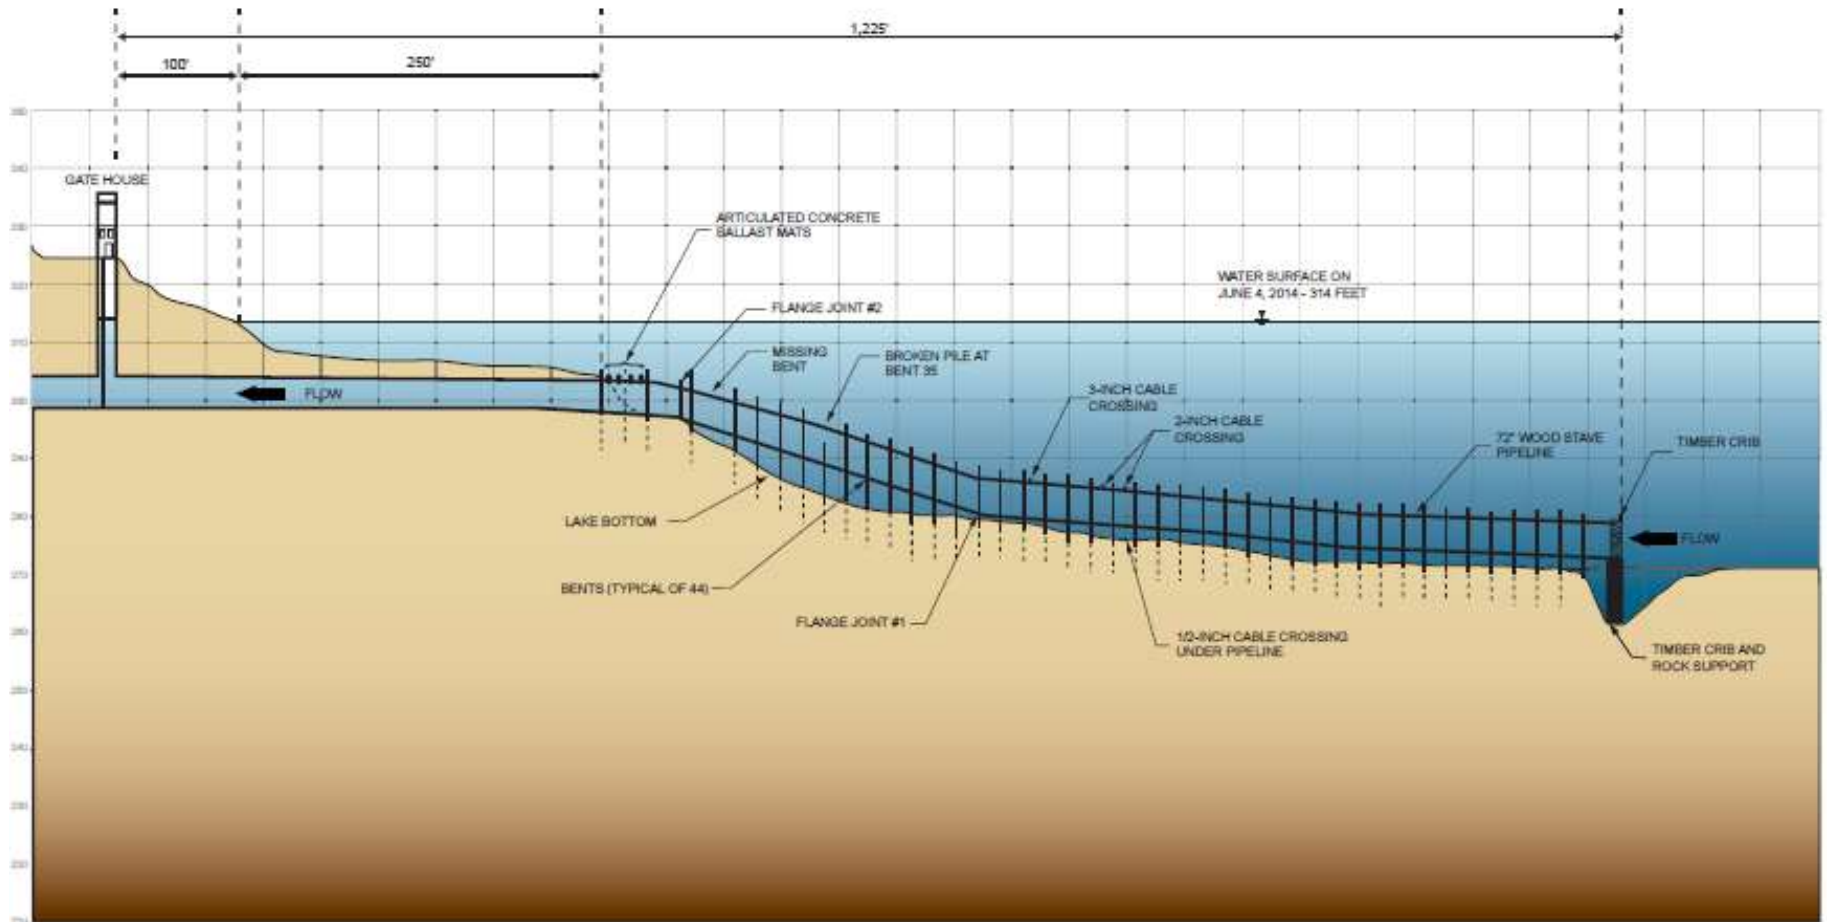
Wood Condition

- Wood in good condition
 - Support structural components
 - Stave pipe (interior and exterior)
- SST bands in good condition
- Original steel fasteners in fair condition
- Some original steel rods corroded to failure

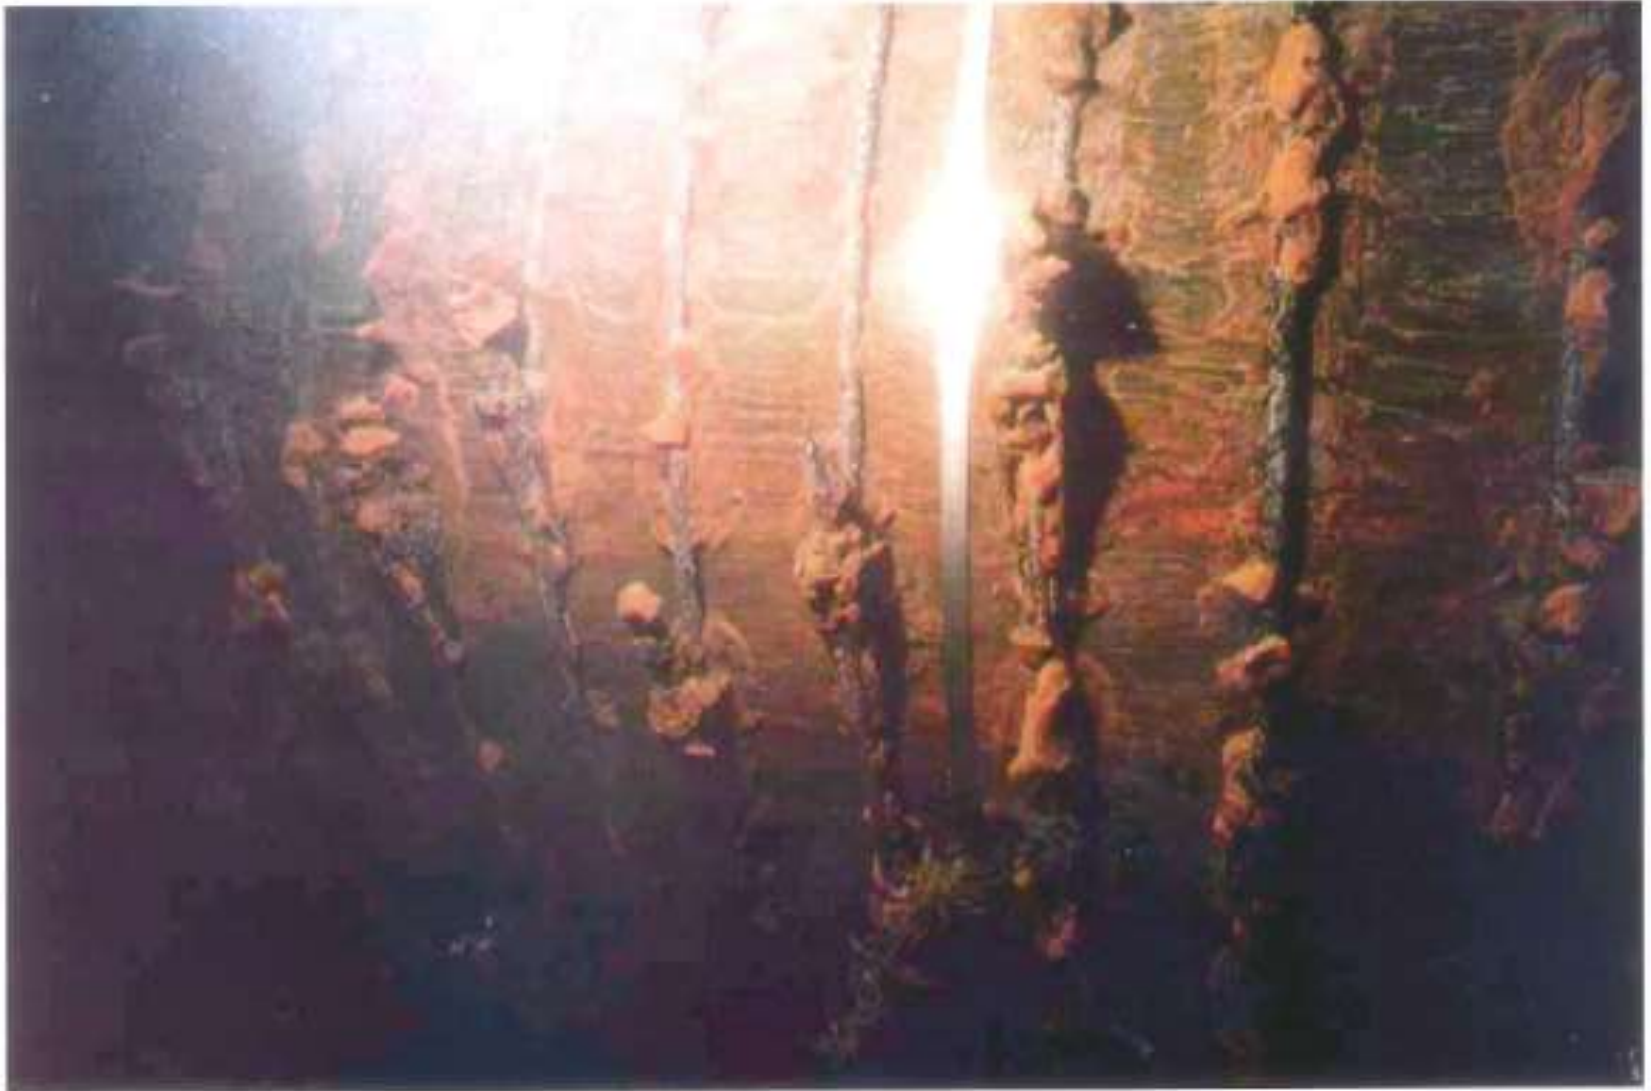
Condition of Steel Rods

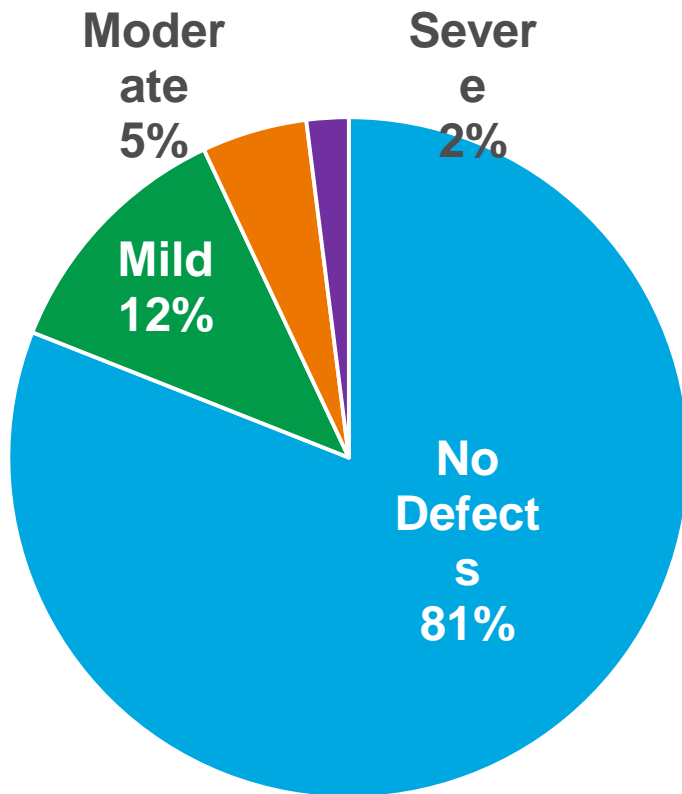
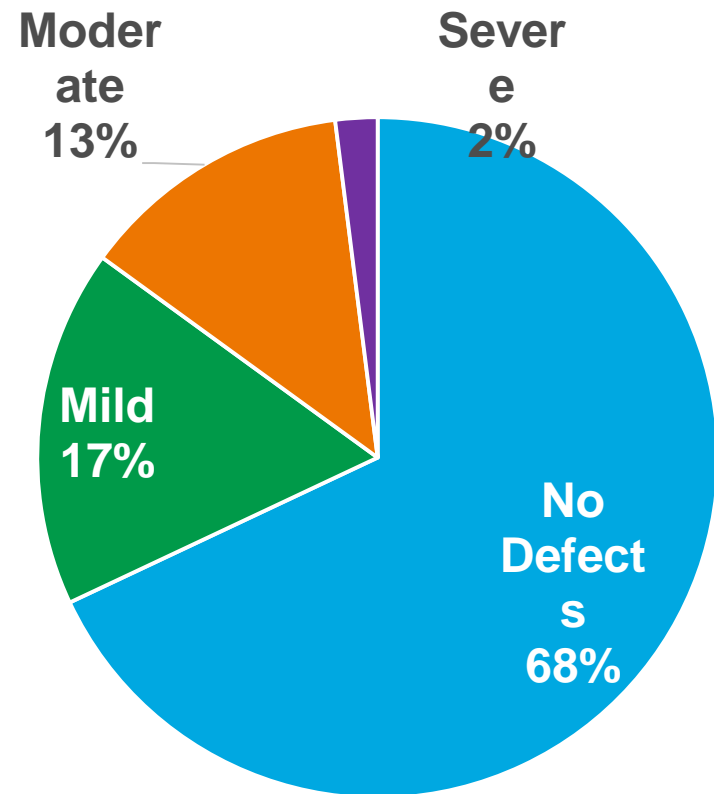
Laser Scanning: Interpretation

- No major deformation
- Isolated liner defects
- Limited, minor fracture acceleration
- Next Step: Point repairs, monitoring plan

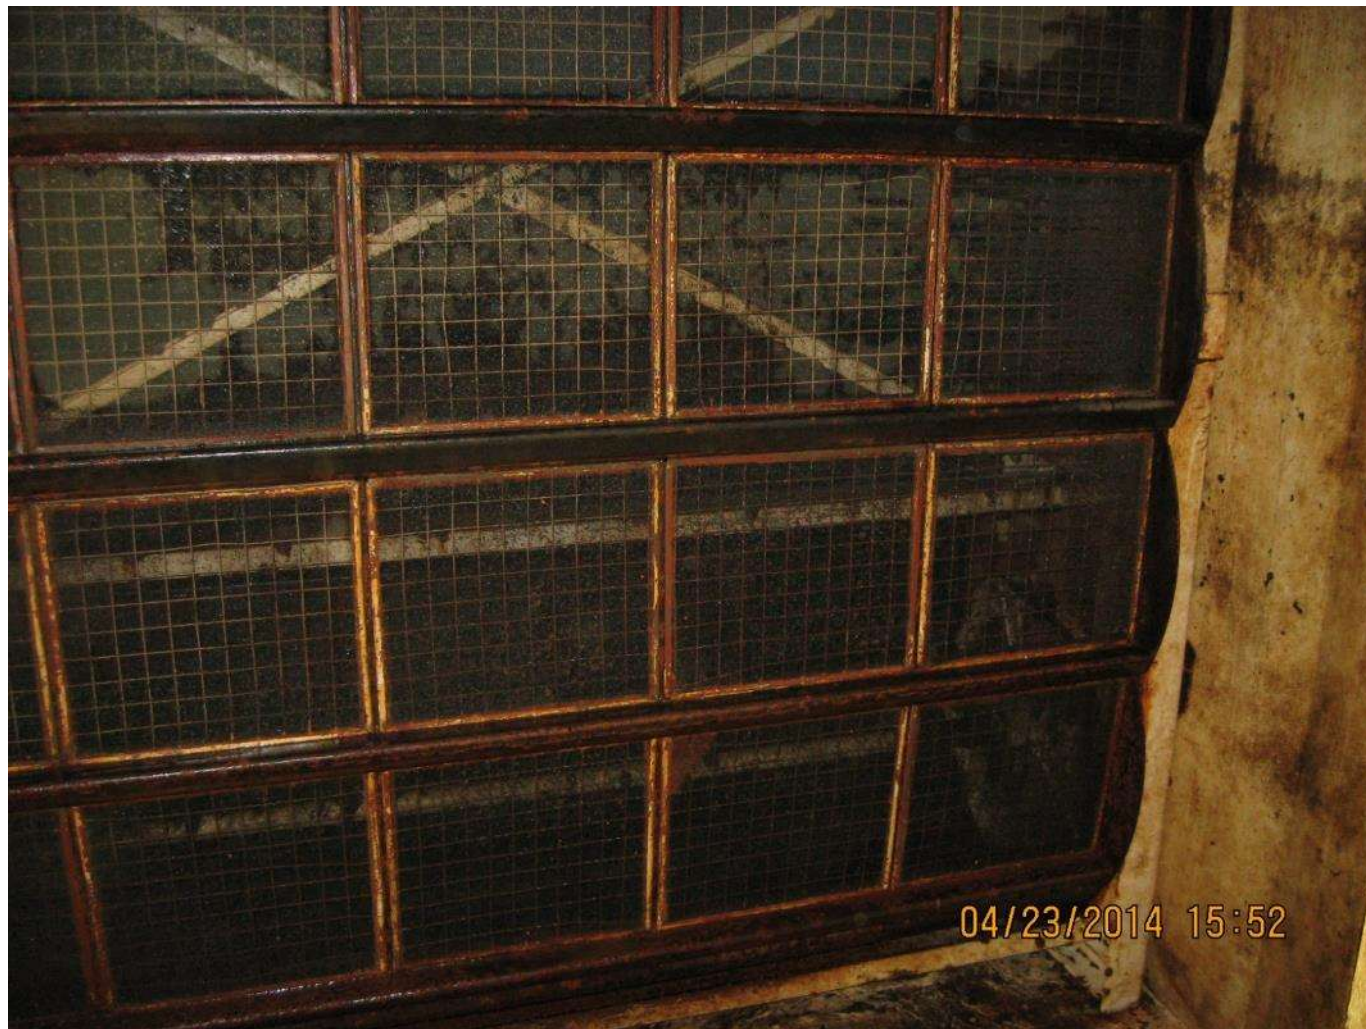
Travelling Screens

- Concrete structure in good condition
- Travelling screens in good condition
- Slide gates
 - Heavy tuberculation
 - Some corrosion loss
 - Replacement needed
- Steel pipes (3) need rehabilitation

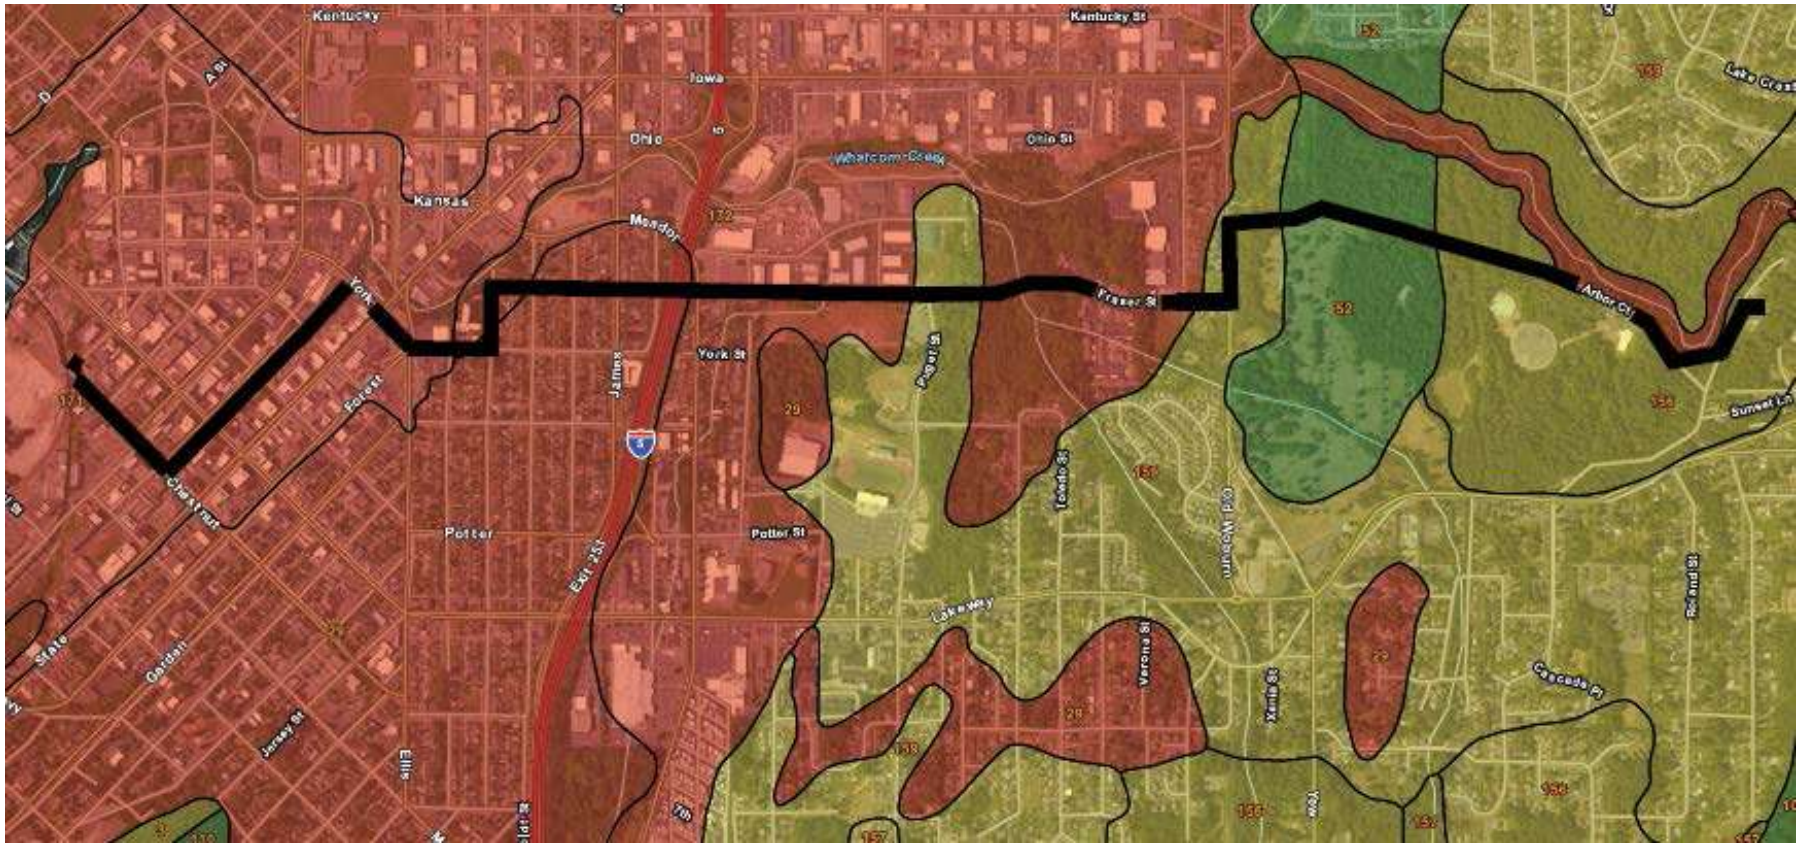
Soil Corrosivity Mapping Along Industrial Pipeline

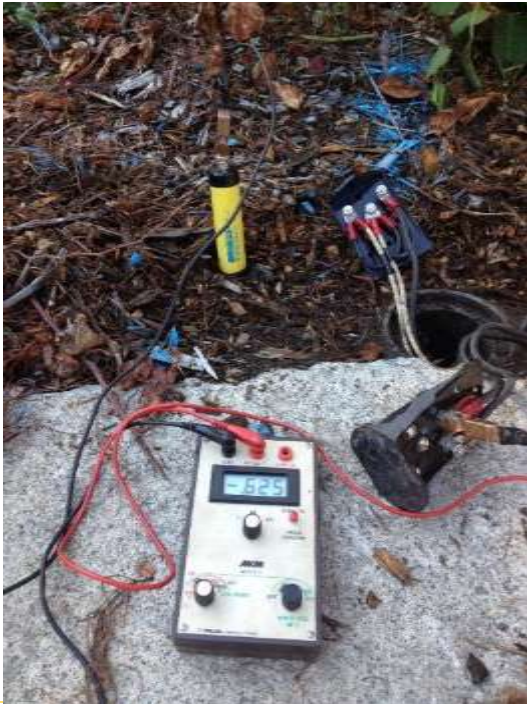
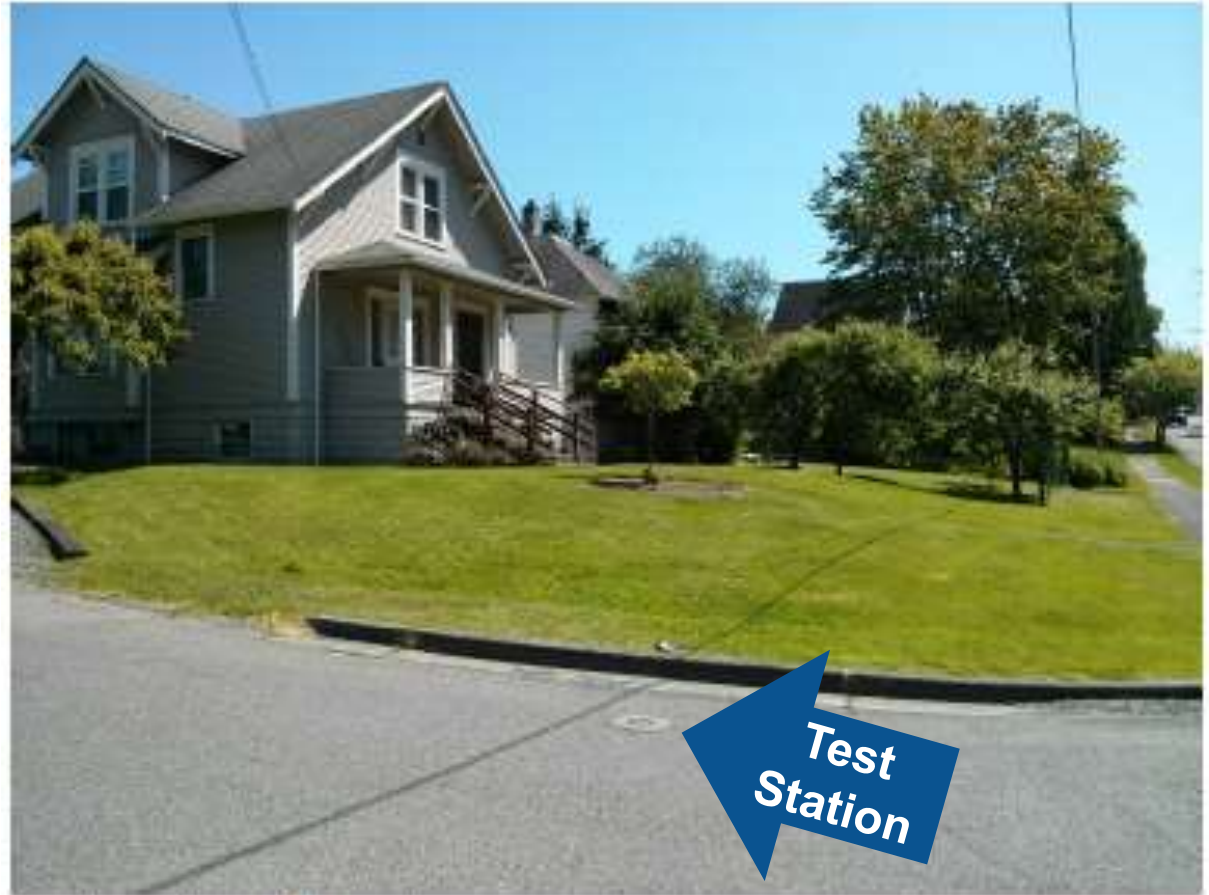
Existing CP Test Stations

- Existing CP system is operational and effective
- Condition assessment complete after Tier 1
- No further condition assessment warranted

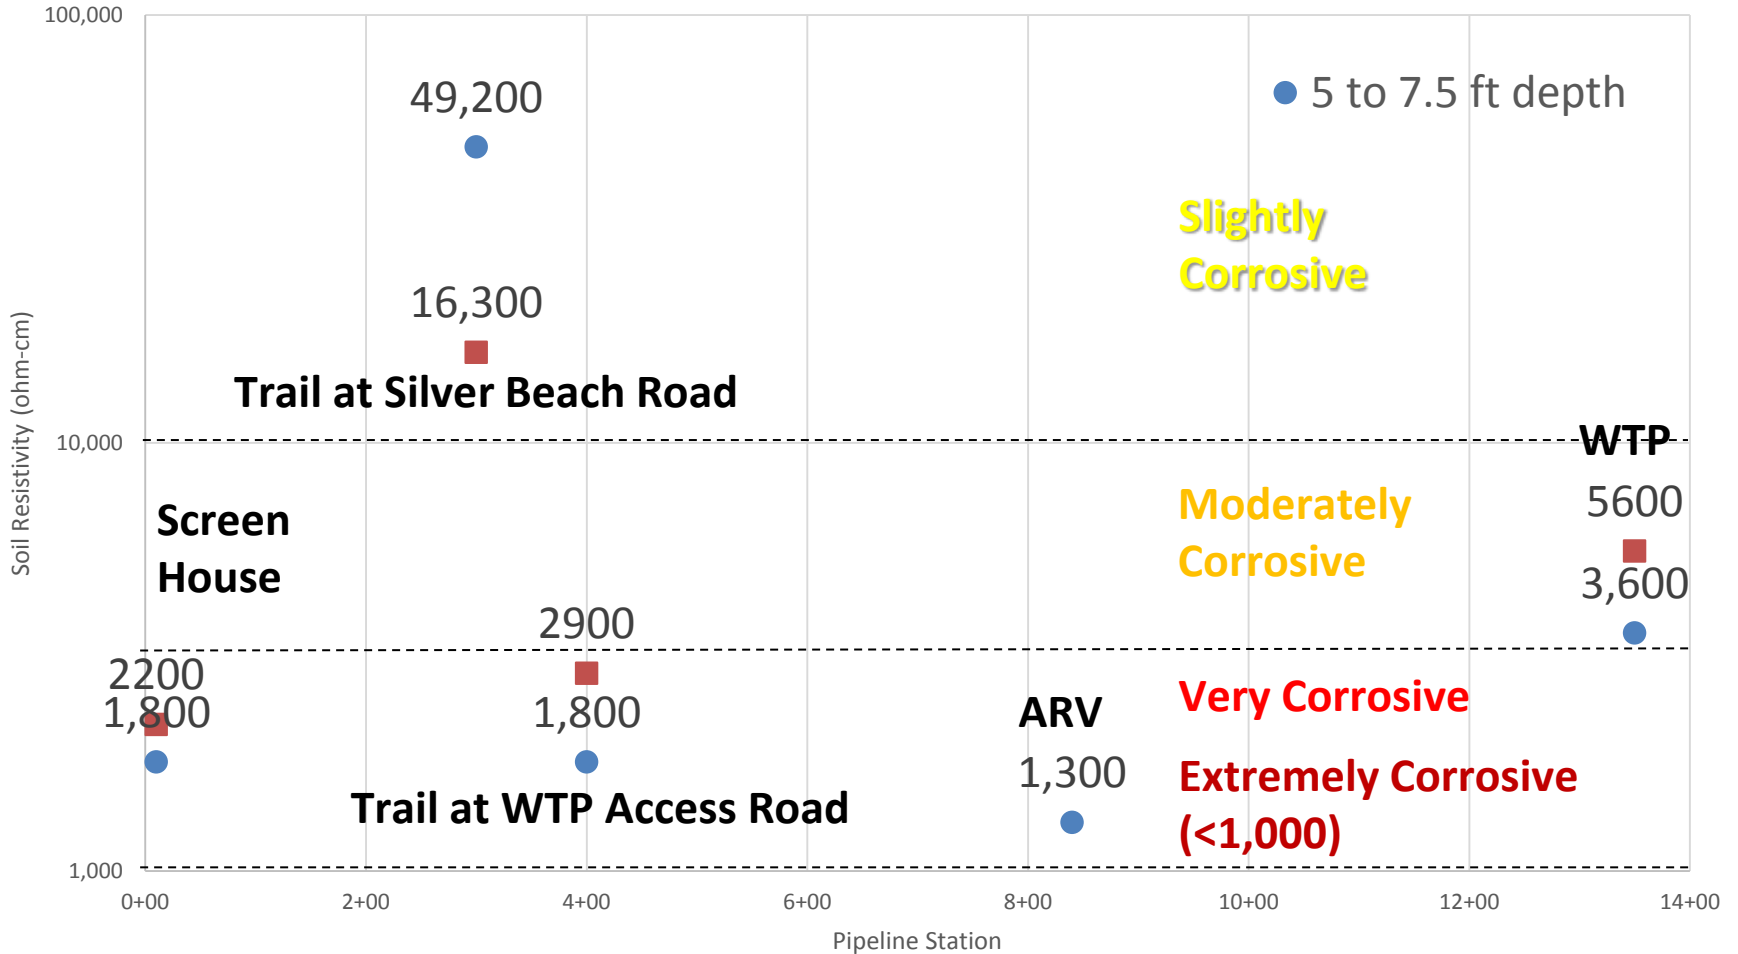
Tier 1 External - Soil Corrosivity

- External Tier 1 Complete
 - Corrosive soils
 - Stray current
- External Next Step: Tier 2 Test Pits
 - Evaluate coating/pipe condition
 - Test for stray current
- Internal Tier 2 Inspection
 - Coal tar enamel lining – excellent condition
 - Minor corrosion at coating defects
 - Localized repairs at few joints required

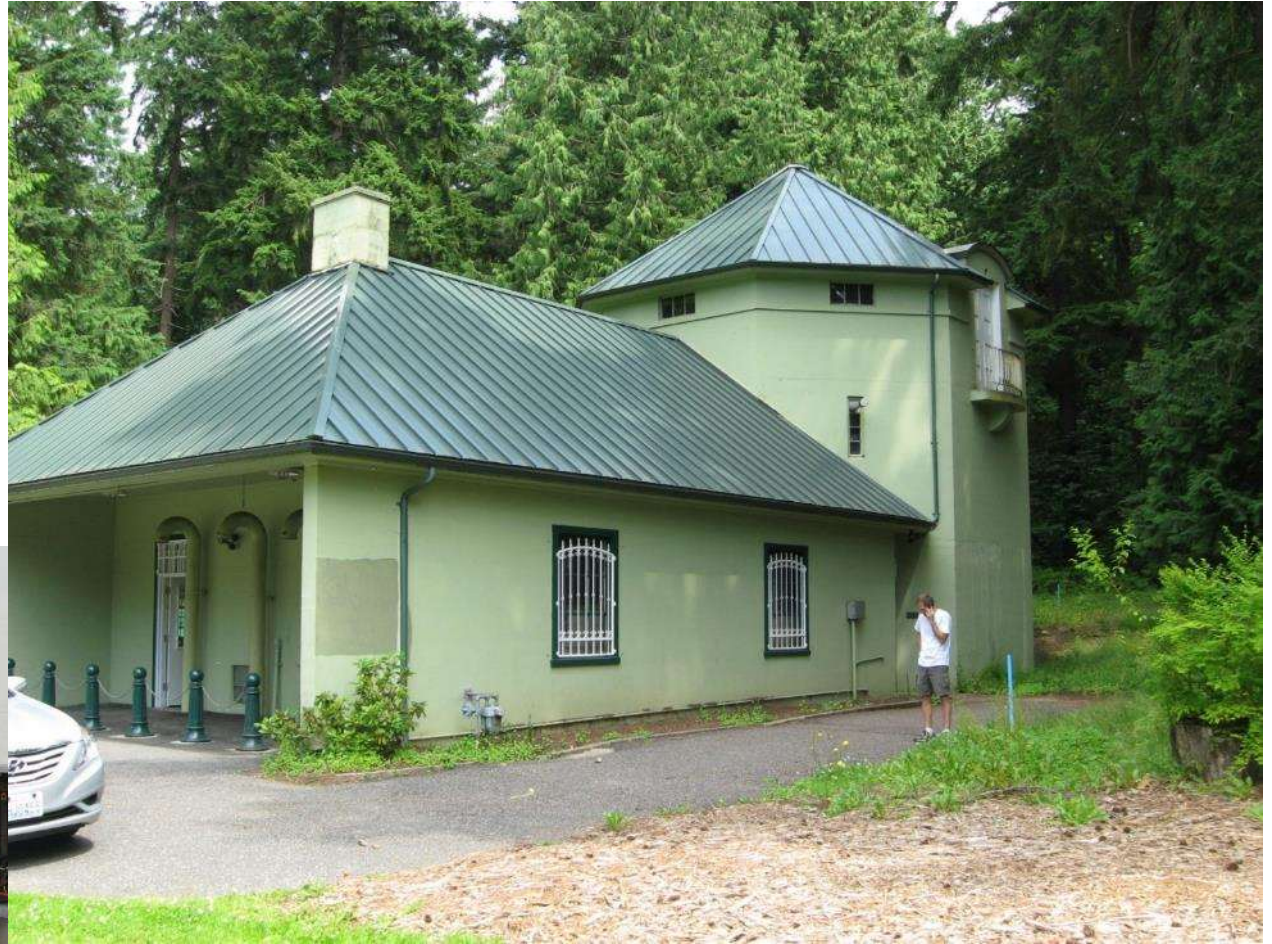
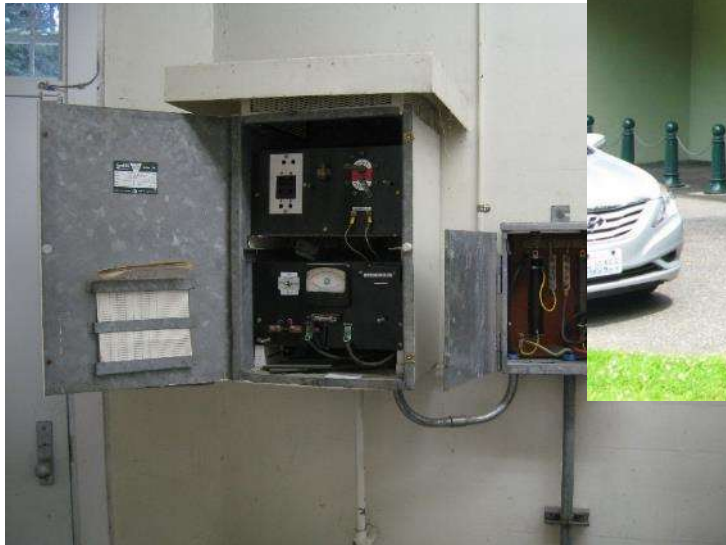
Tier 1 External -Stray Current Adjacent Industrial Supply Pipeline CP System

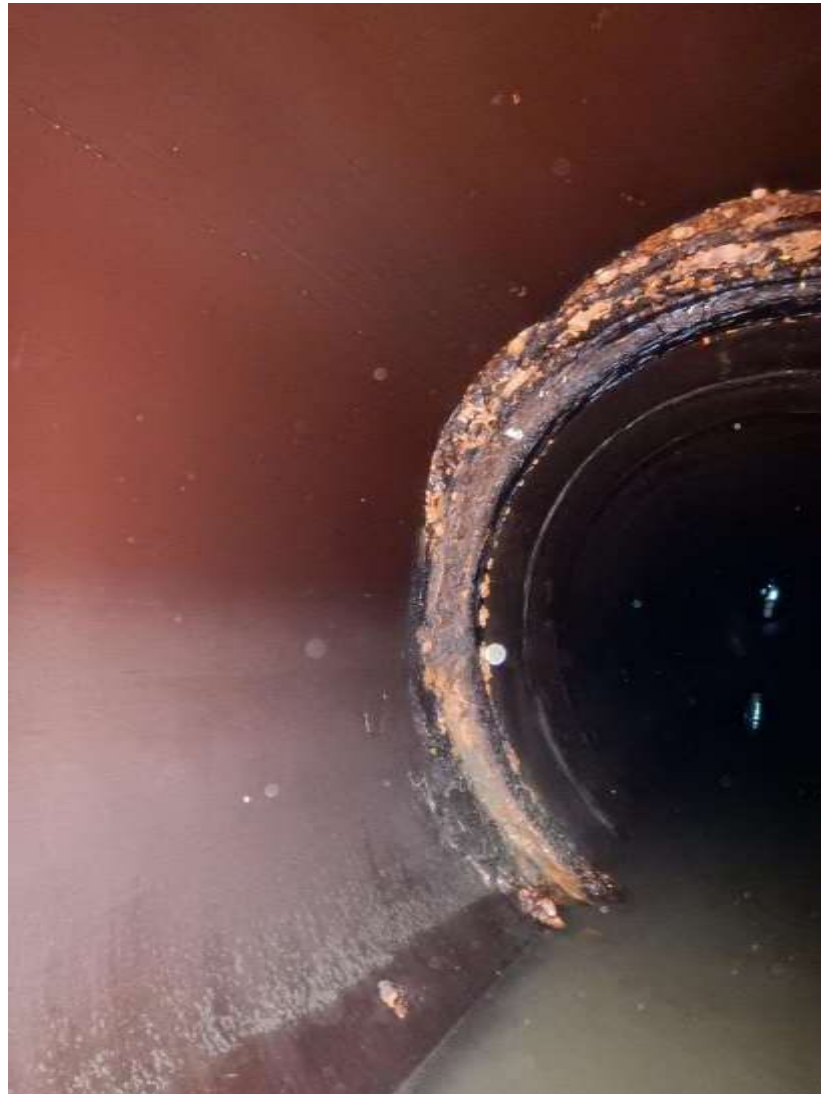
Tier 2 – Internal Condition
