Corrosion Conditions and Mitigation in Reclaimed Water & Groundwater Treatment Facilities

Milt Larsen, PE
Robert Ryder, PE

Kennedy/Jenks Consultants

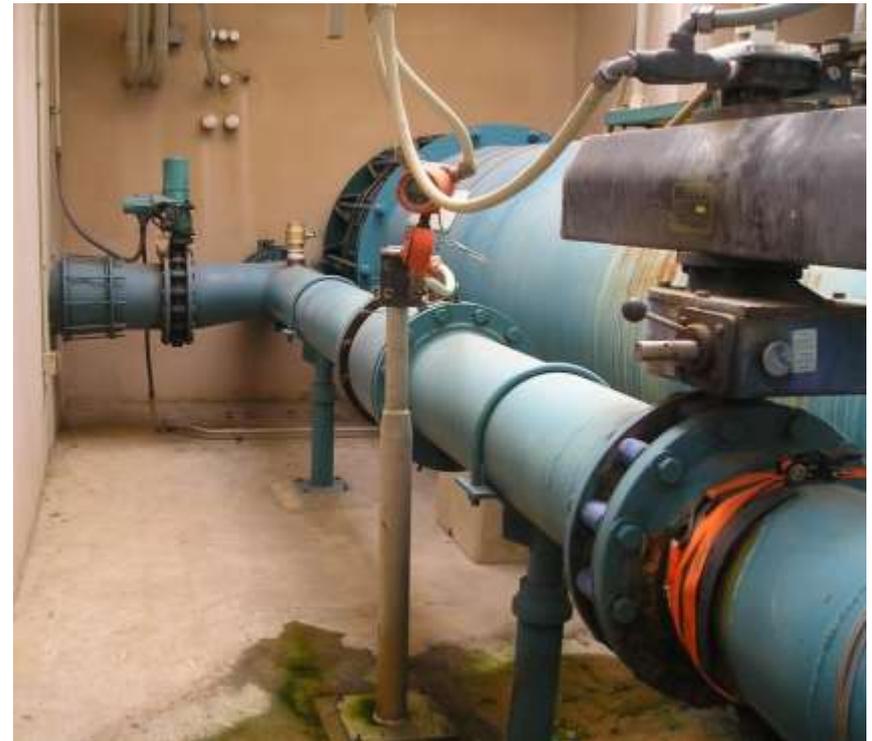
- 10" to 24"
 - ASTM A 53 Grade B Schedule 20
 - AWWA C210 Liquid Epoxy Lining
- ≥ 30 "
 - AWWA C200
 - AWWA C210 Liquid Epoxy Lining

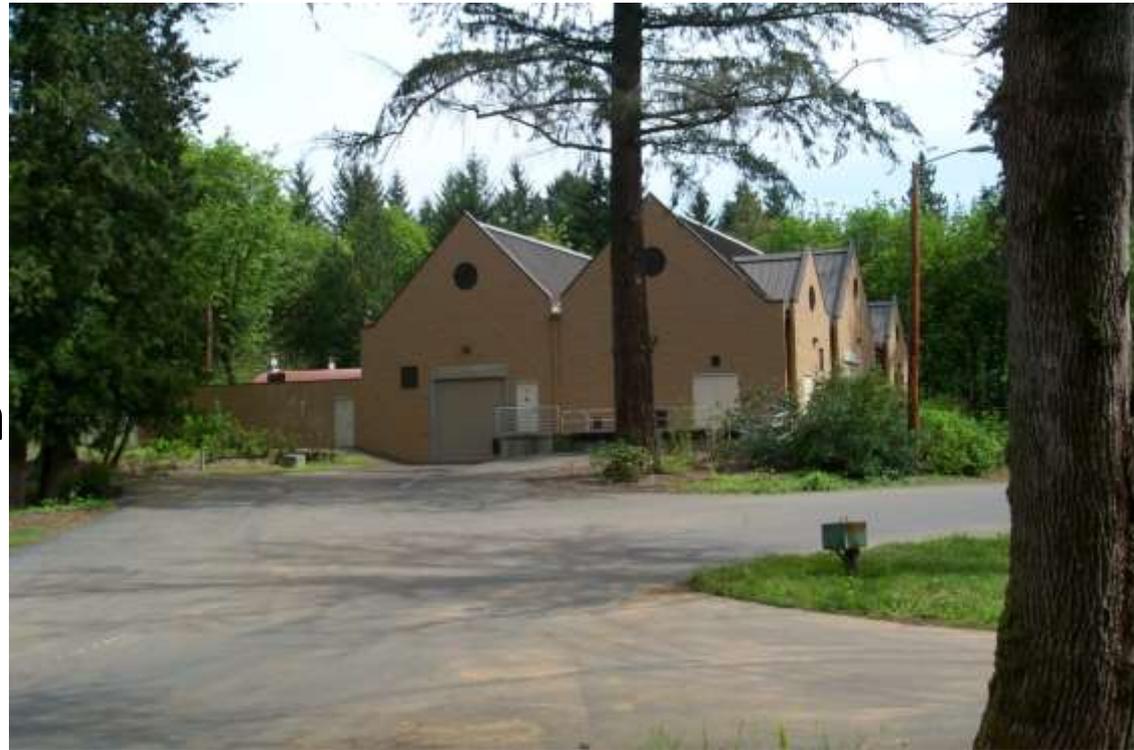
- ▶ 9 MGD
- ▶ 3 wells
- ▶ Mn 0.35 to 0.40 mg/l
- ▶ Fe 0.3 to 0.5 mg/l
- ▶ Operating 20 years
- ▶ Gradual loss of media

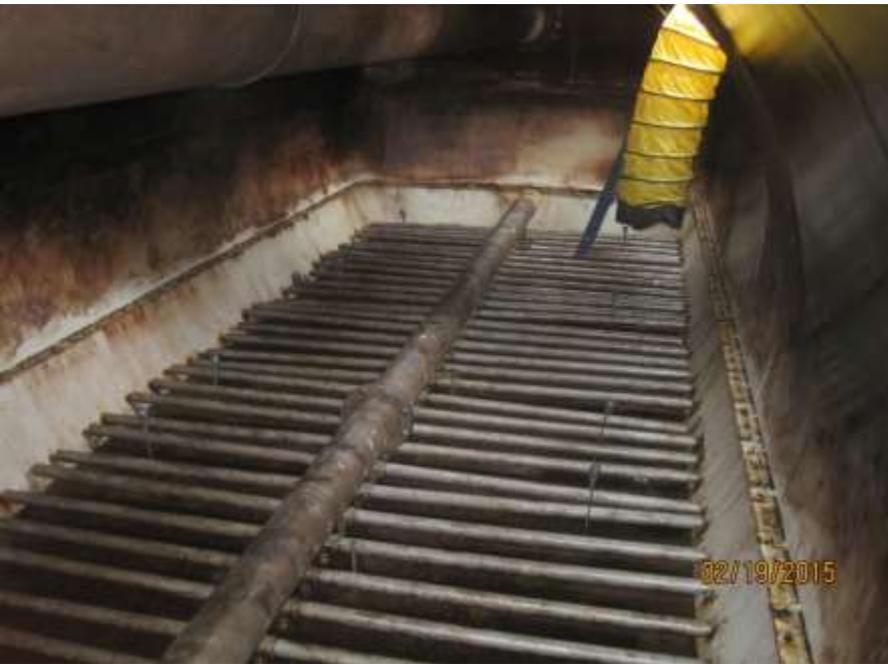
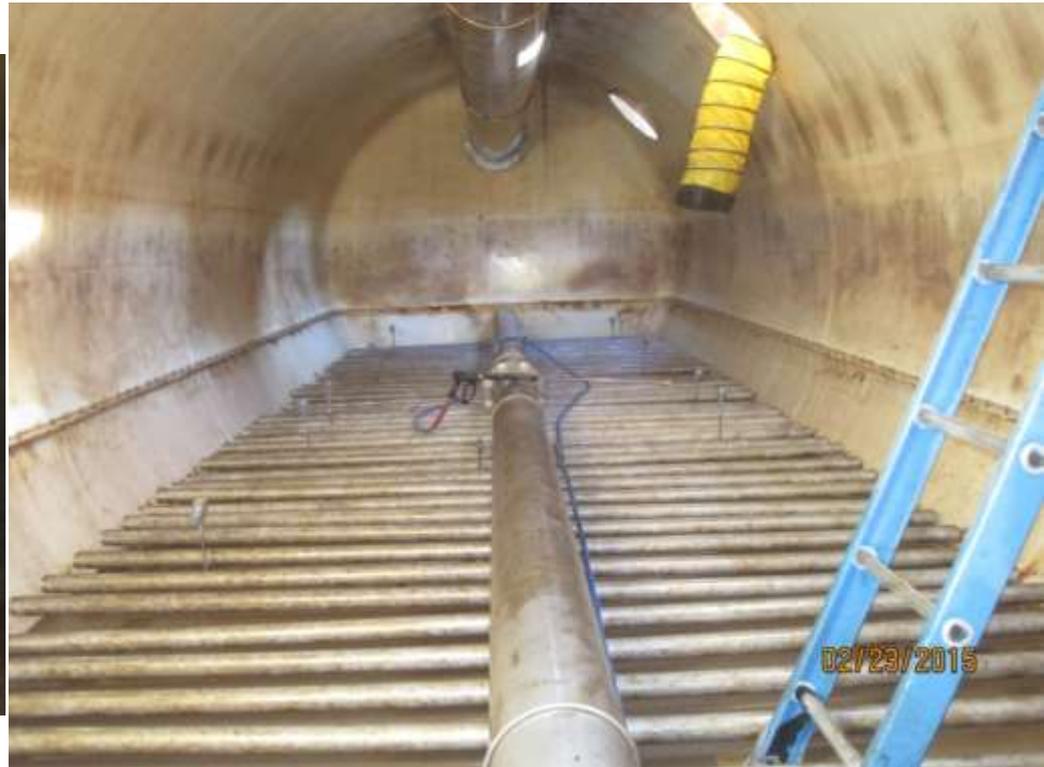
2015 Media Replacement

- ▶ Filter lining: 3 coat polyamide epoxy
- ▶ Adhesion test > 1200 psi after 20 years service
- ▶ Pitting adjacent SS laterals
- ▶ Some pits up to $\frac{1}{8}$ " to $\frac{1}{4}$ " deep
- ▶ Dissimilar metals

- ▶ Considered spot coating repair
- ▶ Complete interior recoat
- ▶ Near white blast
- ▶ Dehumidification
