Portland
Water
Bureau's
Experience
with a Non-
Acute Total
Coliform
Rule
Violation:
Part 1 of 2

KIMBERLY GUPTA, PE
PORTLAND WATER BUREAU

AWWA PNWS CONFERENCE
BELLEVUE, APRIL 30, 2015

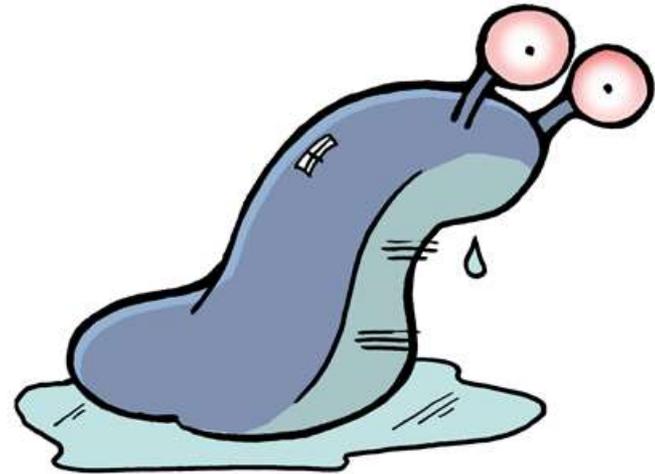
Water Quality in Marquam PZ Prior to the Incident

...it is possible that a slug of this water may have been inadvertently pumped up to Bertha Pressure Zone

Bertha is supplied by the Marquam Hill Tanks

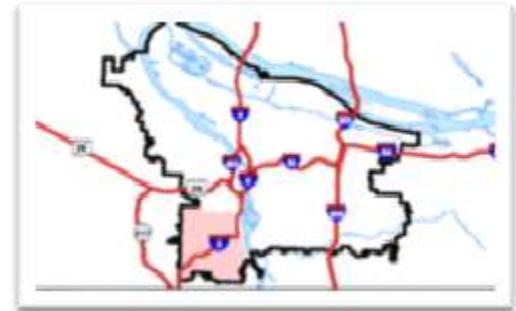
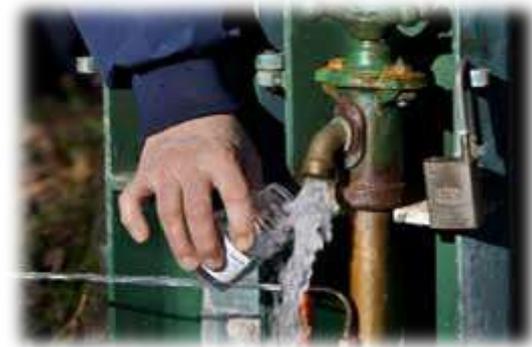
It All Started on September 18

On September 18th, a routine TCR sample came back positive for total coliforms, negative for *E.coli*

- WQSS 200 (SW 27th Ave and Nevada) - located in the Bertha 750 Pressure Zone, in the southwest portion of Portland's distribution system.
- Cl=0.14 mg/L; T=17.9 C

As required by regulation, three resamples were collected at the site (upstream, repeat, downstream) within 24 hours

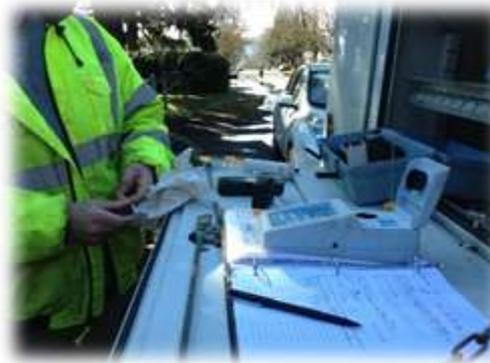
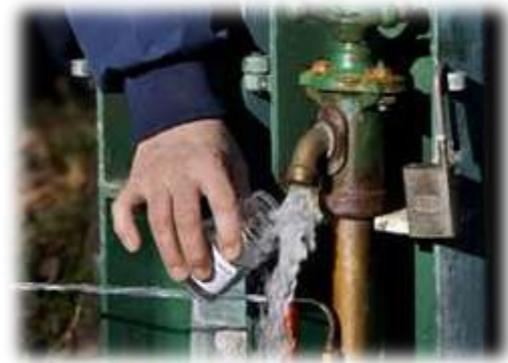
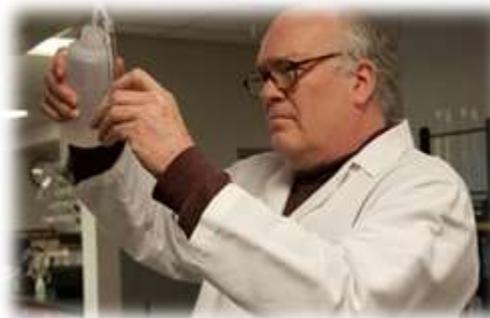
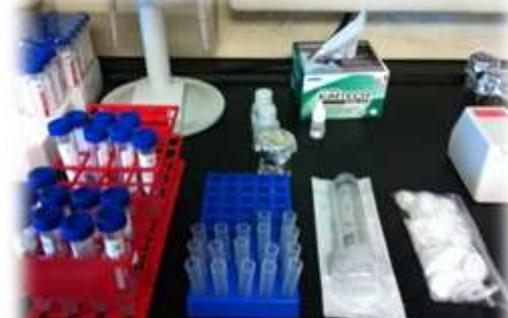
Continued WQ Monitoring

During this next phase of mitigations, water quality was monitored throughout the Bertha area daily (and several times a day in some cases)

Monitored chlorine and temperature but needed an indicator of microbial activity

- Coliform testing could have thrown us back into the resampling loop
- Did not want to wait 7 days for the R2A results
- Monitored for ATP

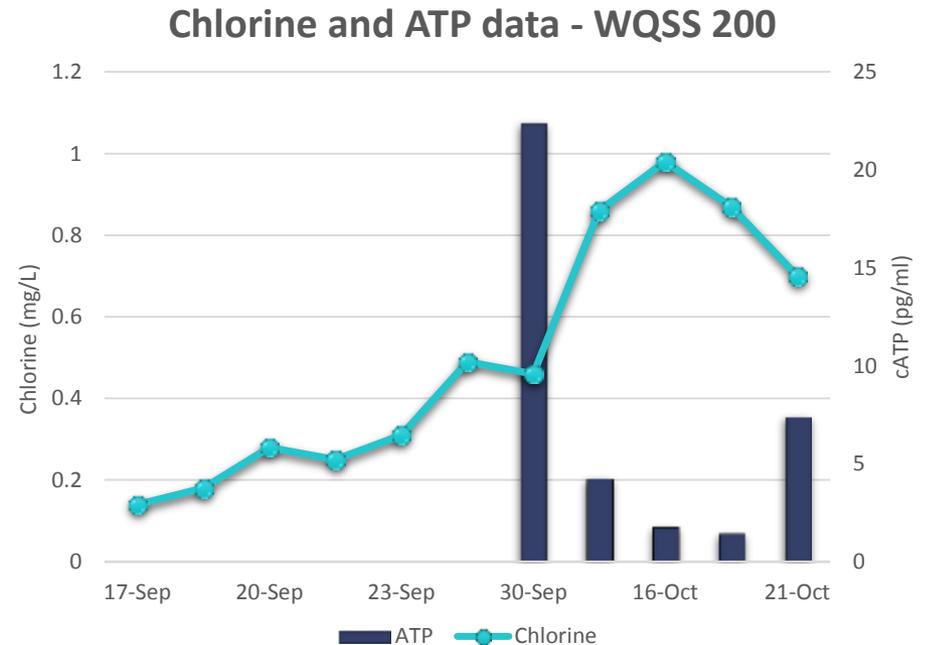
October 21 – Success!

Once monitoring results provided confidence that the mitigations had been effective, five bacteriological samples were collected in the Bertha 750 PZ (including WQSS 200) on October 21

All samples were negative for TC/EC

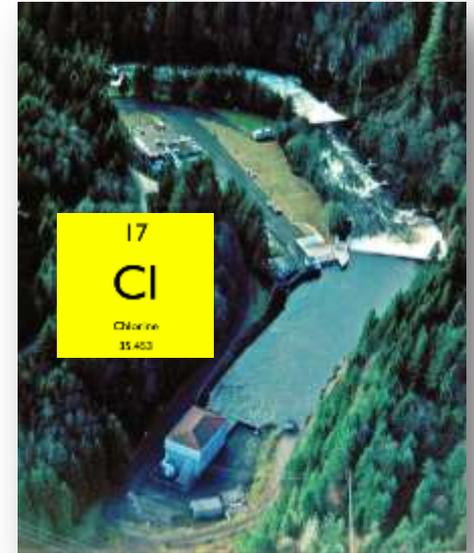
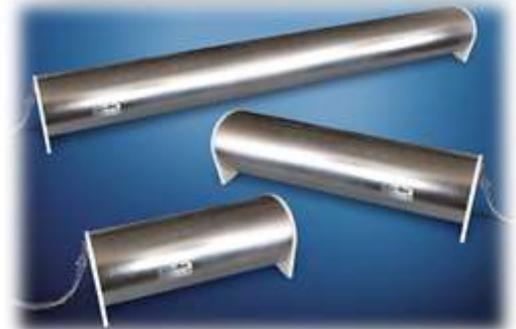
Based on the 2013 results from our nitrification program (as well as the Bertha incident), a very proactive approach to water quality has been instituted

- Seasonally adjust our chloramine target
- Seasonally take storage out of service
- Lowered operating levels/began deep cycling a number of critical tanks
- Installed mixers
- Changed regulator settings to increase demand on certain parts of the system
