Condition Assessment of a 100-year Old Well Station

City of Spokane Hoffman
Well Station

AWWA PNWS Annual Spring
Conference

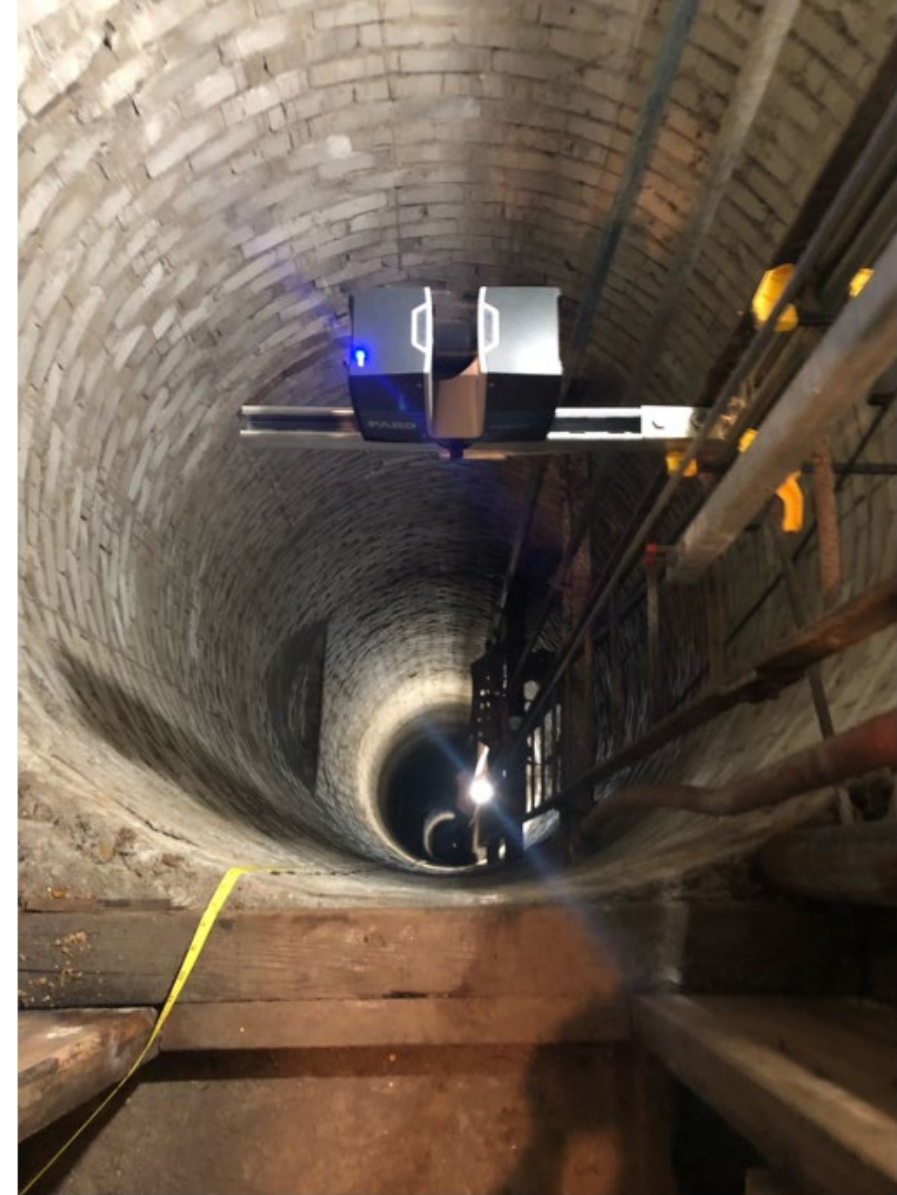
- Objectives:
 - Characterize existing conditions
 - Verify well construction information
 - Evaluate facility modifications needed to access existing wells for repair/alteration
- Approach/Methods:
 - Compiled and reviewed available data
 - e.g., well/building construction, well performance, pumping rates, water levels, prior studies, etc.
 - Identified data gaps and prepared field investigation
 - Completed above- and below-water surveys, using personnel and underwater methods
 - Completed above-water visual structural inspections
 - Conducted 3D laser mapping survey

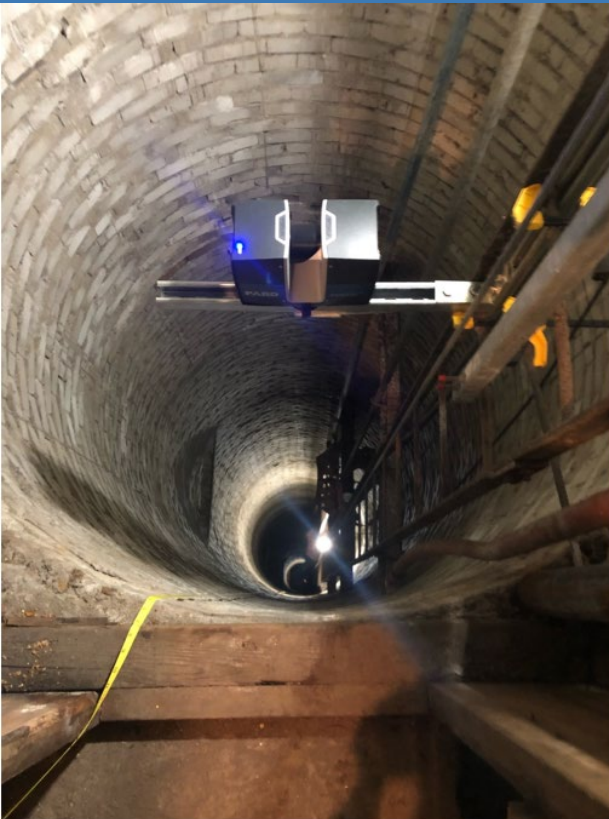
Brick caisson wall near
top of perforated well
casing (approx. 10.5
feet in diameter)

Top of 5-foot
dia. perforated
casing

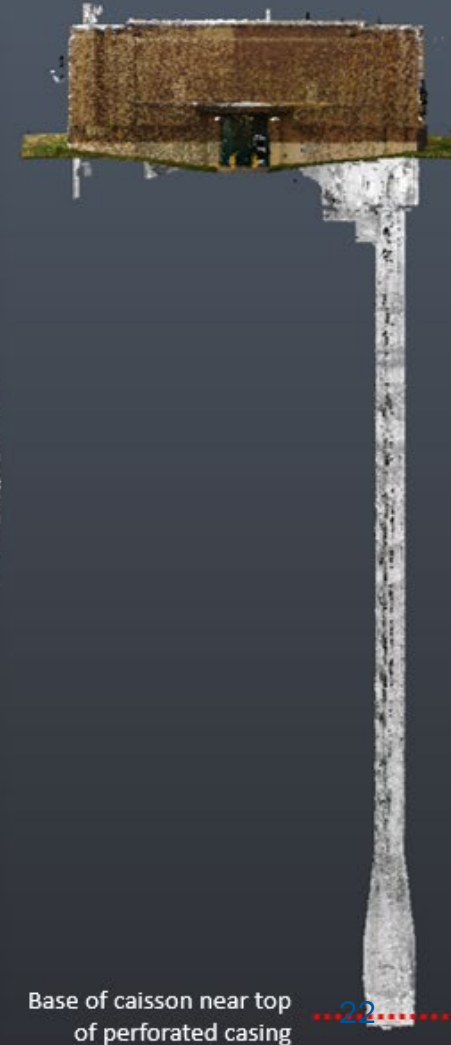
Base of caisson near top
of perforated casing
