Restoring Deer Creek WTP Performance

Pierre Kwan, PE

April 29, 2022
PNWS-AWWA Conference

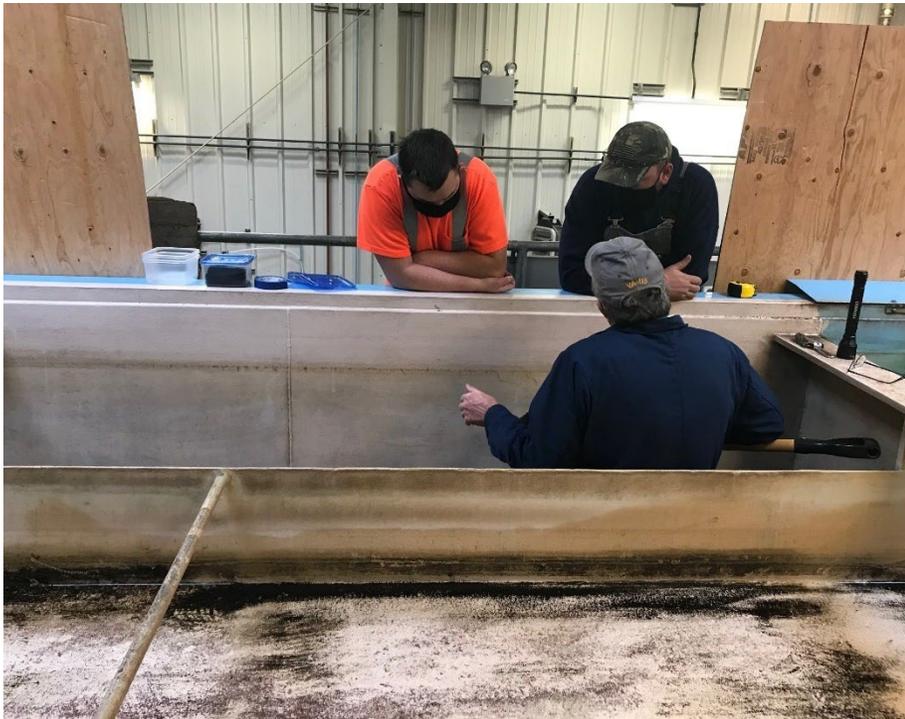
Filter Investigation

- Filter media:
 - Anthracite
 - Silica sand
 - Garnet
- Sand and anthracite at top of filter
- Indicated that media may be intermixing
- Created headloss issues and impacting filter run times?

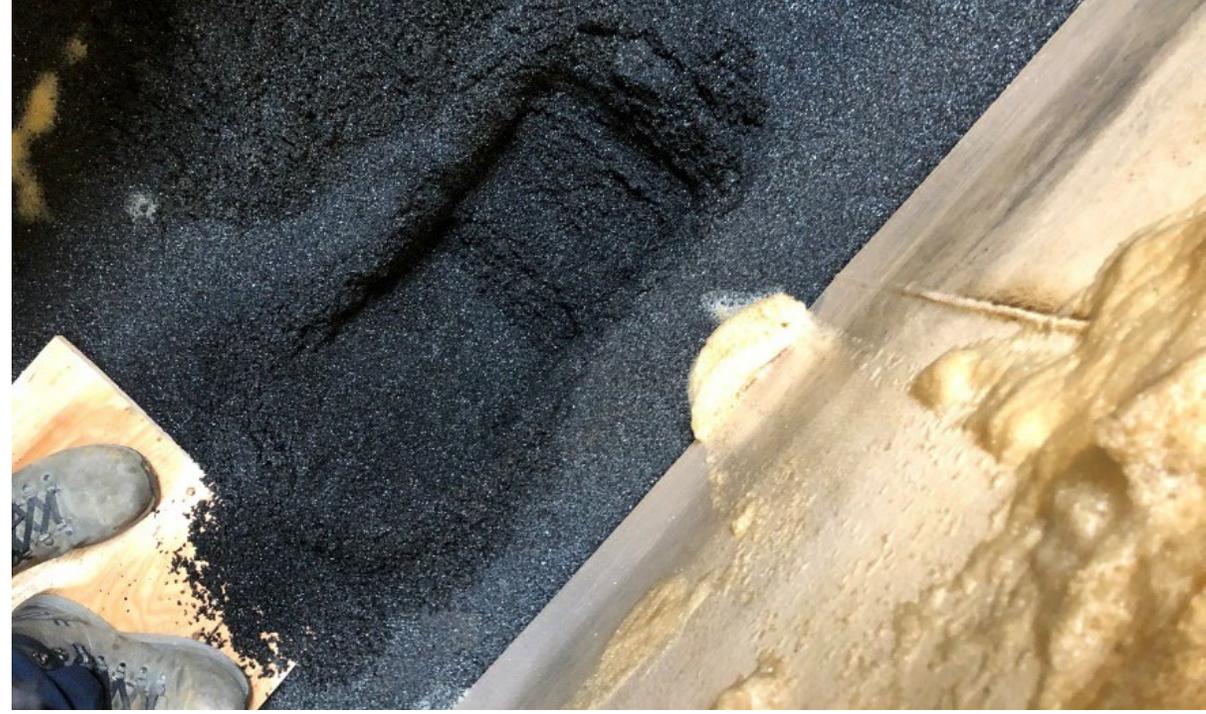
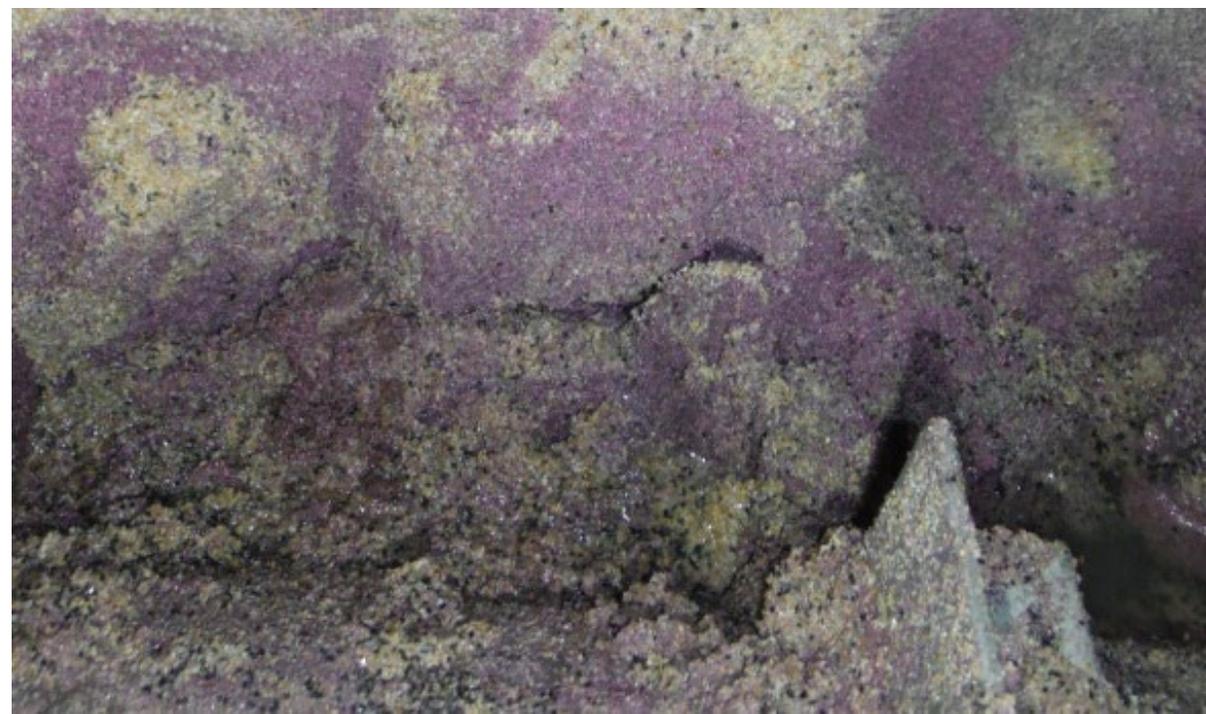
Media Investigation

- Cored filter to get media profile
- Dug up media down to the underdrains
- Pulled samples from various depths for analysis
- Media was consistent with specifications
- Media mixing was discovered throughout entire bed

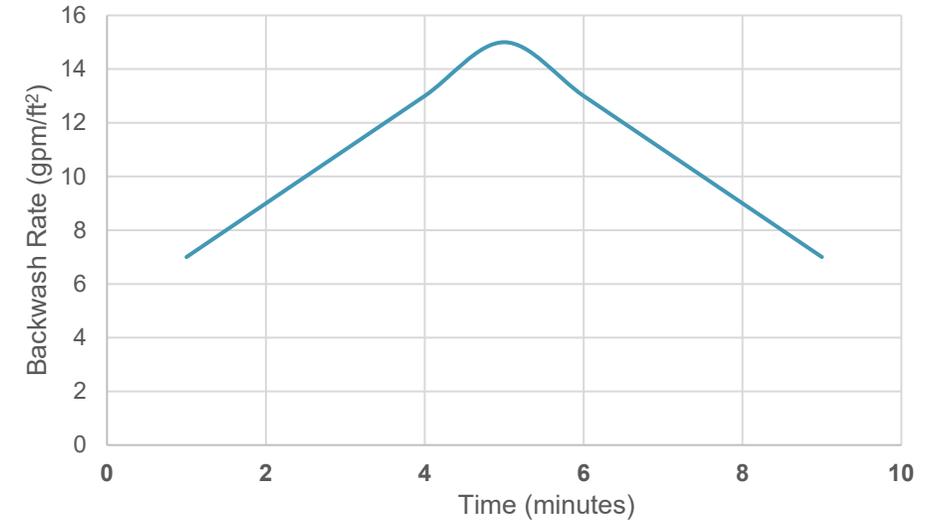
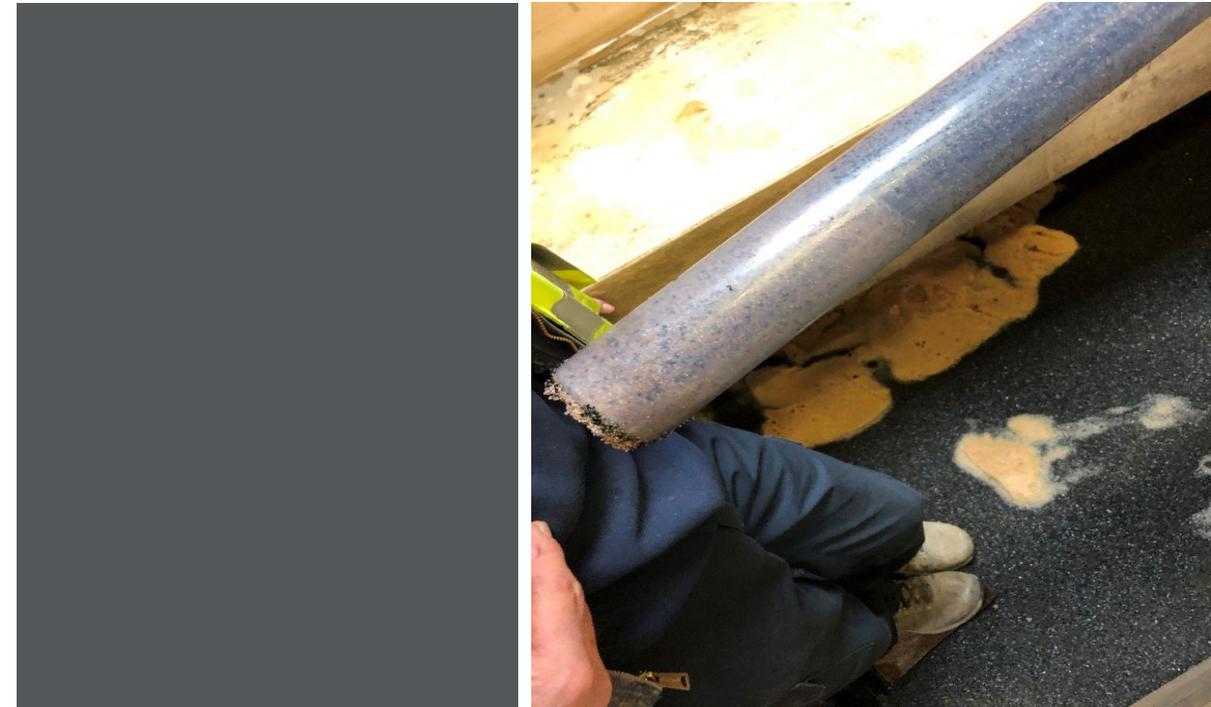
Media Restratification

- Backwashing rate overshoots backwashing setpoint
- Could cause media to mix and 'boil'
- Restratify media using an extended backwash
- Media was successfully restratified
- Added 4 – 6 hours to filter run times.
- Still not back to normal.

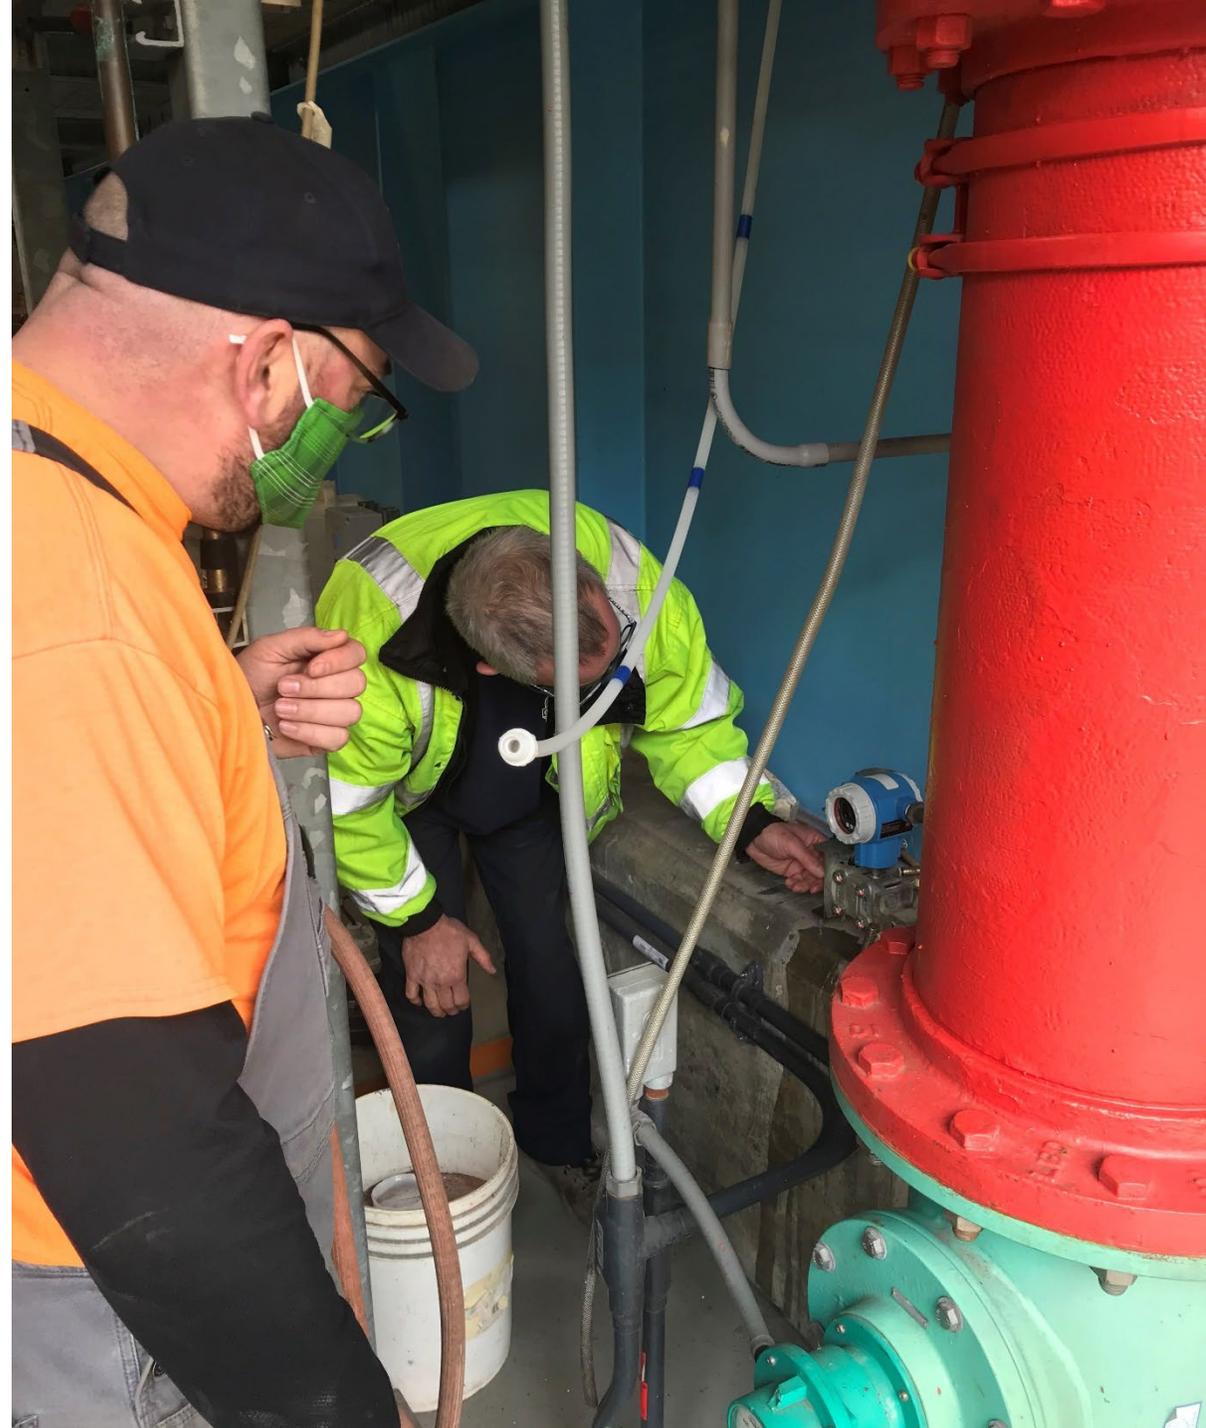
Plant Instruments?

- Tested every level element
- Found **both** level elements were off.
- Feedwater level sensor had faulty transmitter and had to be replaced
- Backwash sensor needed to be re-scaled

- Clean bed headloss dropped from 6 psi to 4 psi.

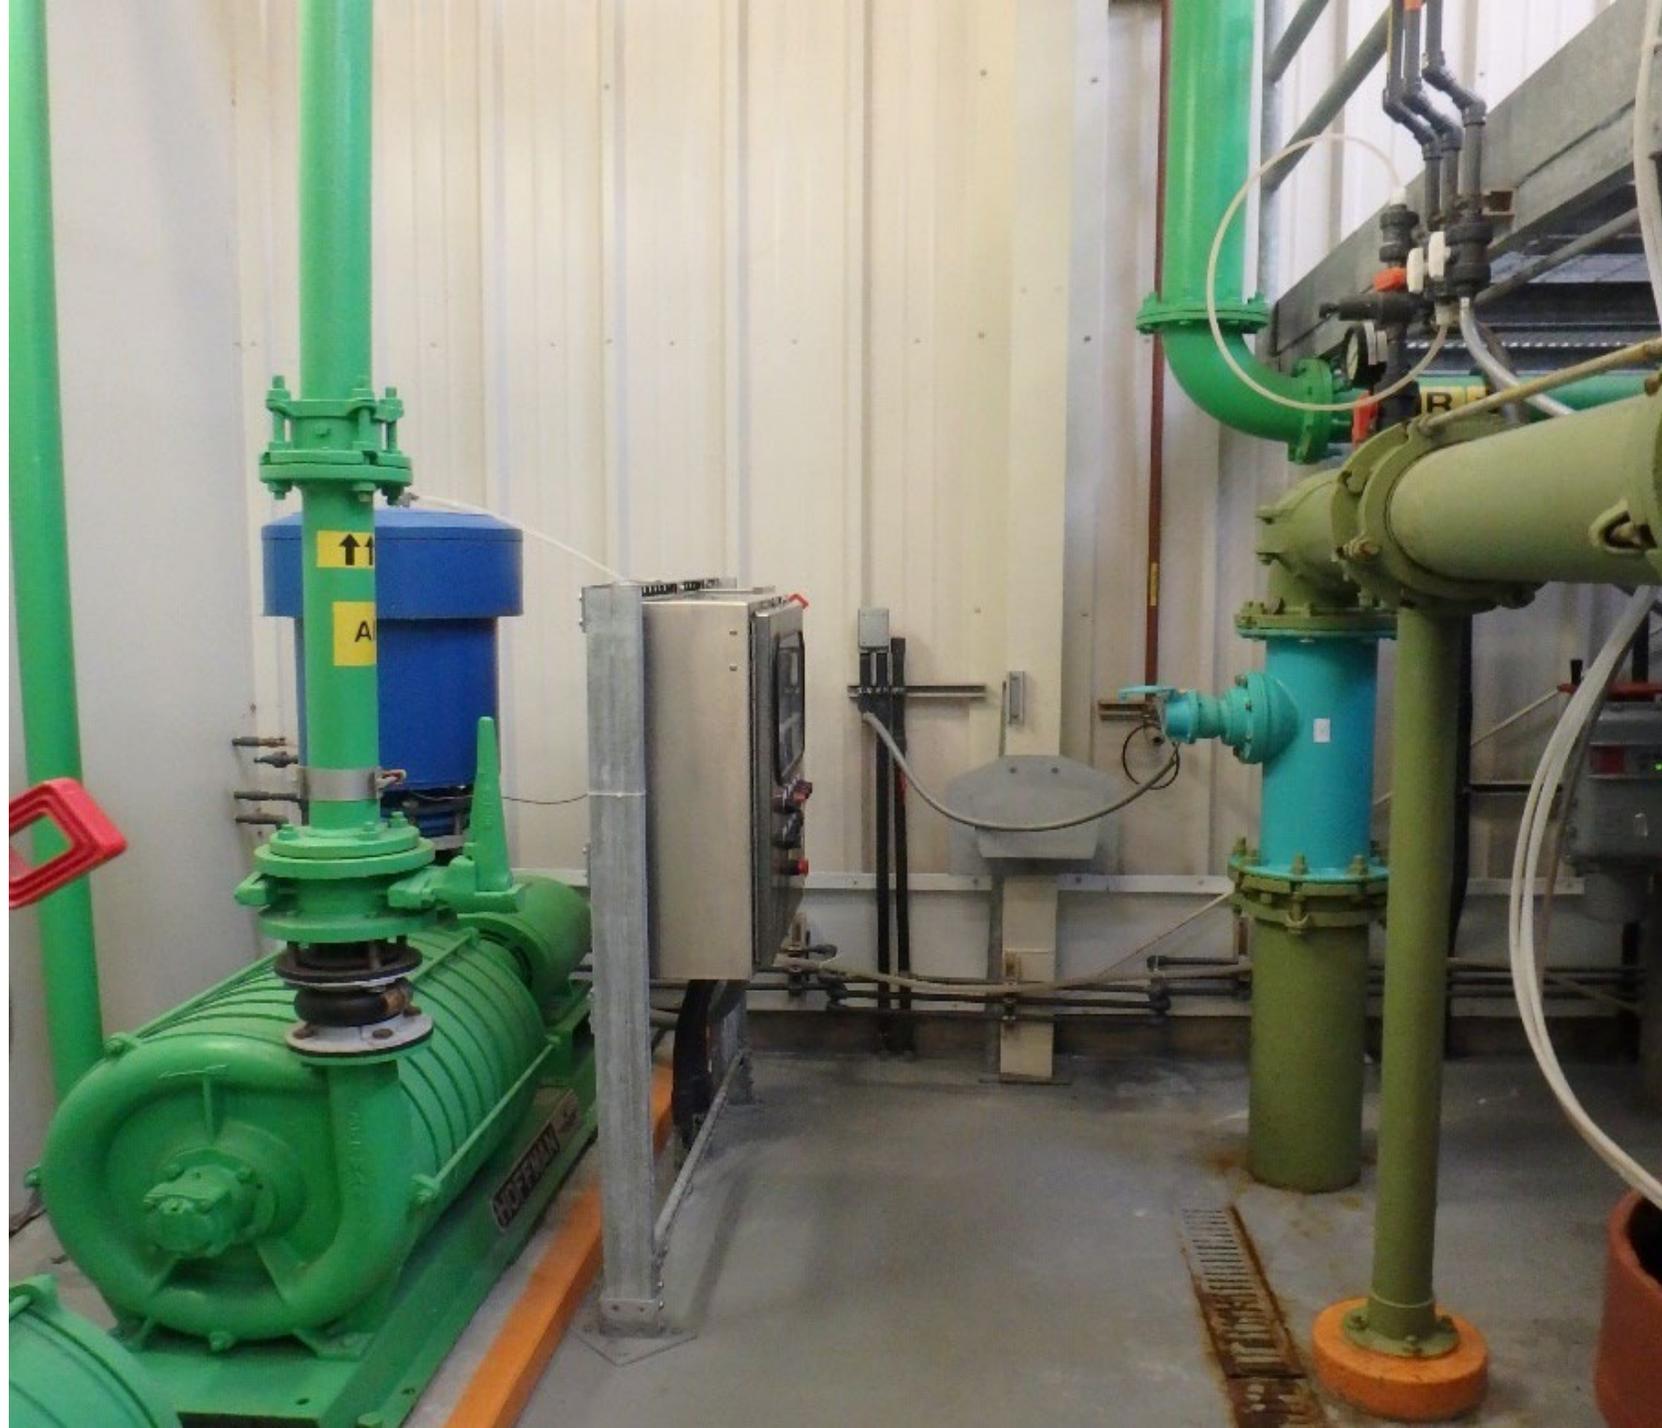
Filter Bubbling

- Smoke tested entire backwash air system
- Removed and inspected air check valves
- Plant smelled like incense for days
- Couldn't find a leak
