Water Supply Well Condition Assessments

Real-World Applications and Results

PNWS-AWWA Annual Conference
May 3-5, 2023

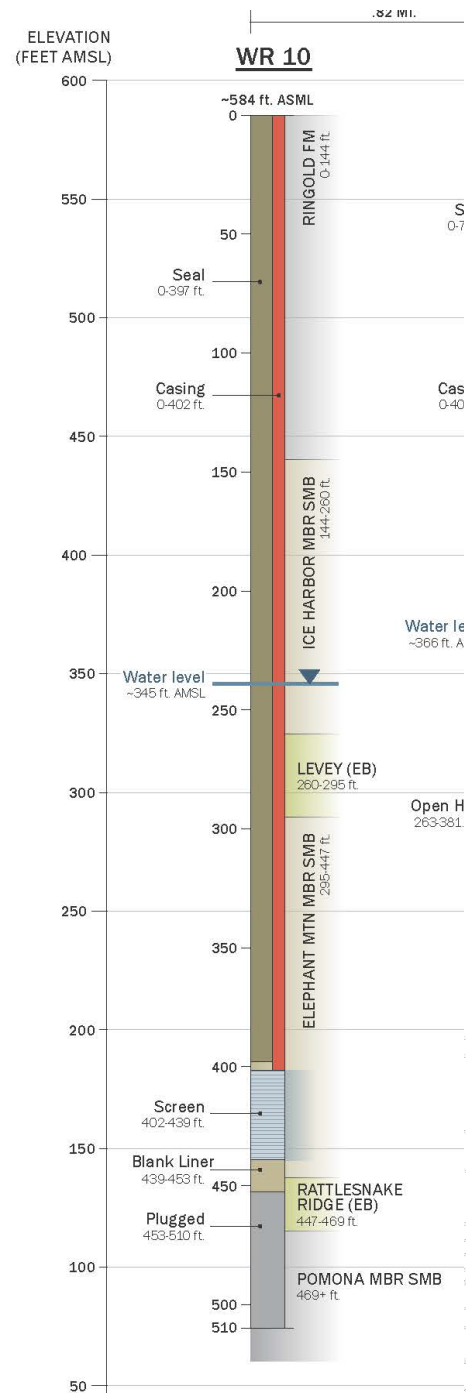
- CRBG Well:
 - Drilled 2006, replaced failed well (2005)
 - 452 ft deep, screened 402-430 ft bgs
 - >1,000 gpm
- History/Issue
 - Failed well was grouted
 - Quickly start on 10
 - Soon developed WQ problems
 - Left in stand-by mode 15 yrs
 - In 2020, will ASR bubble push bad water away?

- Findings: (1) Water quality had improved, (2) Screens clean, (3) Well productive, (4) Brush and disinfection only
- Outcome: (1) ASR is feasible, (2) City still needs to meet peak demand

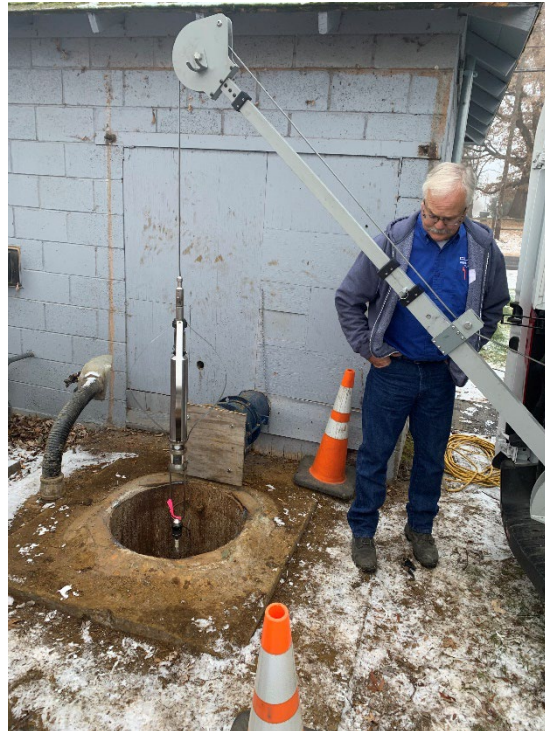
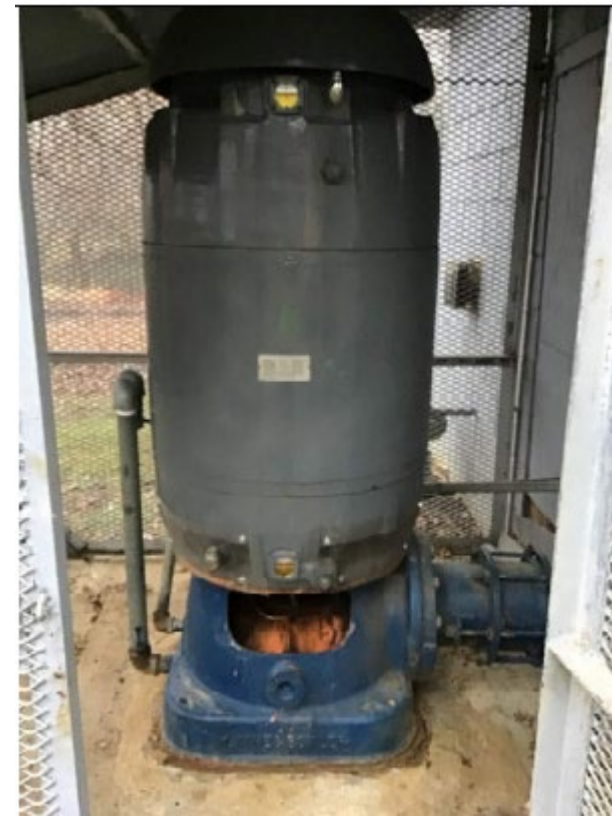
- Well moderately active
- Significant MIC (corrosion)
- Casing required cleaning prior to condition evaluation
- Cleaning process caused casing failure
- Well was re-built with new casing and seal
- Water was clean post-disinfection
- Well is now suitable for ASR

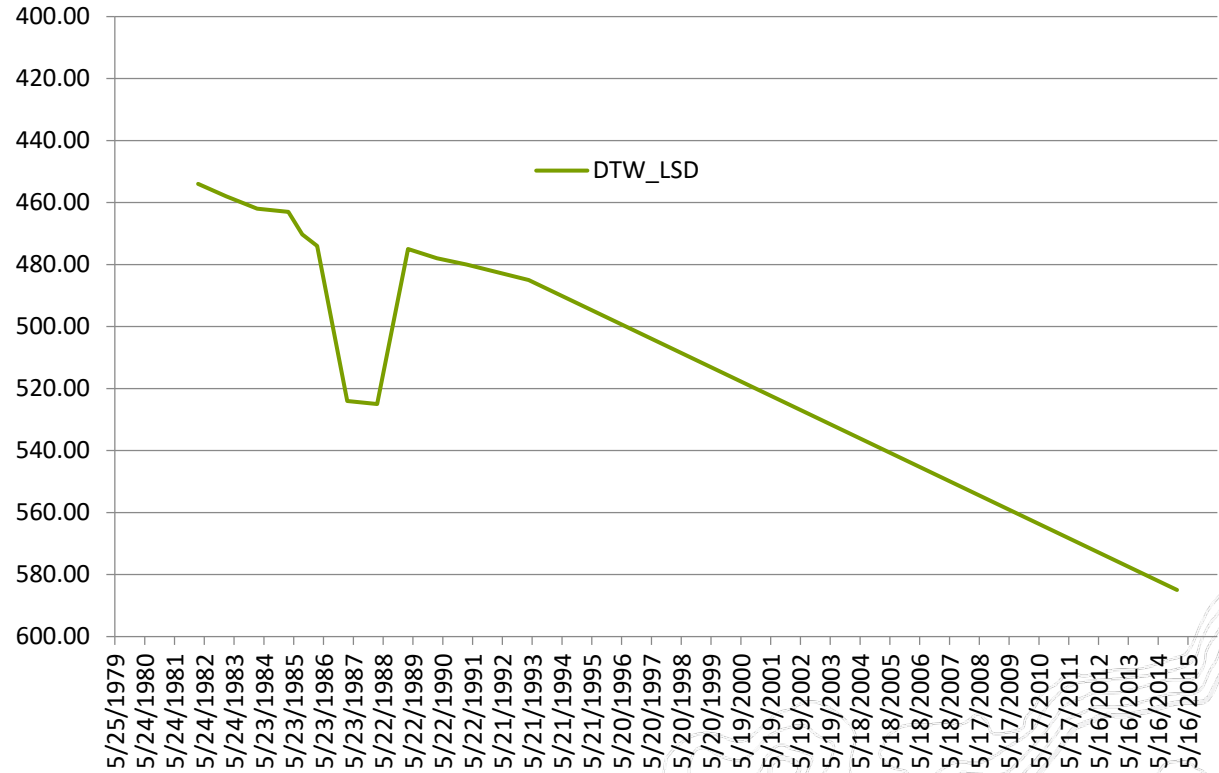
- 750 gpm loss
- 135 ft static drop
- WQ degradation

- Findings: oil feed, surface biology
- Outcome: keep it running, sample supply system, plan for new well in a few years

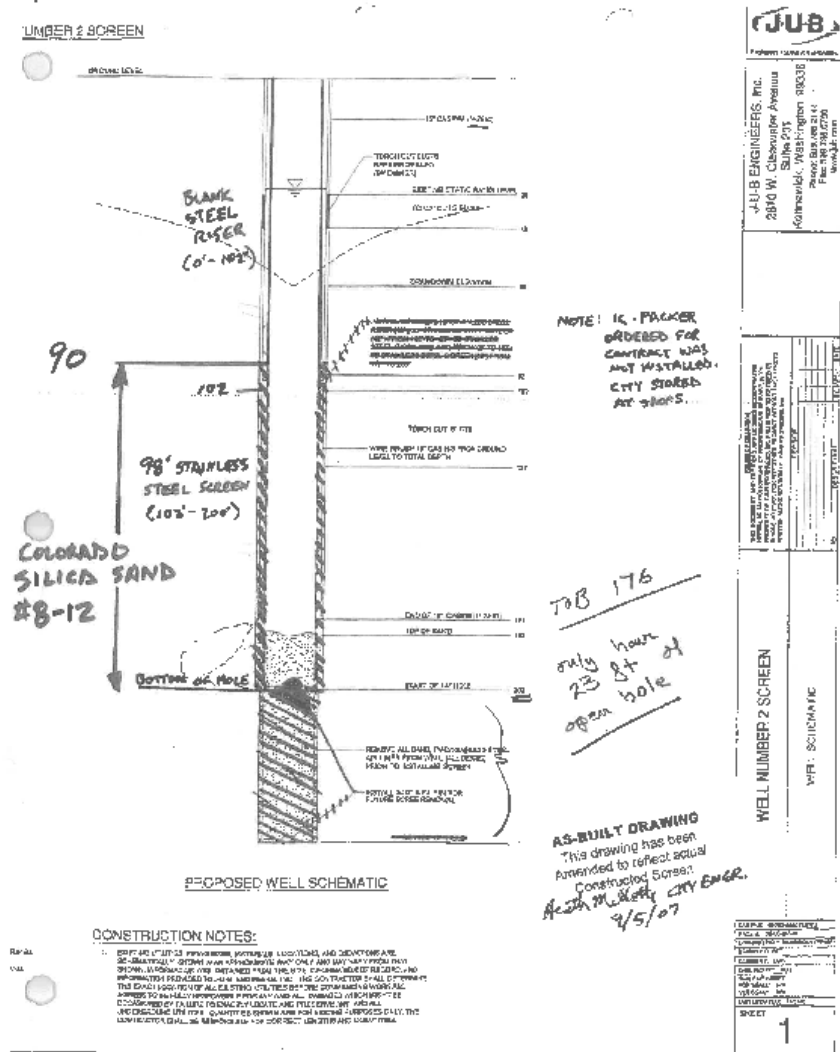
- History/Issue
 - Pre-Rebuild; sanding
 - Post-Rebuild; sanding, nitrate-N
 - 1,000 gpm to <250 gpm

- Basalt Well
 - Shallow well in developed area, WQ
 - Water Rights allow deeper completion
 - Downsizing to case, seal, advance = too small
- Outcome –
Decomm/Replace

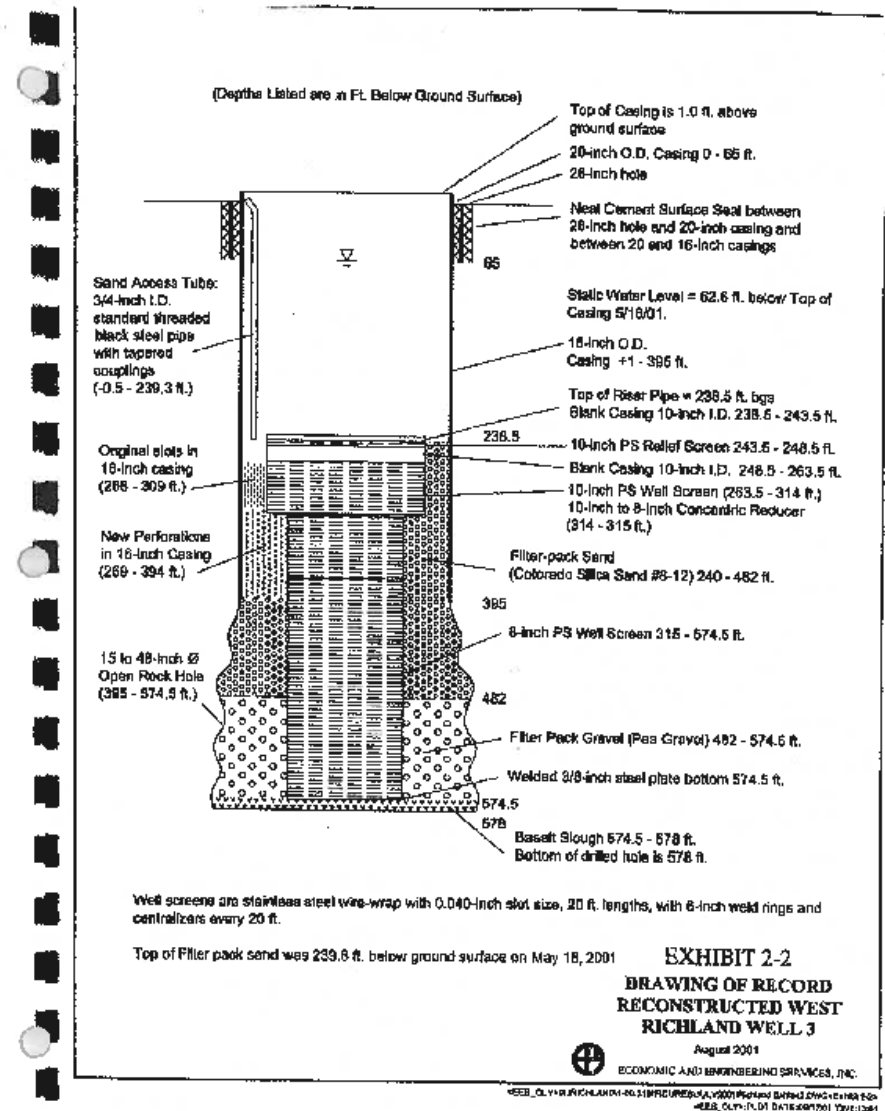
- Pre-Rebuild; sanding, lower borehole collapse
- Post-Rebuild; sanding, WA degraded
- 2,500 gpm to <500 gpm

- Findings: corroded, debris, last rebuild, options limited
- Outcome: decomm/replace

- ORP positive; LSI positive (high CaCO_3 ppt); highly active with Fe-Mg oxidizing bacteria
- Liner broken and offset
- Slots extremely overgrown
- Lower borehole filled with debris and not plumb

- Can't fix (broken/displaced liner) or clean (slots)
- Replace well at better location in City
