Yakima, Washington
May 4, 2012

Lessons Learned on Bellevue's Reservoir Recoating Projects

Daniel Williams, MWH
Chris Brookes, City of Bellevue

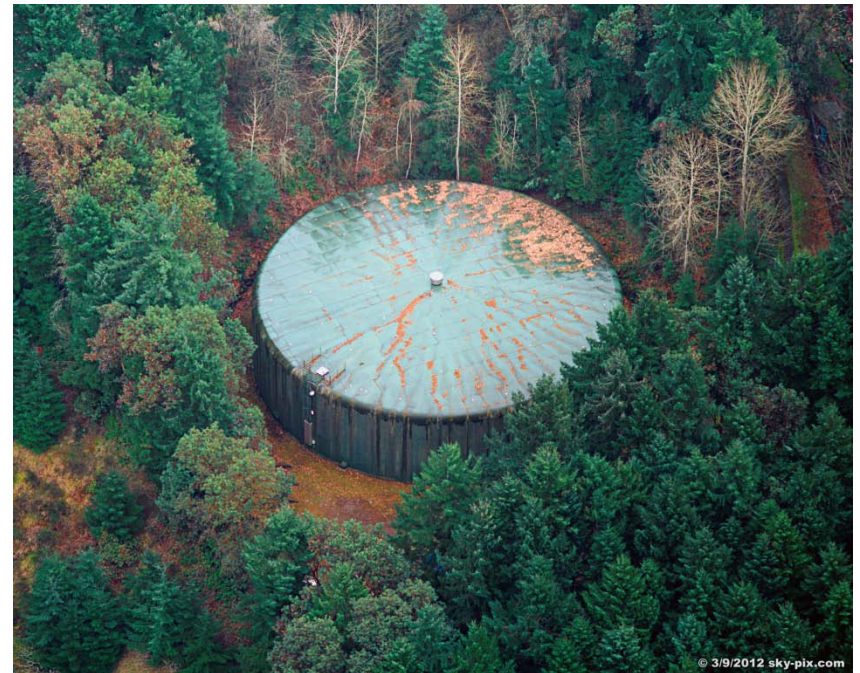
Factoria Reservoir - 1

Factoria Reservoir Improvements Project

- Replaced Interior Coating System
- Top-coated exterior Roof
- Pressure washed walls
- Other misc improvements
- Low Bid = \$356K

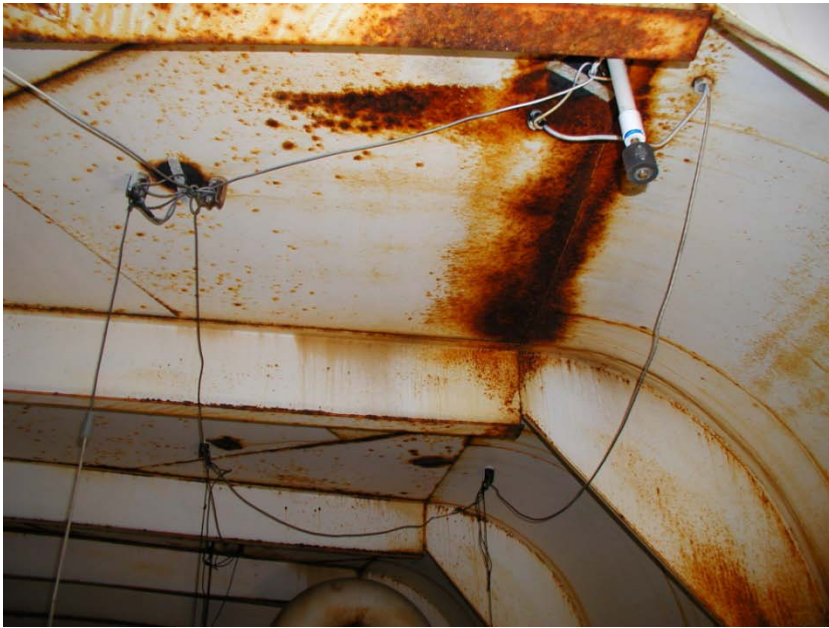
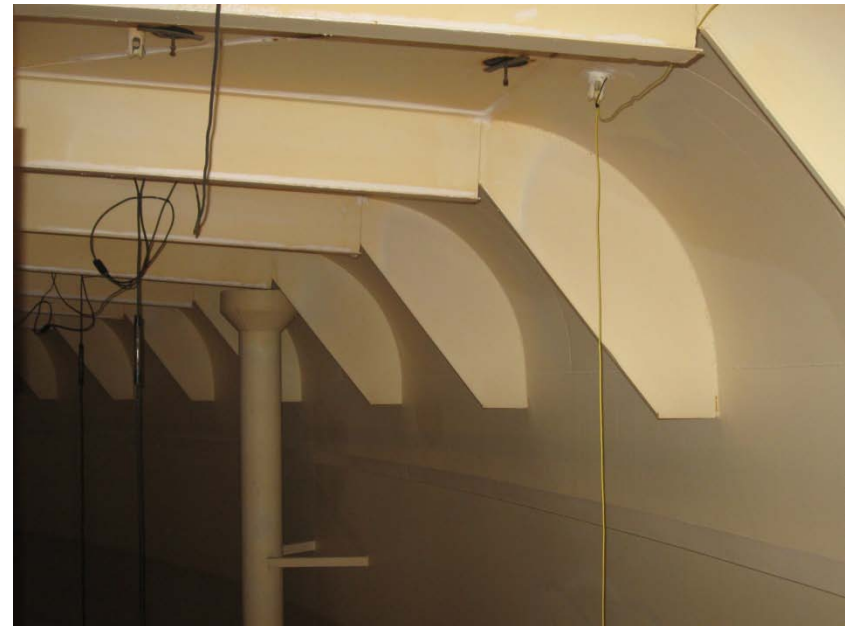
Factoria Reservoir - 3

Rafter Beam / Roof Plates -- Before

Rafter Beam / Roof Plates
w/ Caulking after 7 Years

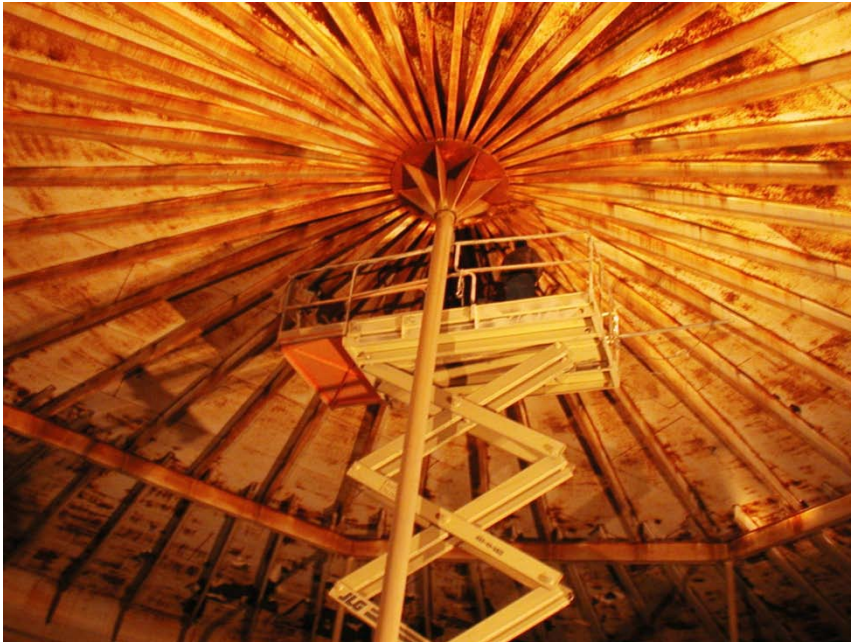
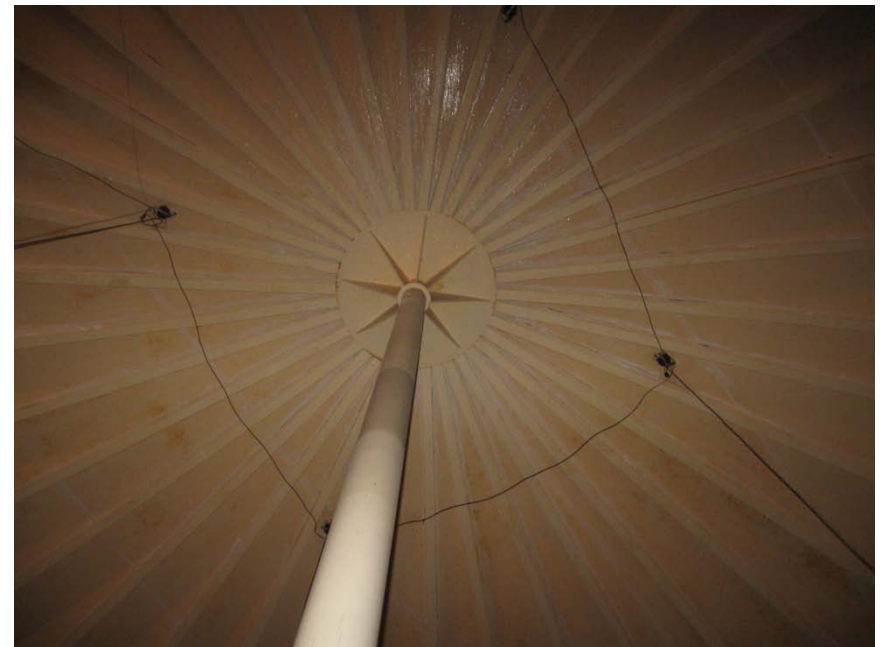
Factoria Reservoir - 4

Rafter Beam / Roof Plates -- Before

Rafter Beam / Roof Plates
w/ Caulking after 7 Years

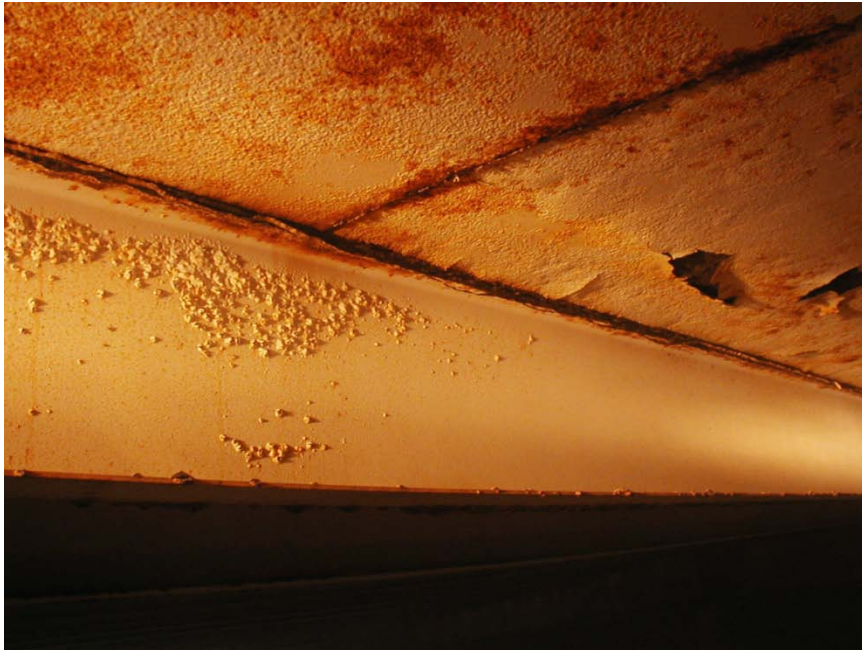
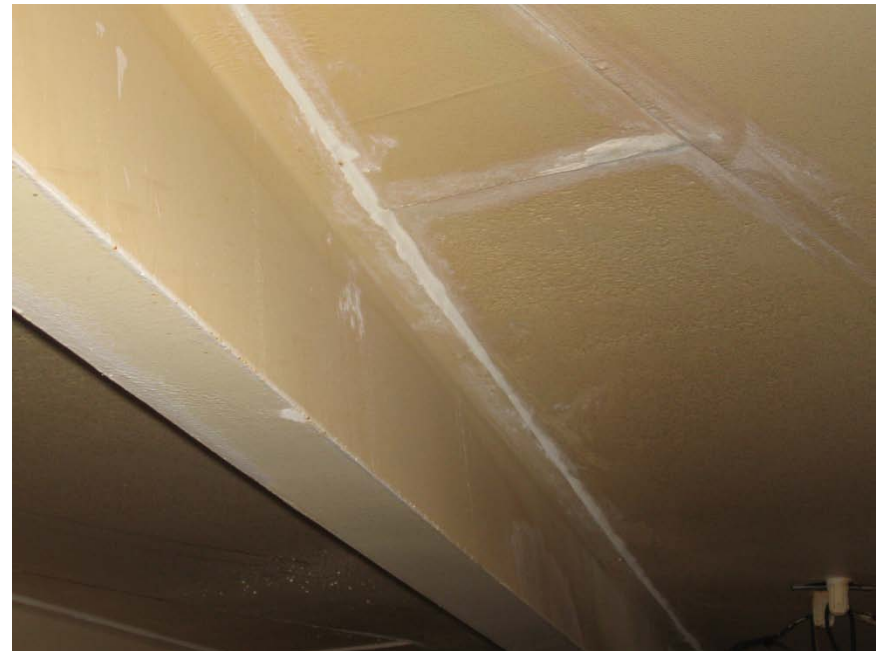
Factoria Reservoir - 5

Rafter Beam / Roof Plates -- Before

Rafter Beam / Roof Plates
w/ Caulking after 7 Years

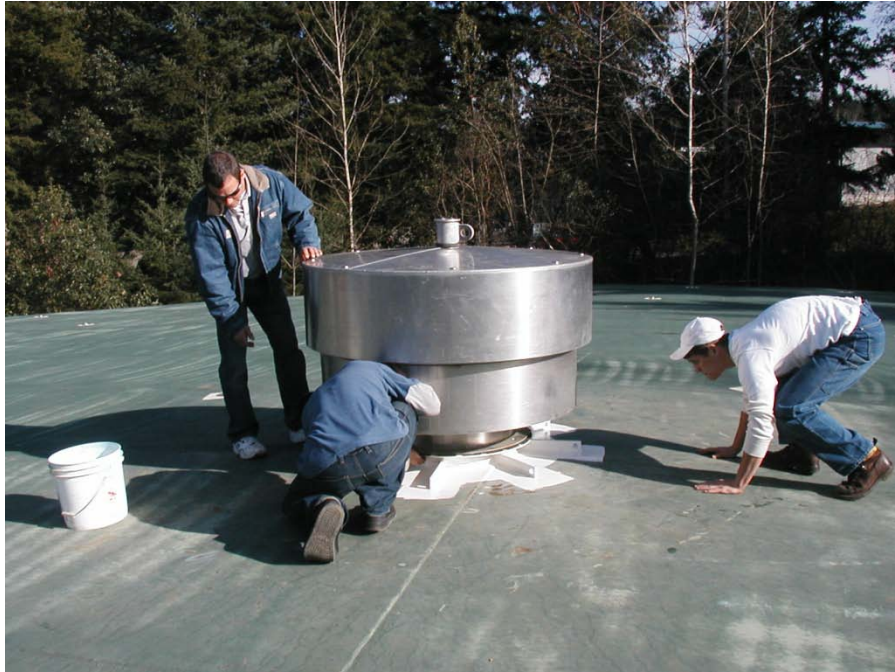
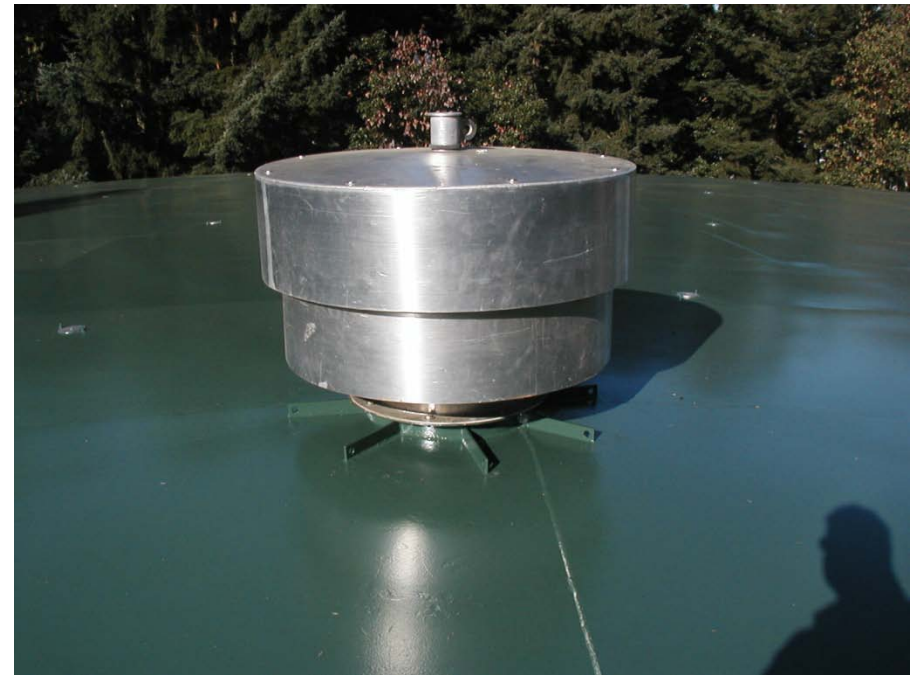
Factoria Reservoir - 6

New Vent with modified Fall Protection

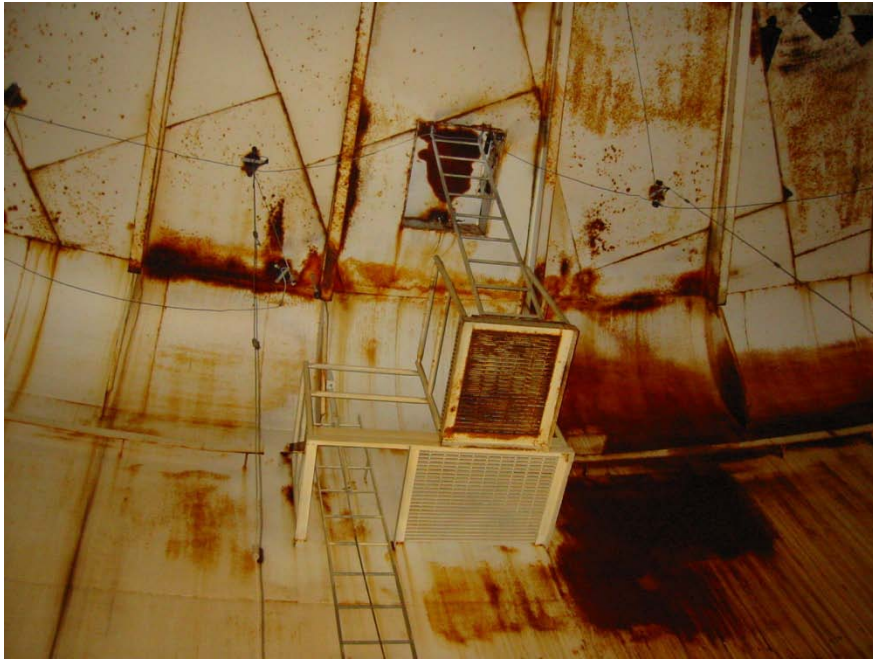
Factoria Reservoir - 8

Ladder / Landing -- Before

Ladder / Landing -- After

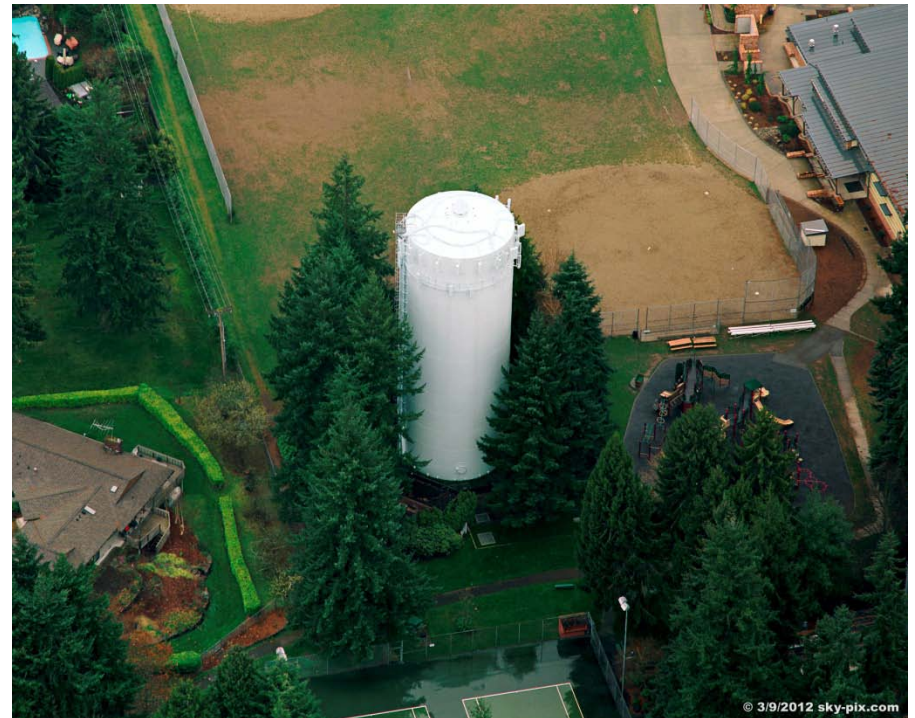
Clyde Hill 465 Standpipe - 1

Clyde Hill 465 Standpipe Reservoir Repainting Project

- 36 feet in diameter
- 90 feet tall
- Top-coated exterior Walls

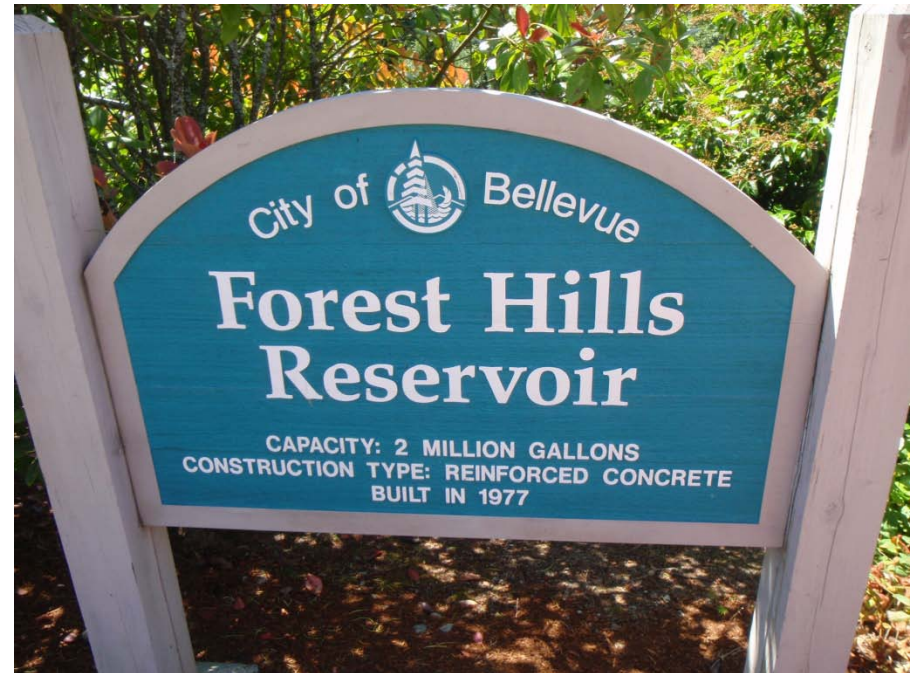
Forest Hills Reservoir Roof Membrane Coating Replacement Project

- 2 MG concrete tank (DYK)
- Diameter = 120 feet
- Wall height = 25 feet
- Low Bid = \$75K

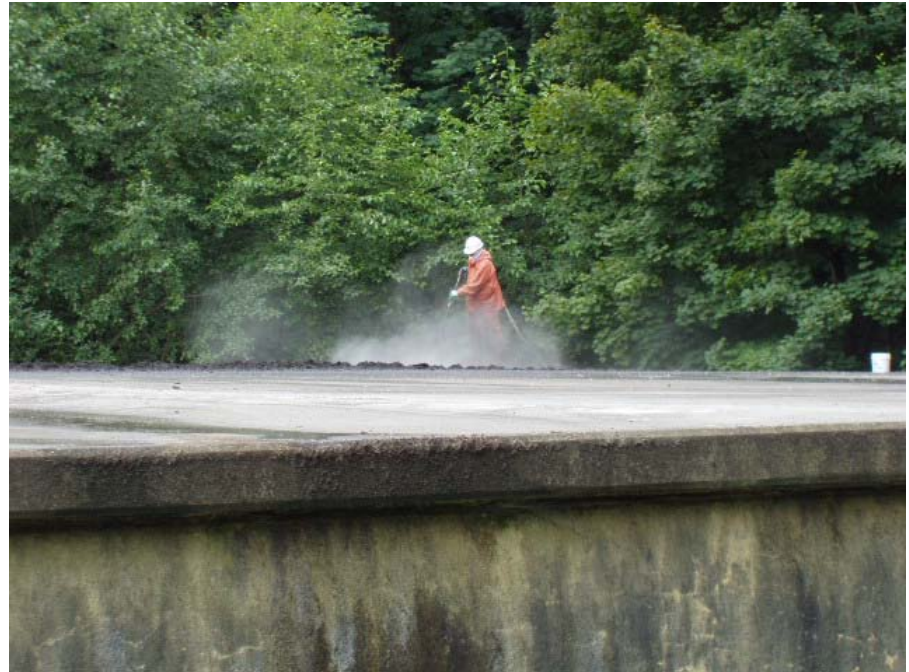
Newport Reservoir Roof and Sidewall Recoating Project

- 3 MG concrete tank (DYK)
- Diameter = 160 feet
- Wall height = 20 feet
- Replace roof coating system

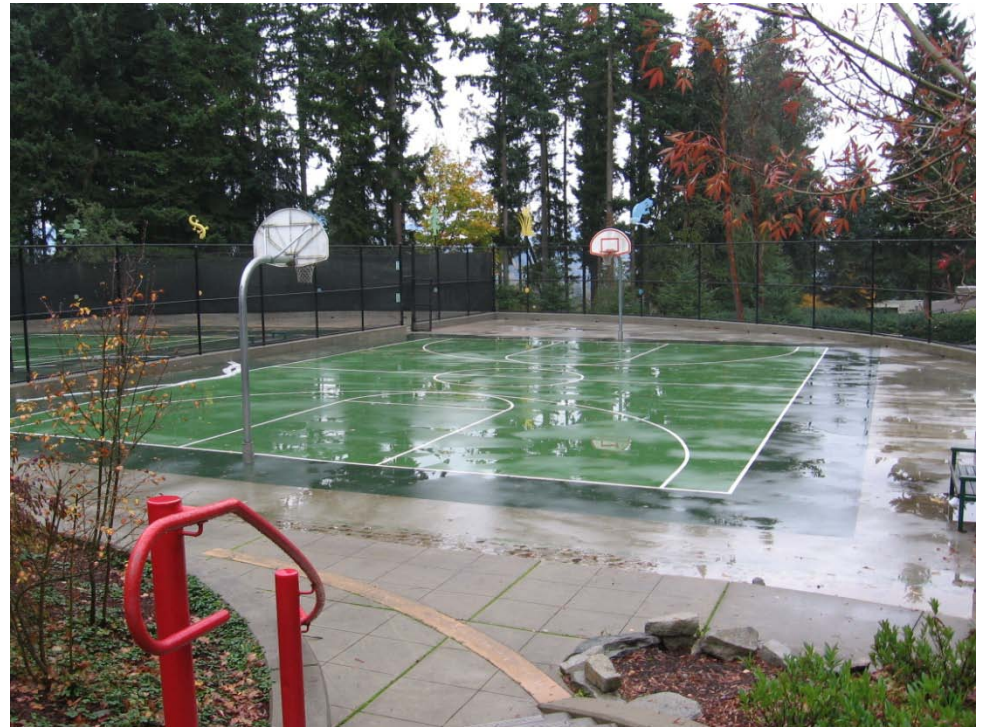
Cherry Crest Reservoir Concrete Repairs

- 3 MG concrete tank
- Diameter = 160 feet
- Wall height = 20 feet
- Epoxy grout cracks in Roof

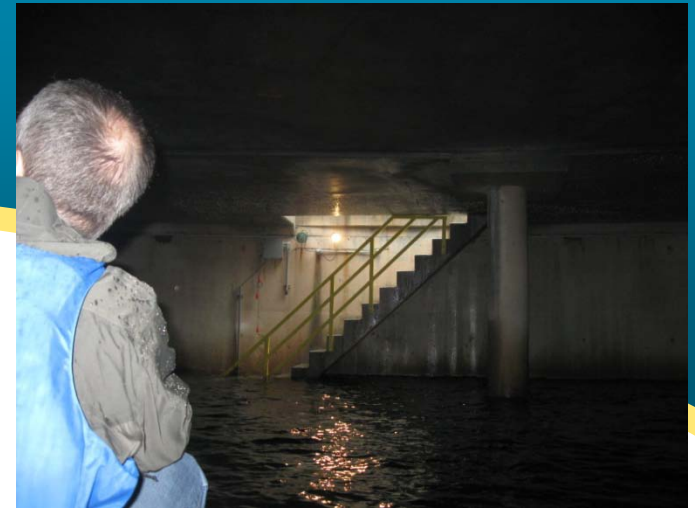
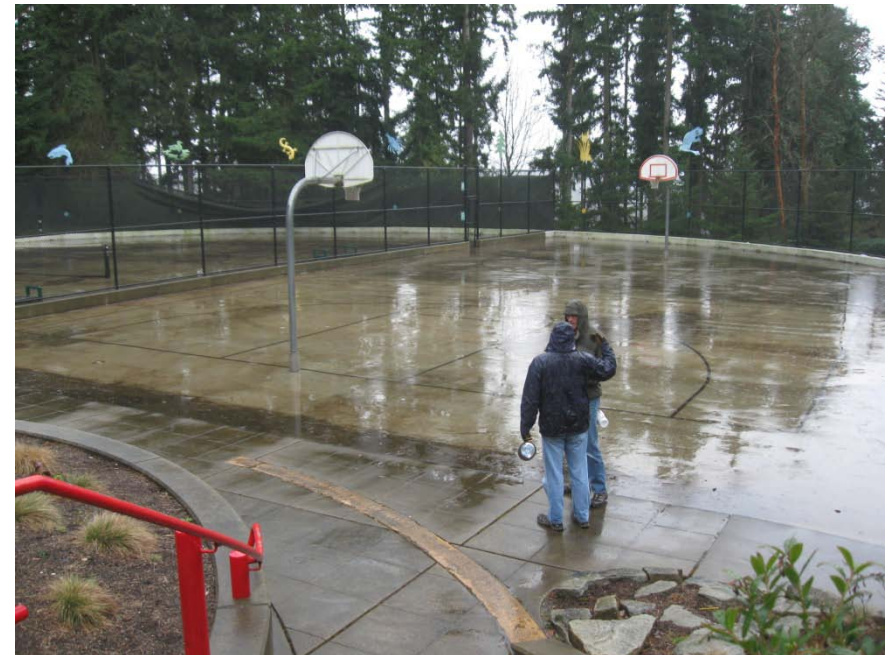
Cherry Crest Reservoir - 6

Currently – No Visible Leaking through Crack Repairs

Sport court is removed. City to leave Tank Un-coated

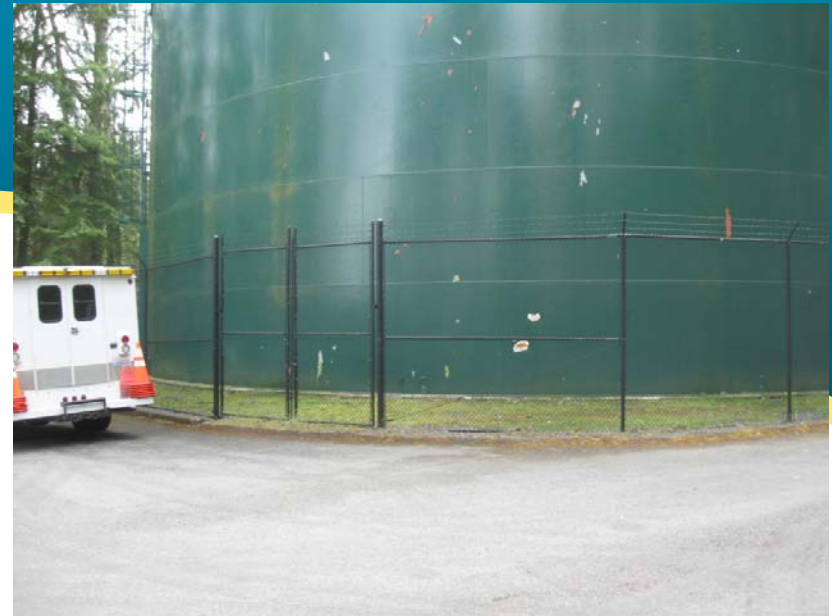
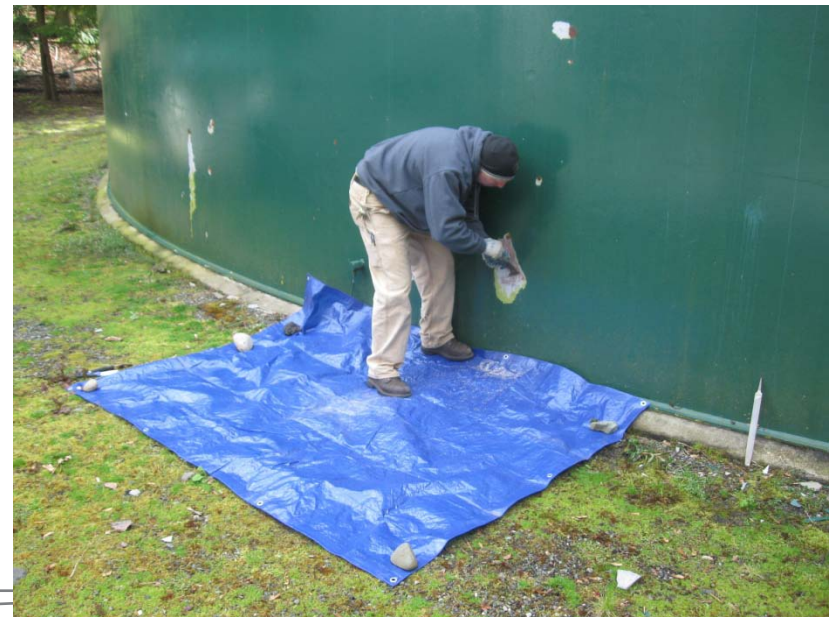
Parksite Reservoir Recoating Project

- 2 MG steel tank
- Diameter = 93 feet
- Wall height = 40 feet
- Remove lead-based coating system
- Class 1A containment
- Recoat entire exterior surface
- Low bid = \$248K
- Class 1A Containment = \$48K
- Lead-based coating removal = \$109K

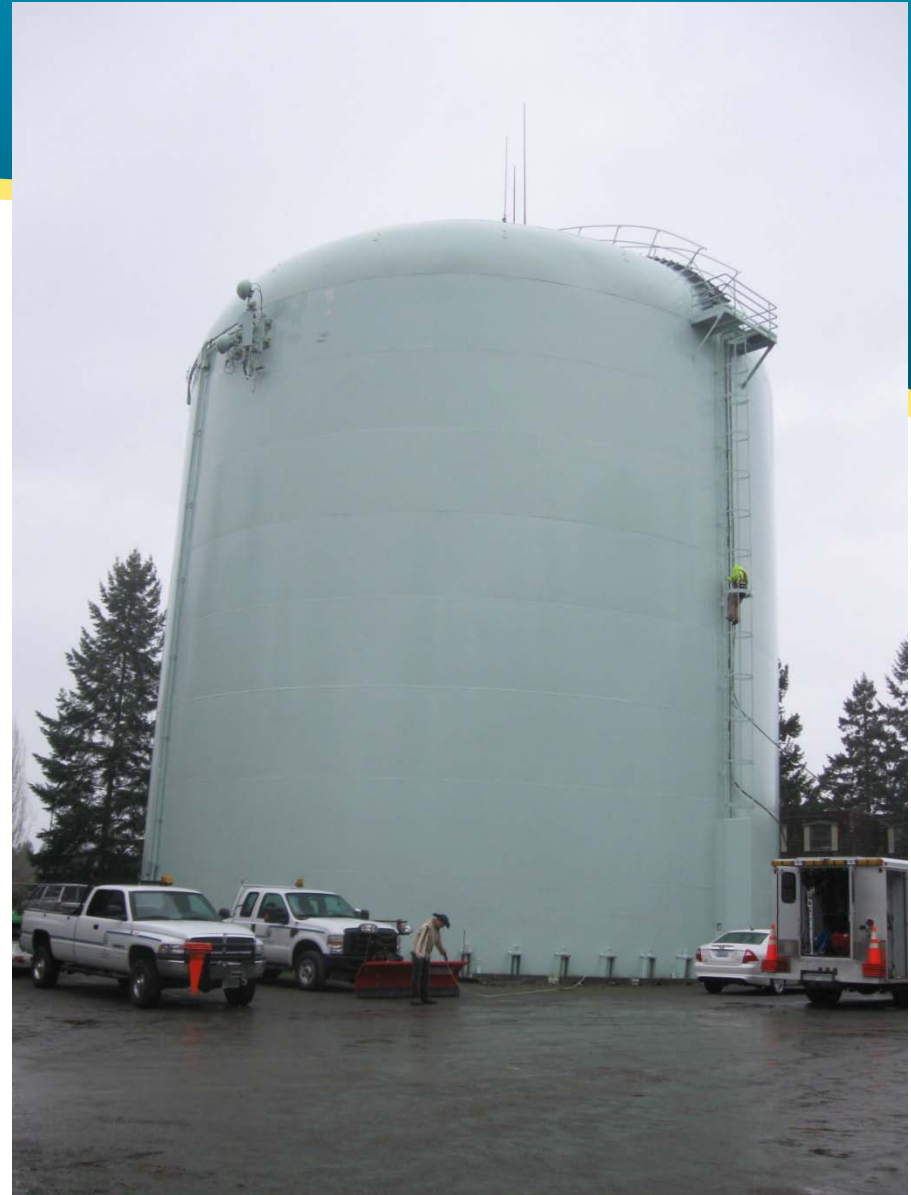
Crossroads North - 2

- 2 MG steel tank
- Diameter = 68 feet
- Wall height = 63 feet
- Recoat interior ceiling
- Low bid = \$141K
- Scaffolding = \$51K
- Replace bolts = \$16/EA

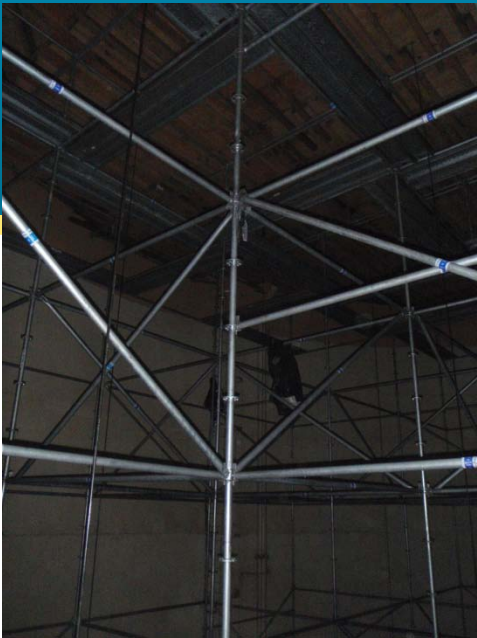
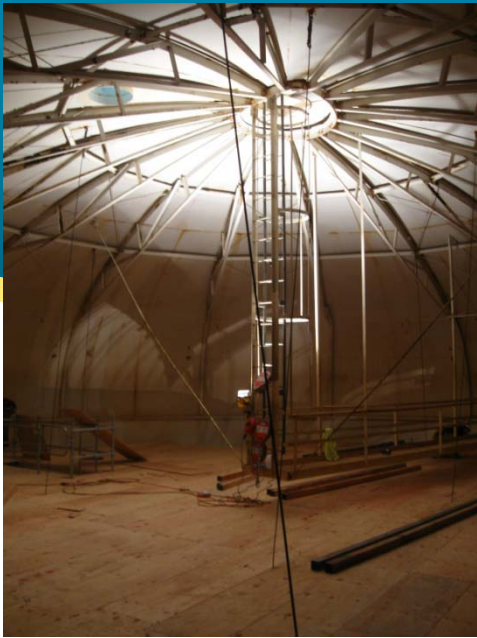
Scaffolding System (\$51K)

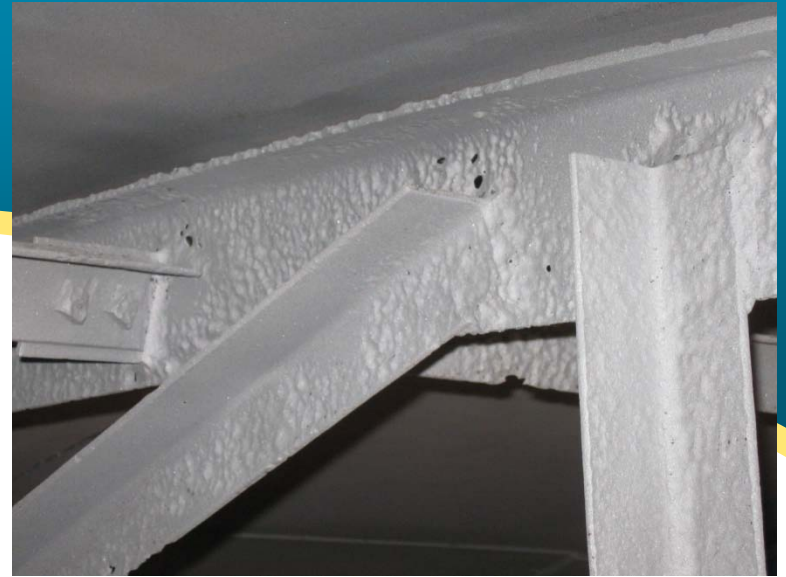
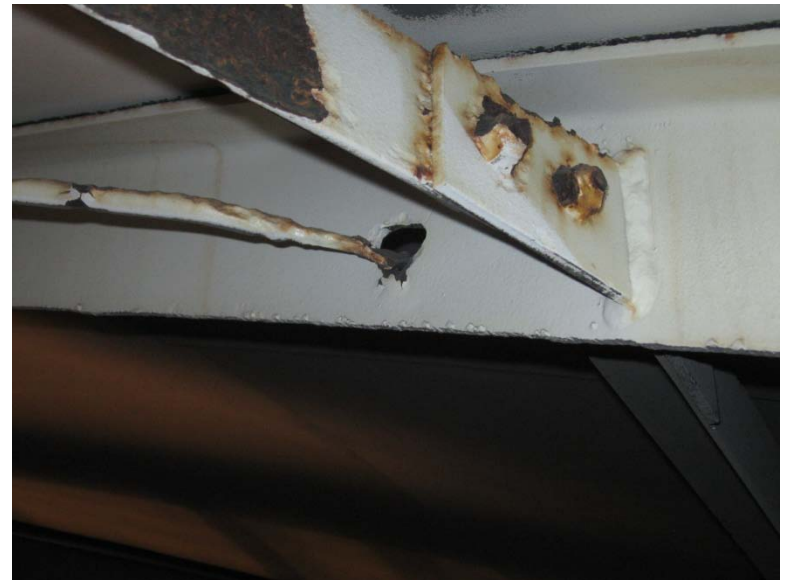
Existing Corrosion

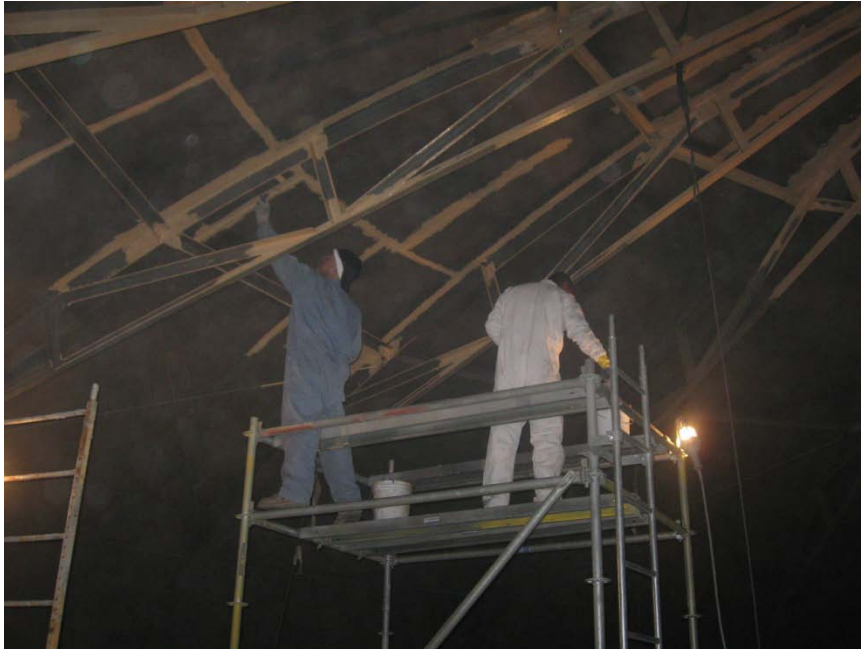
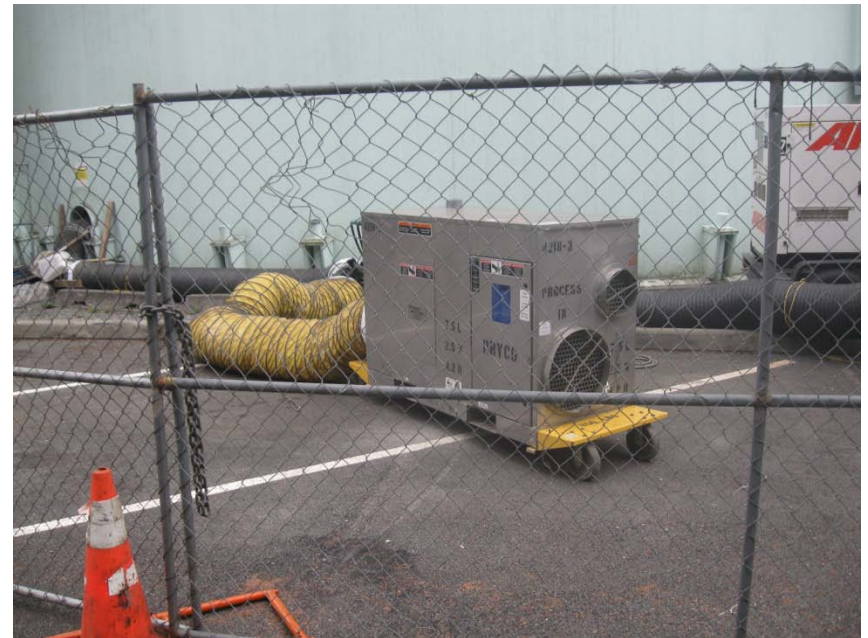
Crossroads North - 8

Stripe Coating w/Brush

Dehumidifier

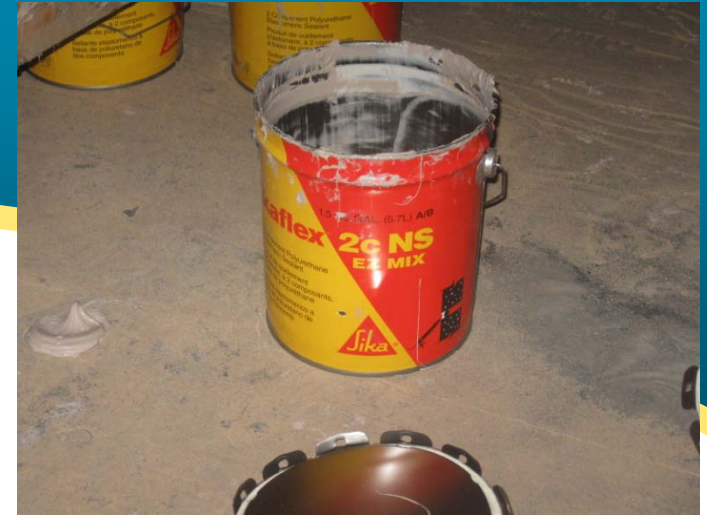
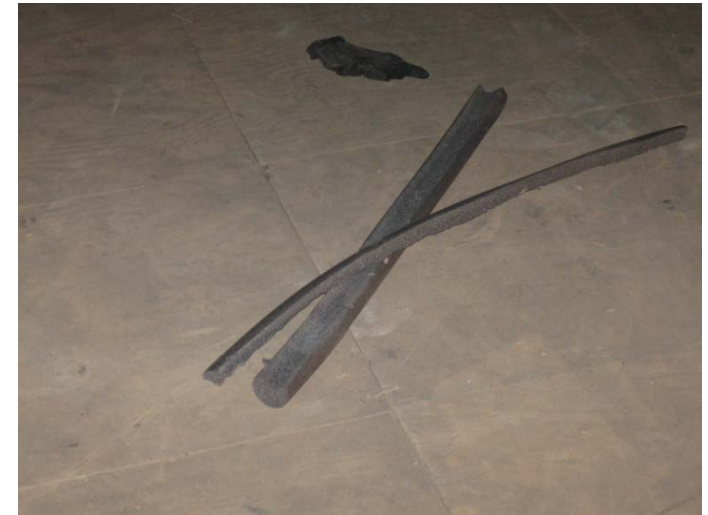
Caulking between Truss
and Roof Plates

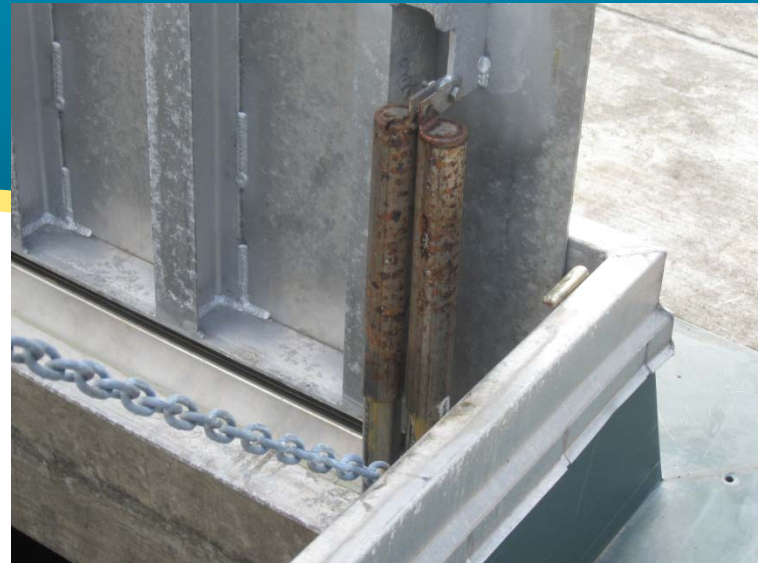
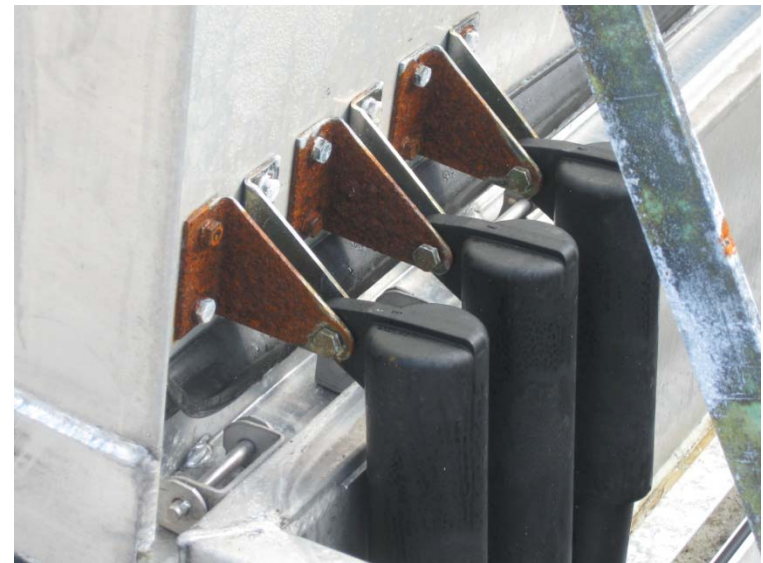
Hatch Components –
Corrosion after 7 years

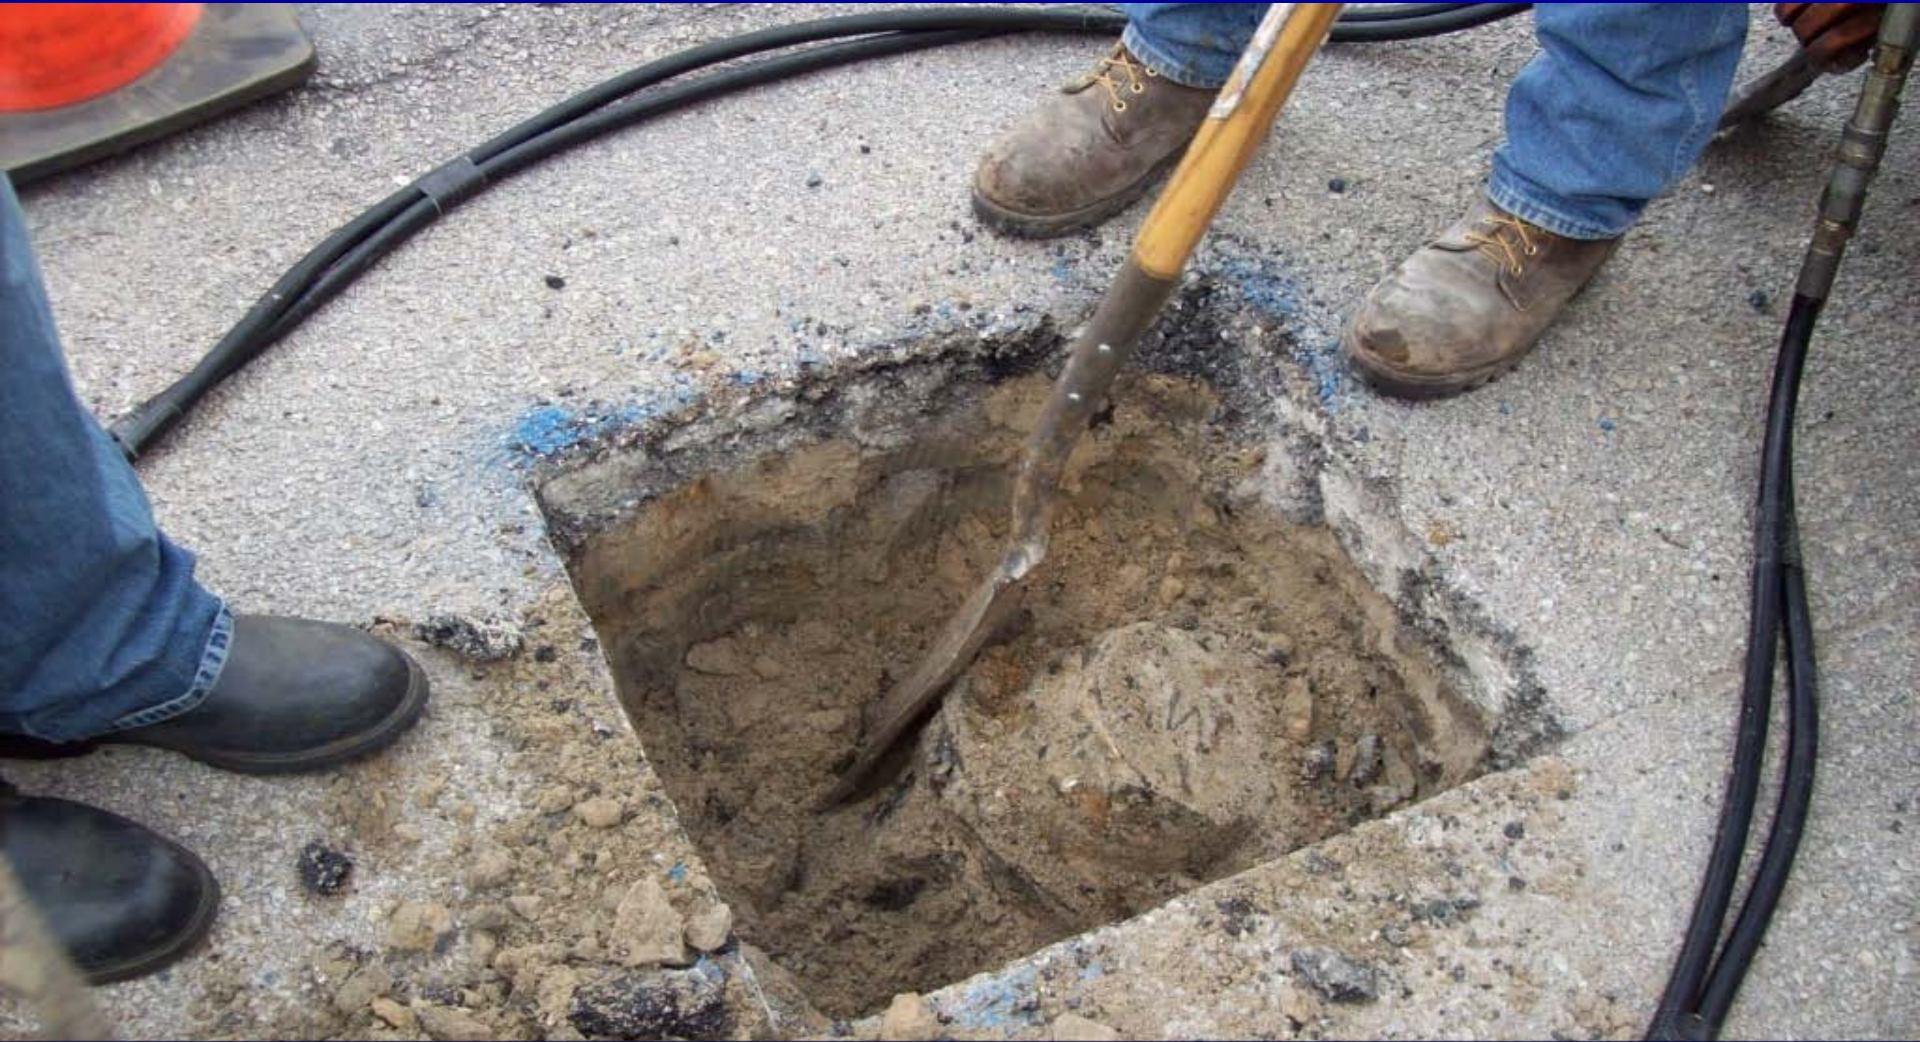
Paved Over Valves

16" Valve Found Under Asphalt

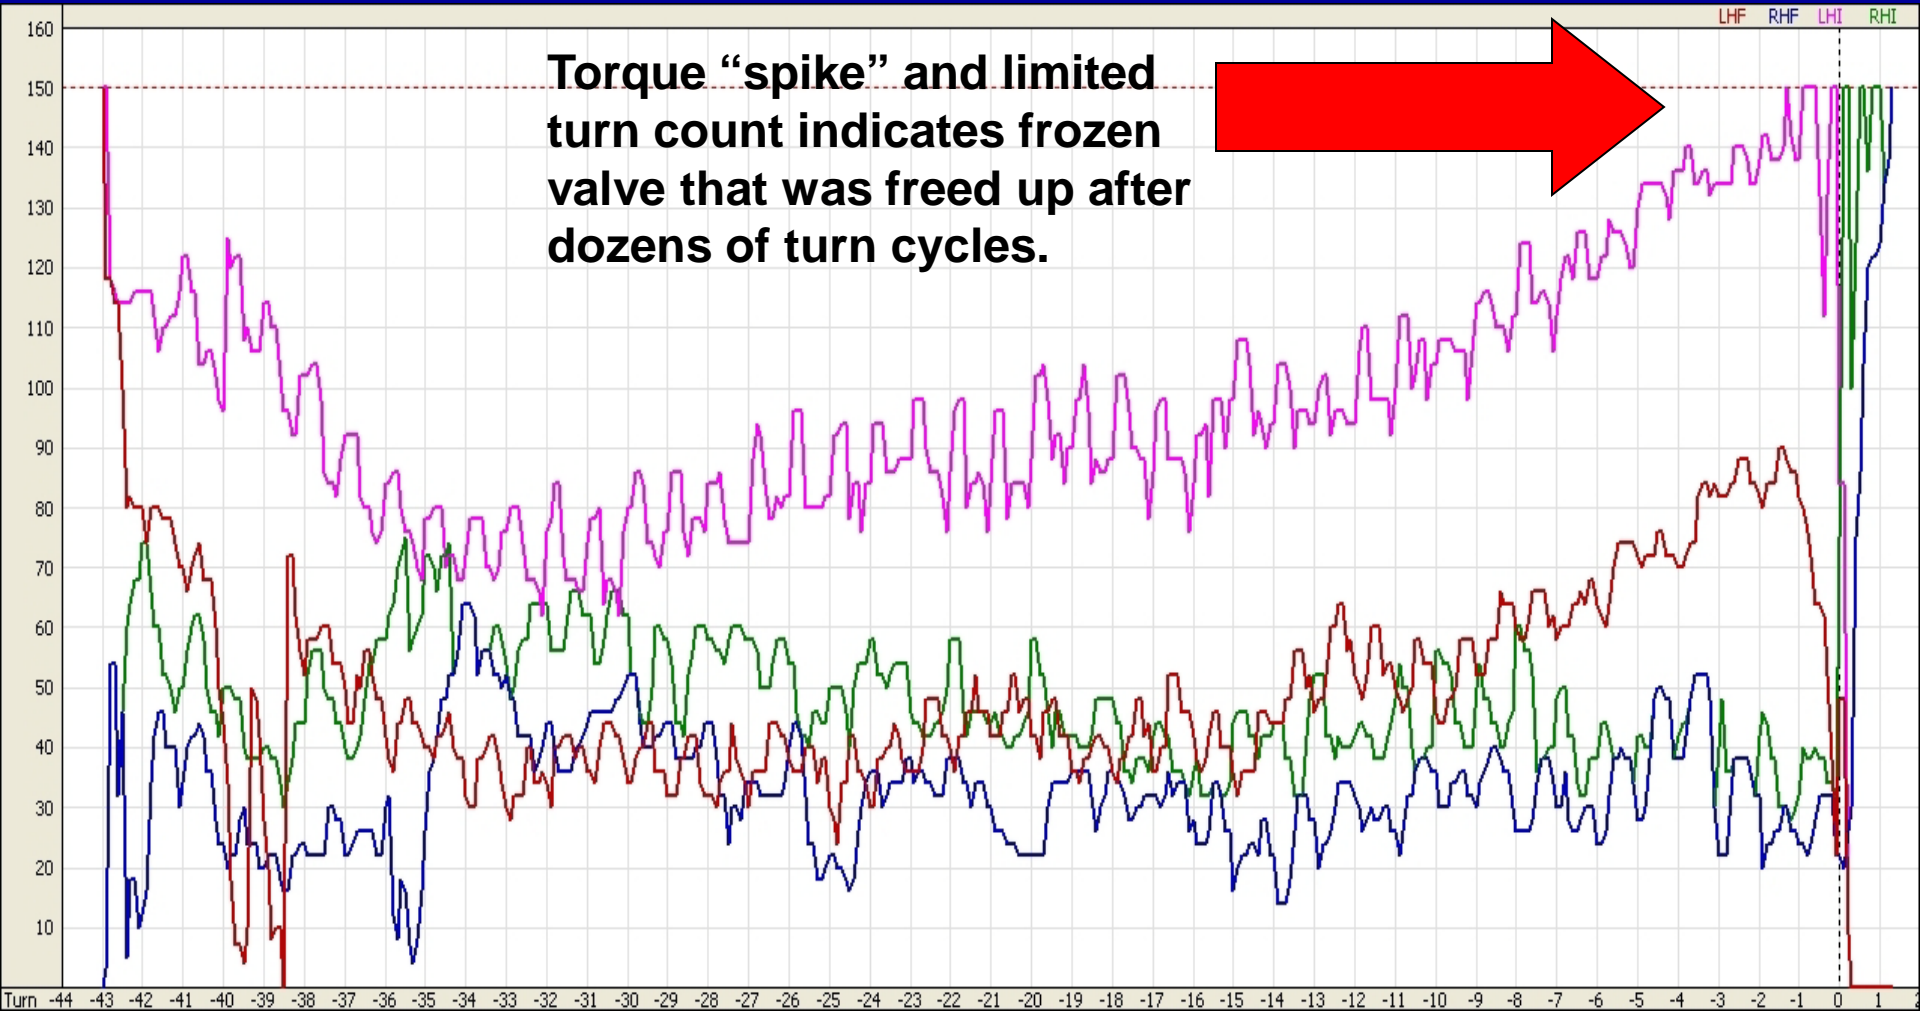
Torque Chart – Frozen Valve

Torque “spike” and limited turn count indicates frozen valve that was freed up after dozens of turn cycles.

30” Butterfly Valve @ West Bellfort Ave. & Kirkwood Dr.

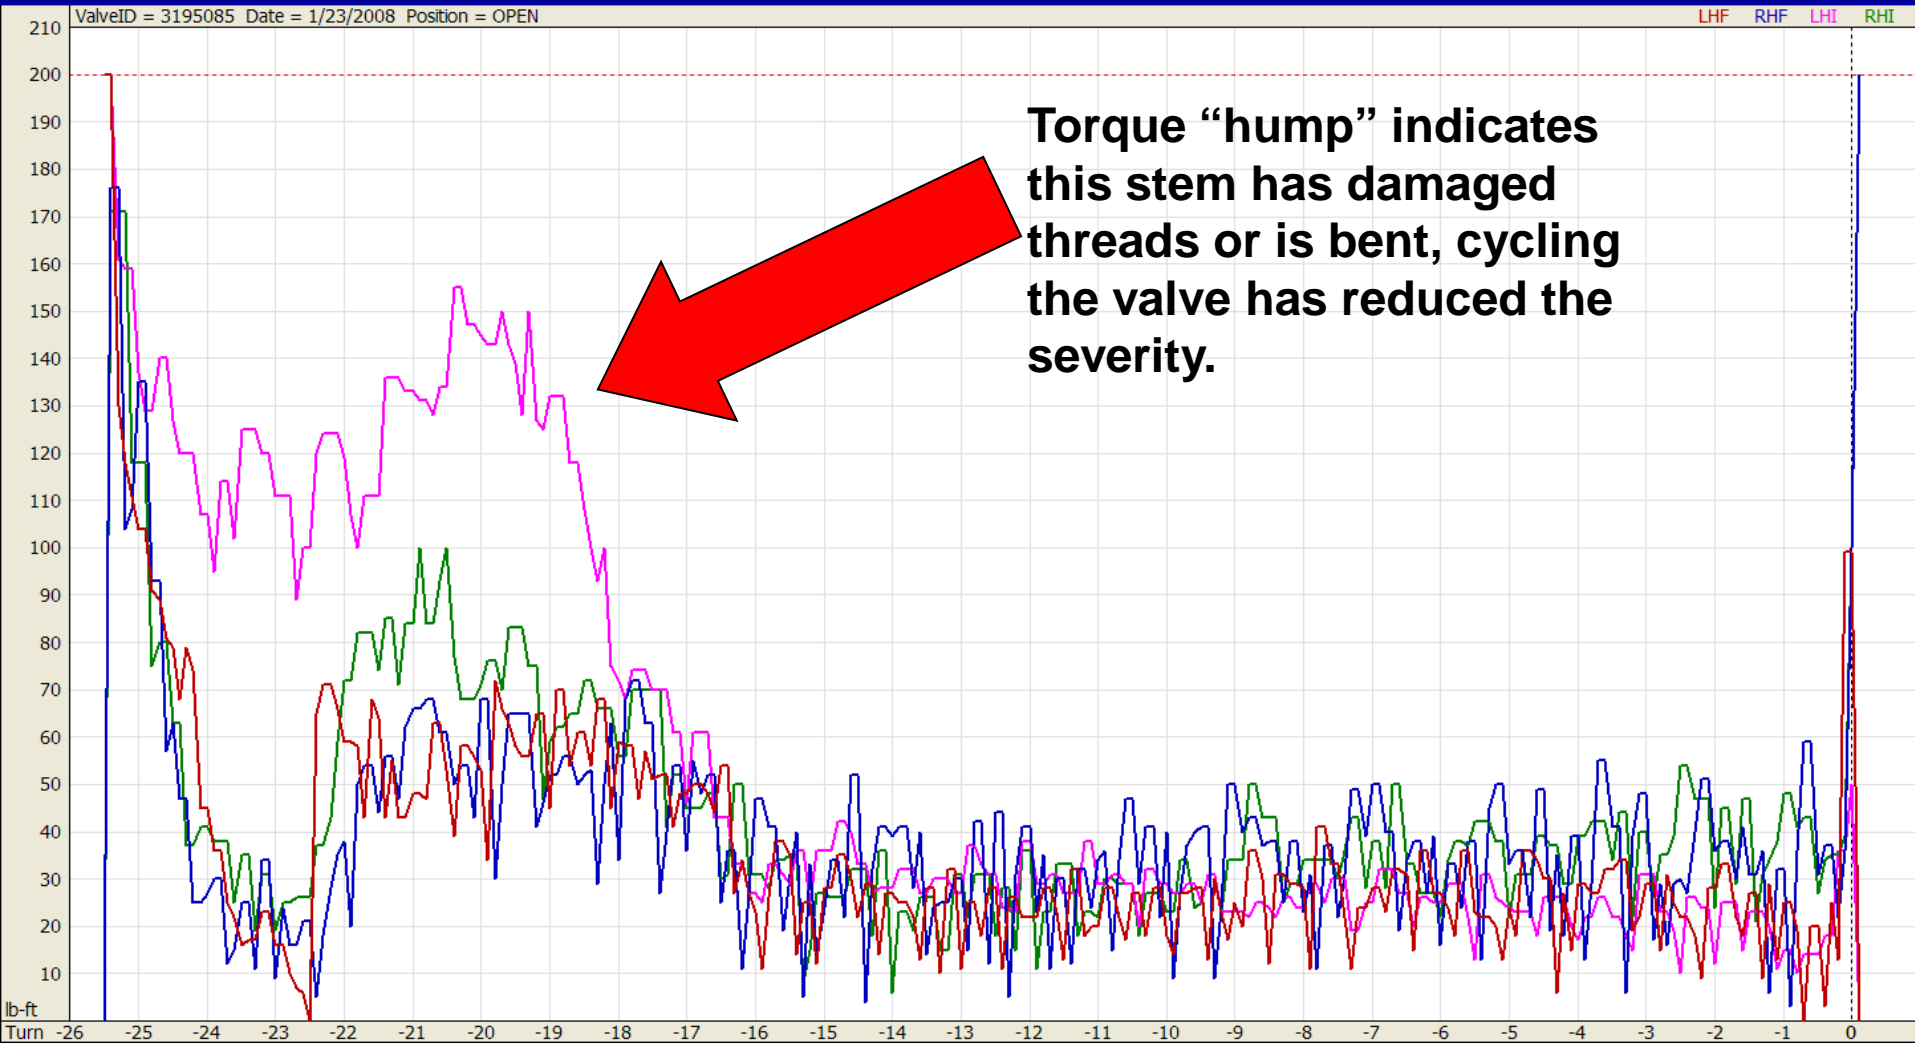
Torque Chart – Bent Stem

16" Gate Valve @ Clara Rd. & Okanella St.
