Yakima, Washington
May 4, 2012

Lessons Learned on Bellevue's Reservoir Recoating Projects

Daniel Williams, MWH
Chris Brookes, City of Bellevue

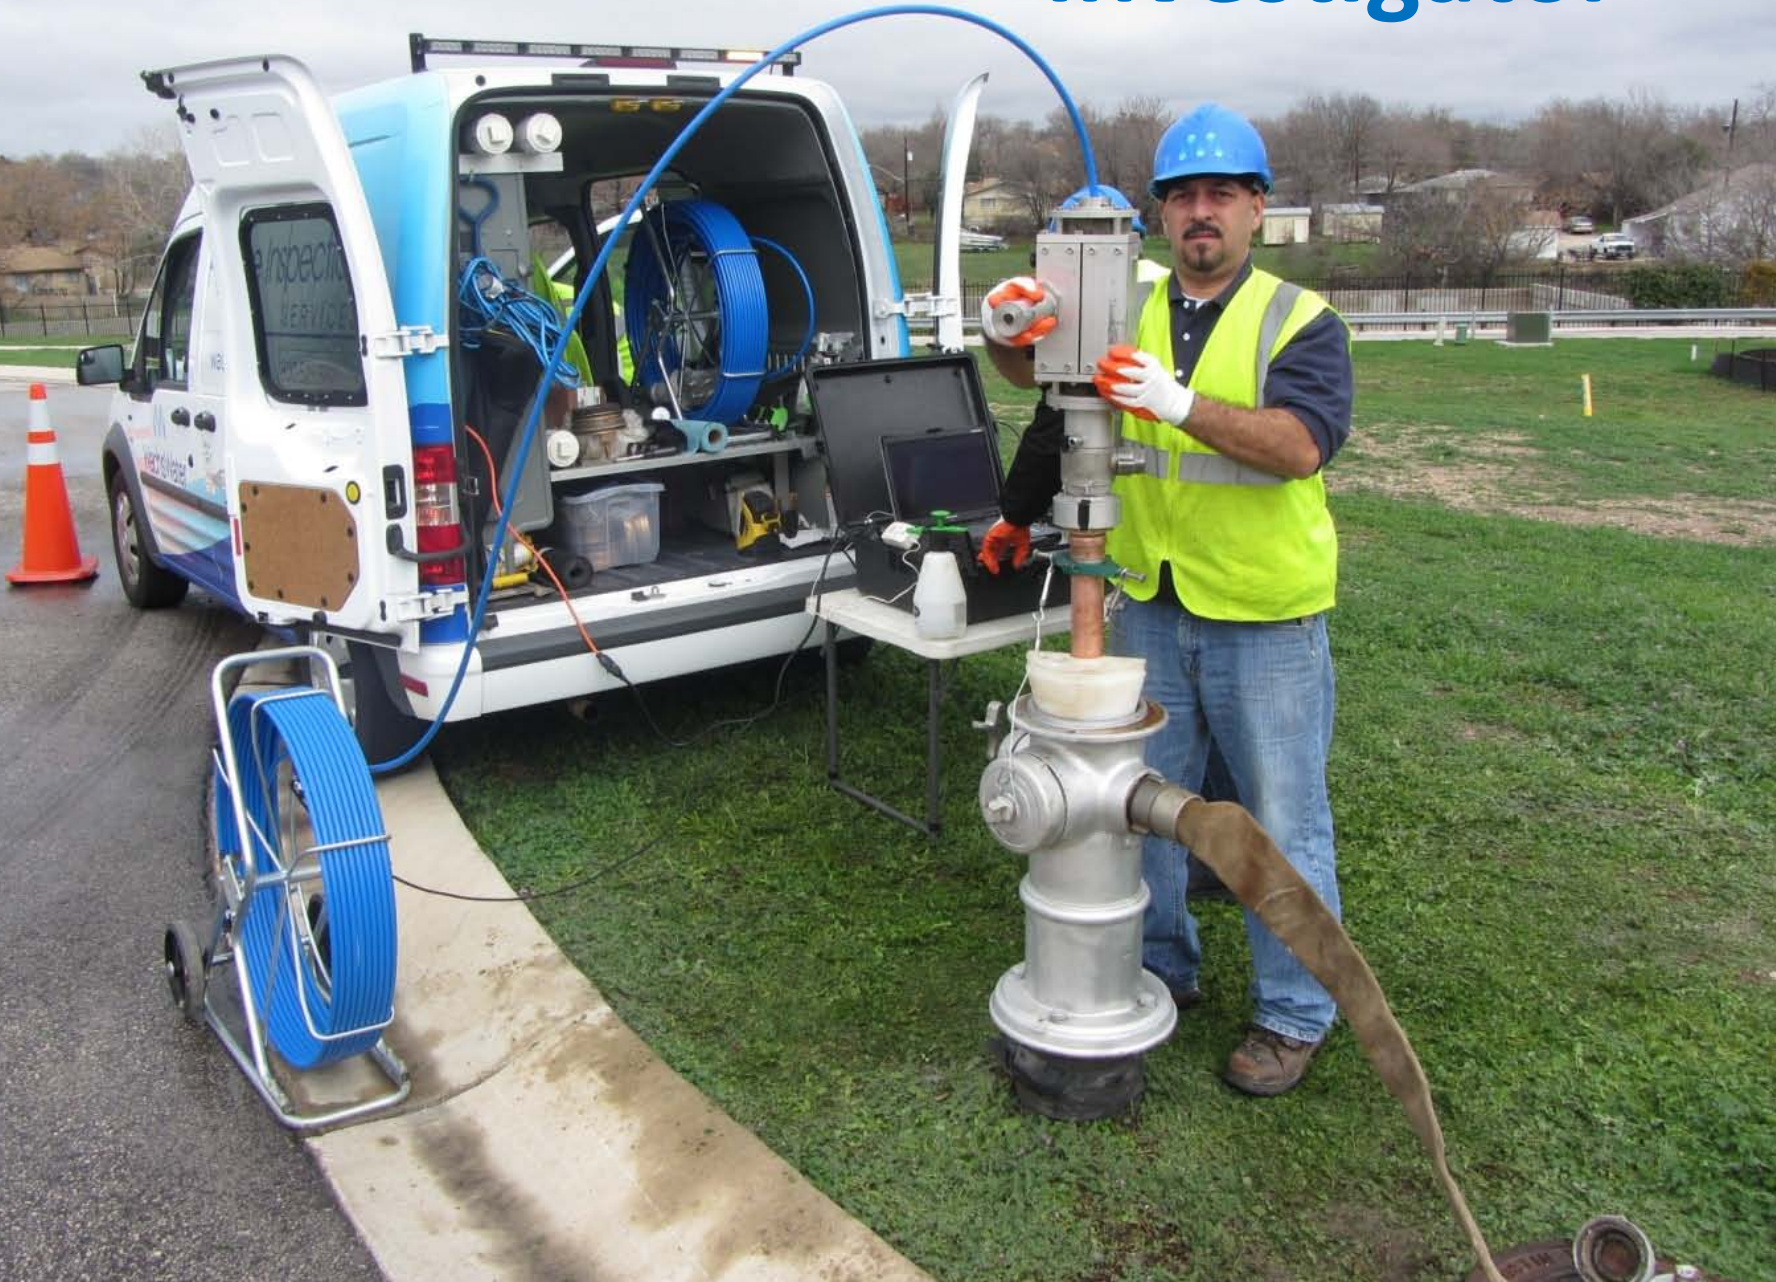
Investigator™

- Non-Invasive Technology
- CCTV Video, Acoustic, w/Sonde
- Highly Accurate

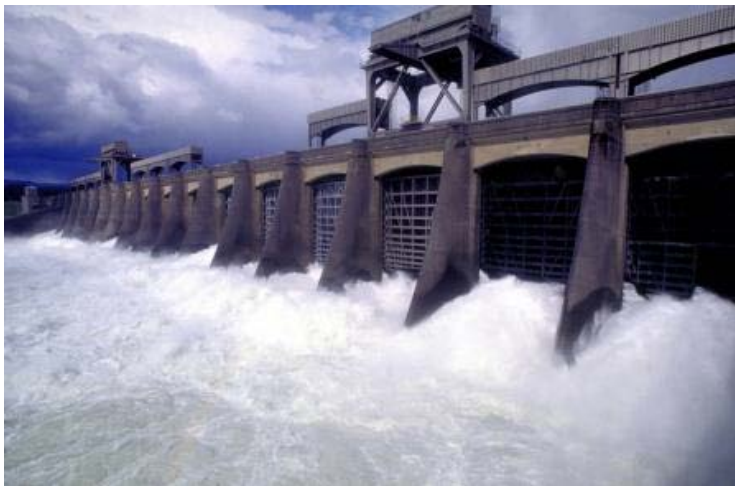
The Bonneville Dam

70% of electricity in Northwest is currently from hydropower, mostly from very large projects

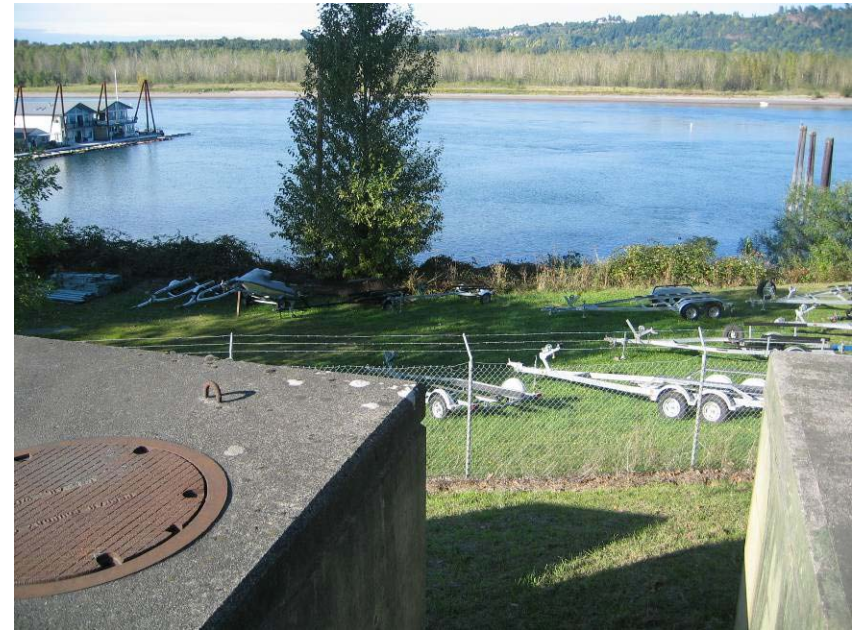
Midway WWTP Study

- Turbine in WWTP outfall to the Puget Sound
- 30 kW plant from 50 feet of head and 8 MGD
