MEETING THE CHALLENGES OF IN-WATER DESIGN AND CONSTRUCTION

JAMIE DUBOIS, P.E. PROJECT ENGINEER
WATER DIVISION

- New River Intake Pump Station*
- Untreated “Raw” Water Pipeline
- Upgraded Water Treatment Plant
- Treated “Finished” Water Pipeline
- New Waluga Reservoir*
- New Bonita Pump Station*

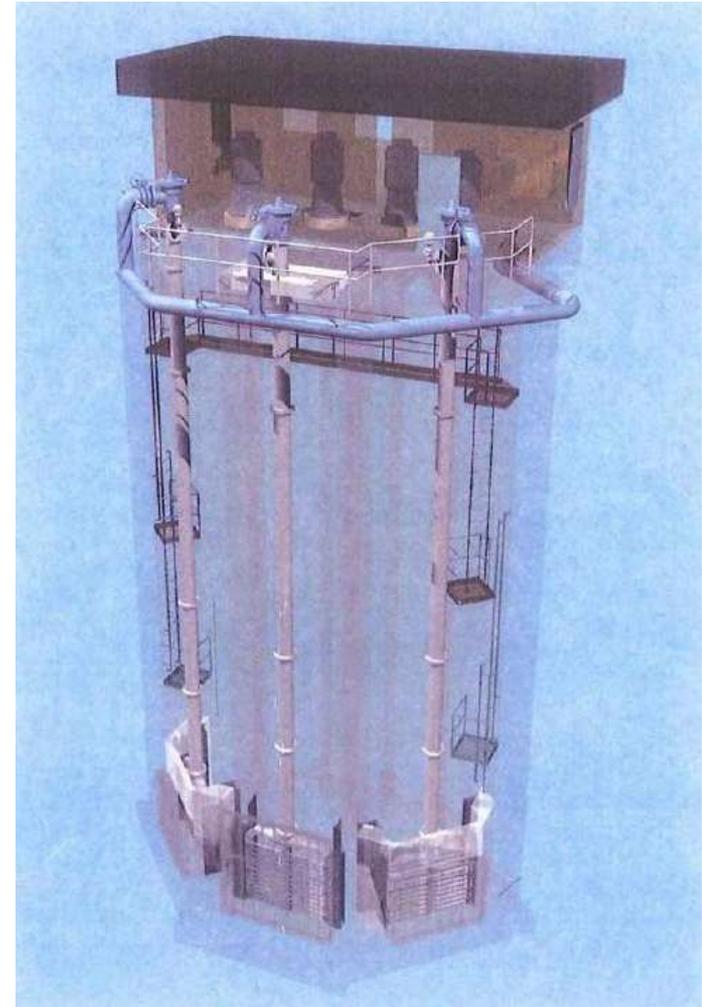
Existing Intake built in 1969.

- Vulnerability to withstand seismic events.
- Maximum pumping capacity of 16.5 MGD
- Firm capacity of 11.7 MGD.
- Insufficient pump intake and impeller submergence during low river/peak demand season.
- Poor sweeping velocity to carry algae mats and debris downstream.

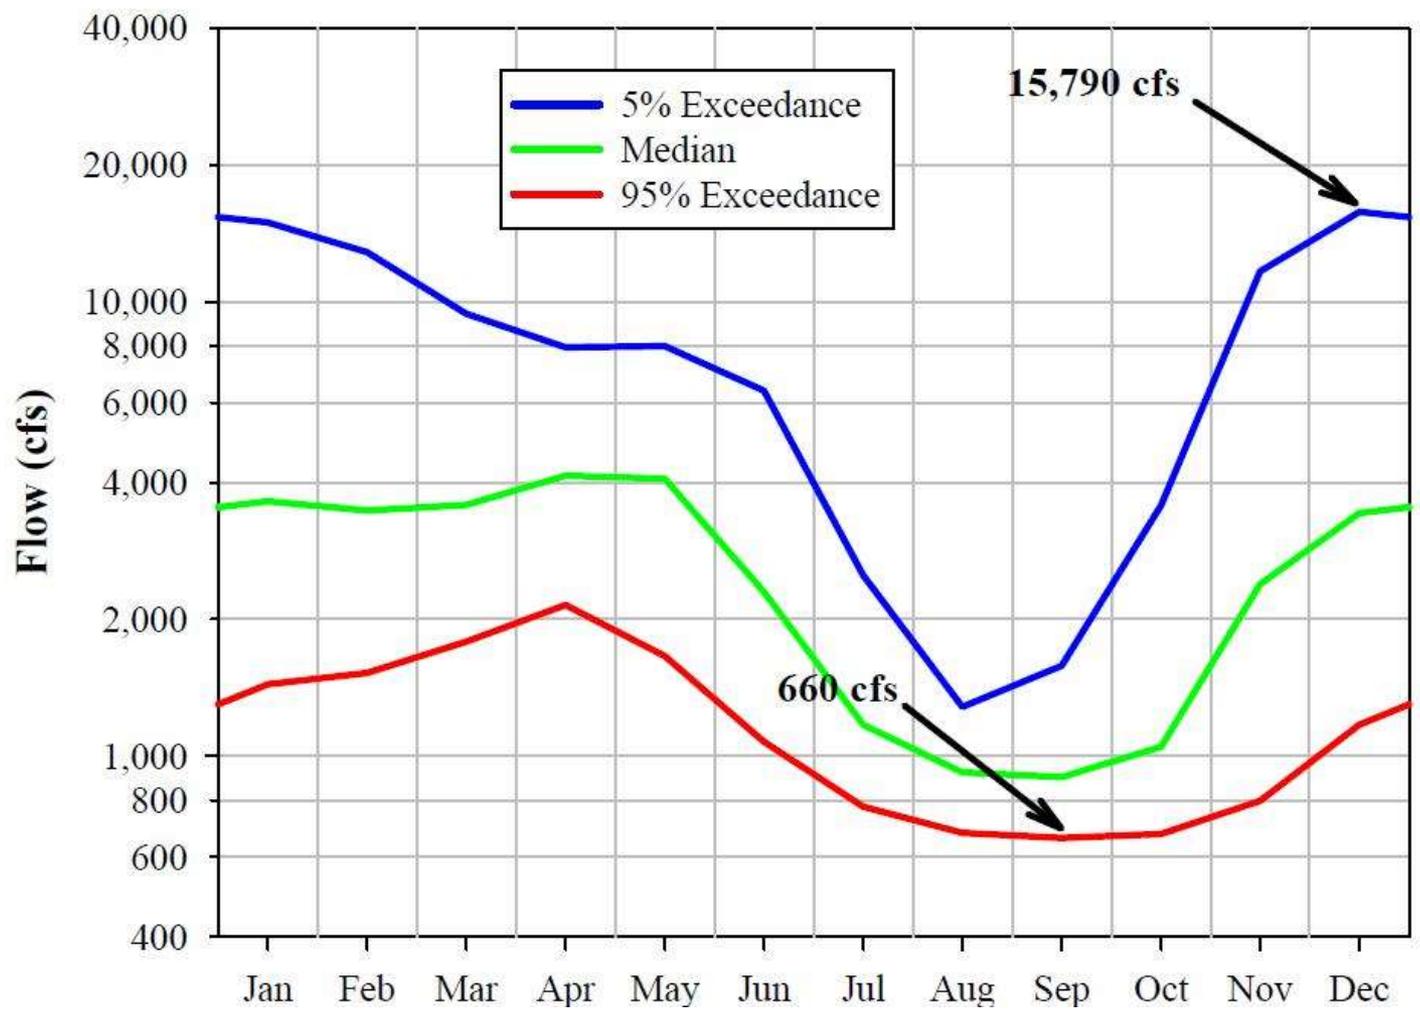
Monthly 5%, 50% (Median), and 95% exceedance flows for the Clackamas River near Oregon City

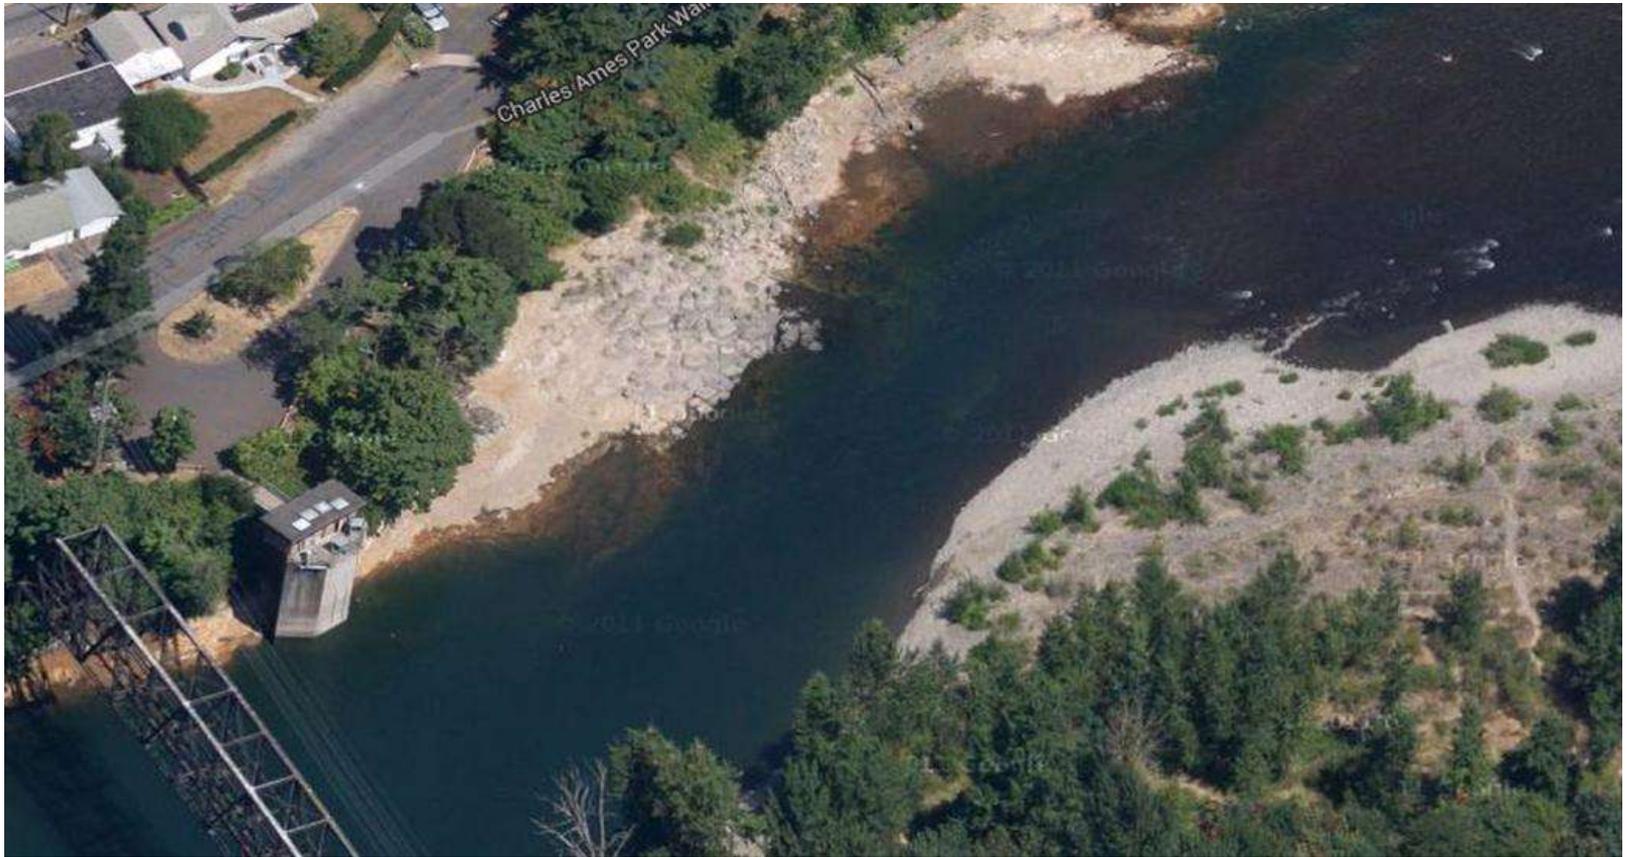
- Intake located at upper end of pool with riffles leading into and out of the pool.
- Bank at intake is soft rock that tends to be scoured clean
- Rocky outcrop of hard rock and boulders 100 ft upstream

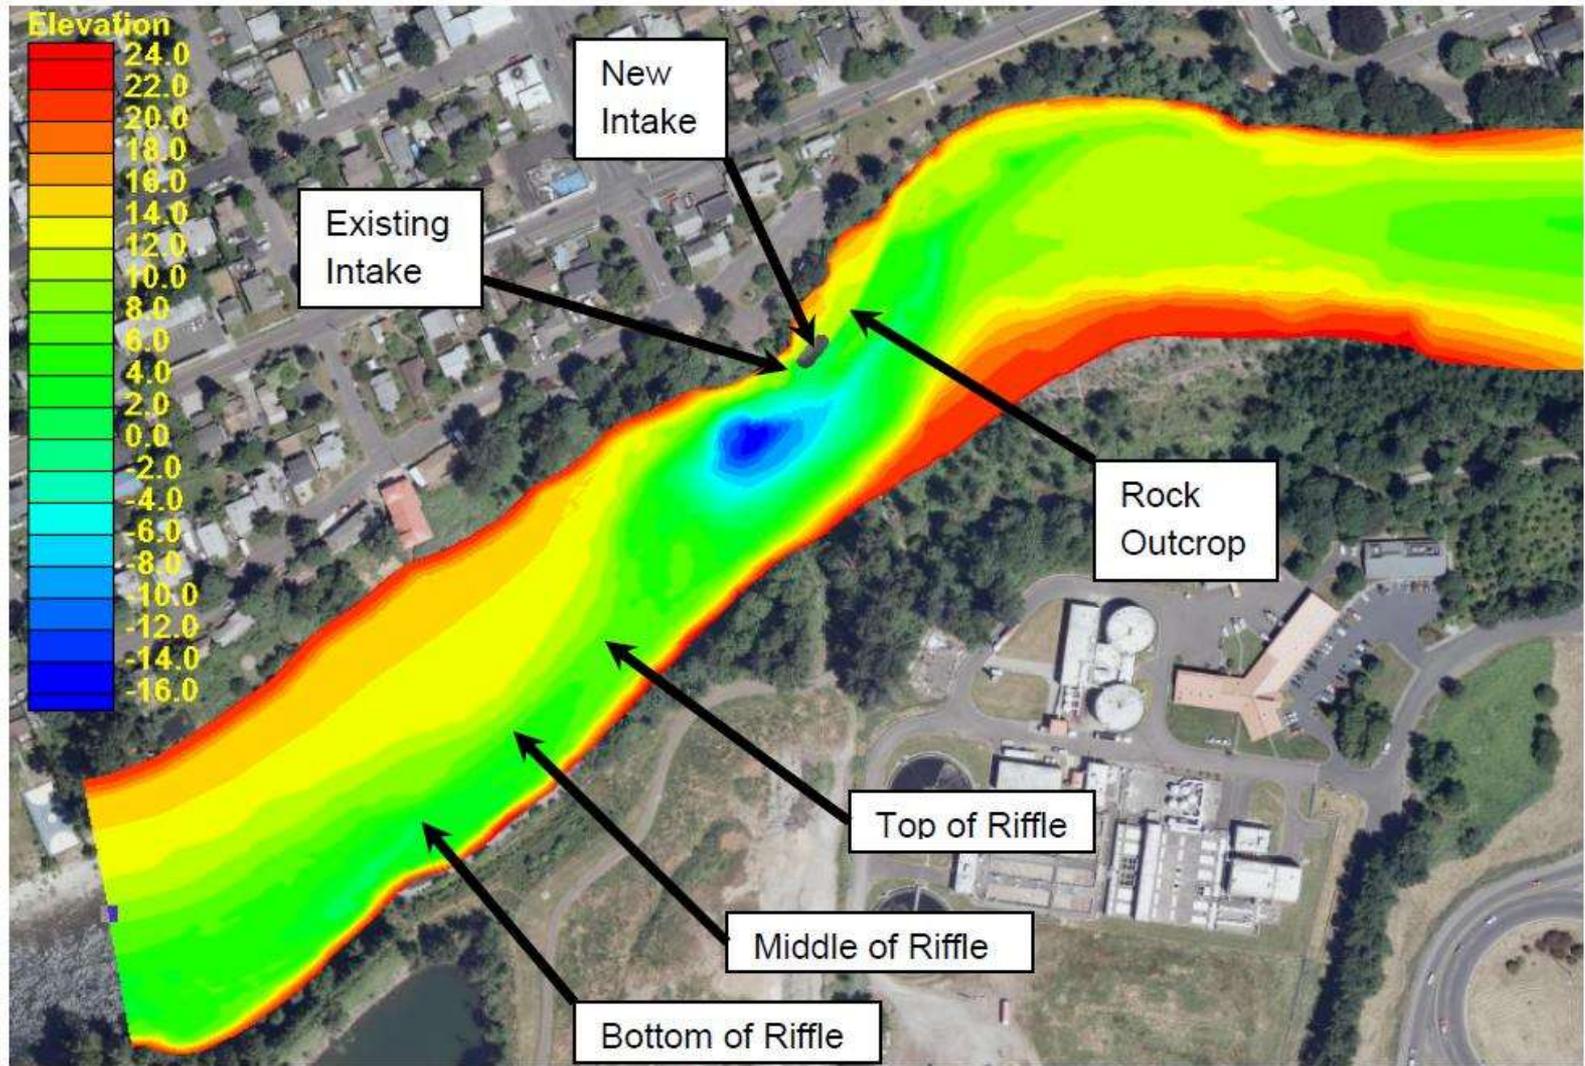
Extent and bathymetry of model developed to estimate 2D flow conditions

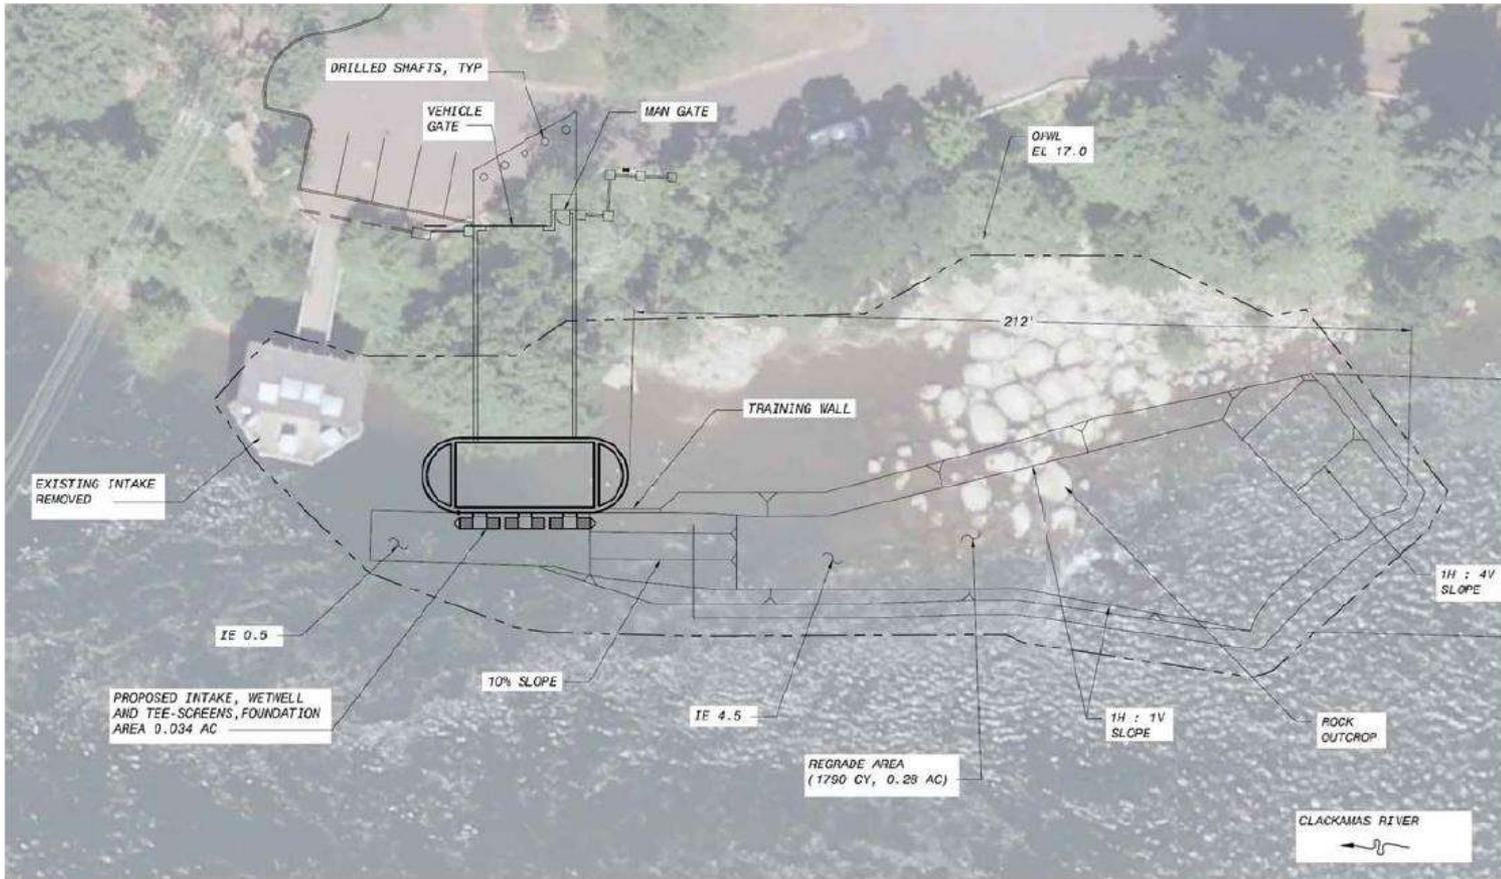
- Currently an eddy occurs during various low flow conditions resulting in poor sweeping velocity across the intake fish screens.
- Channel excavated upstream of the intake to funnel flow toward screens.
- Channel required excavation of 1,600 cubic yards of rock.

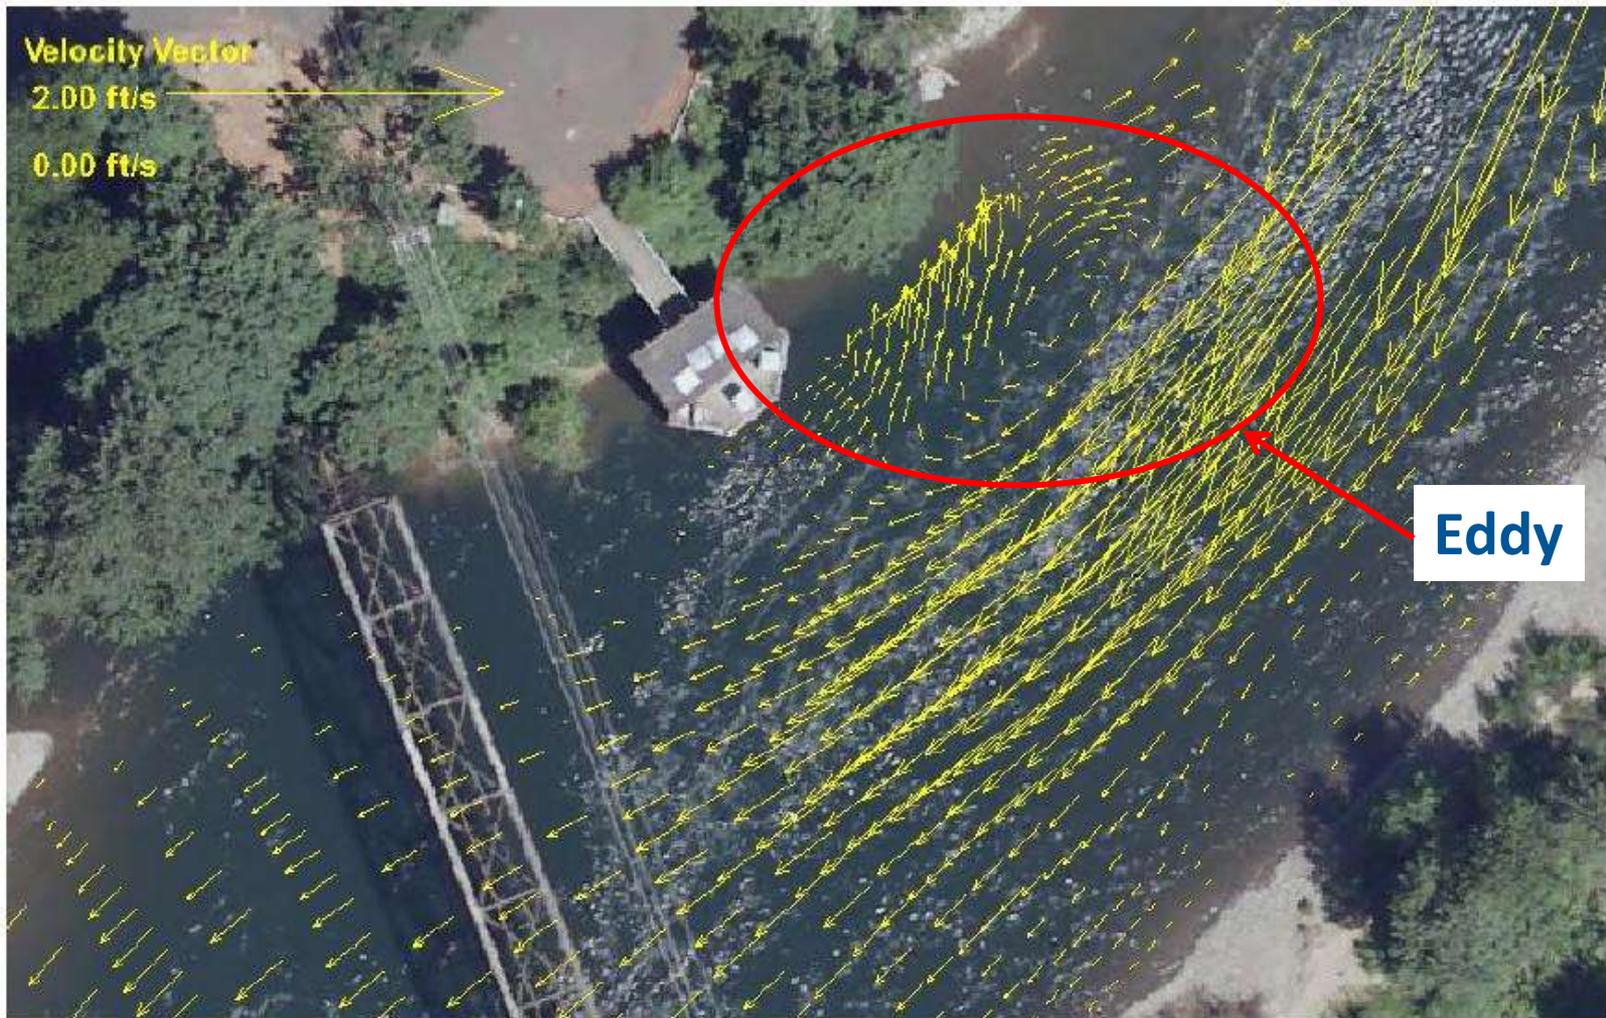
Run 1: Existing bathymetry, low flow, maximum withdrawal (Sweeping Velocity = -0.2 ft/sec)

Model Run	Bathymetry	Flow (cfs)	% Excd	Intake Conditions			Withdraw Rate (cfs)	
				WSE (ft)	Depth (ft)	Sweeping Vel (ft/s)		
1	Existing	660	95%	9.5	Low	6.8	-0.20	59
2	Existing	660	95%	11.3	High	8.6	0.04	59
3	Proposed	660	95%	8.1	Low	7.6	0.51	53
4	Proposed	660	95%	12.0	High	11.5	0.49	53
5	Existing	1,050	25% ⁽¹⁾	10.0	Obs ⁽¹⁾	6.9	-0.20	10
6	Proposed	1,050	25% ⁽¹⁾	10.8	Typ ⁽²⁾	10.3	1.29	59
7	Existing	15,790	5%	21.7	Typ ⁽²⁾	16.7	6.01	59
8	Proposed	15,790	5%	21.7	Typ ⁽²⁾	21.2	7.15	59

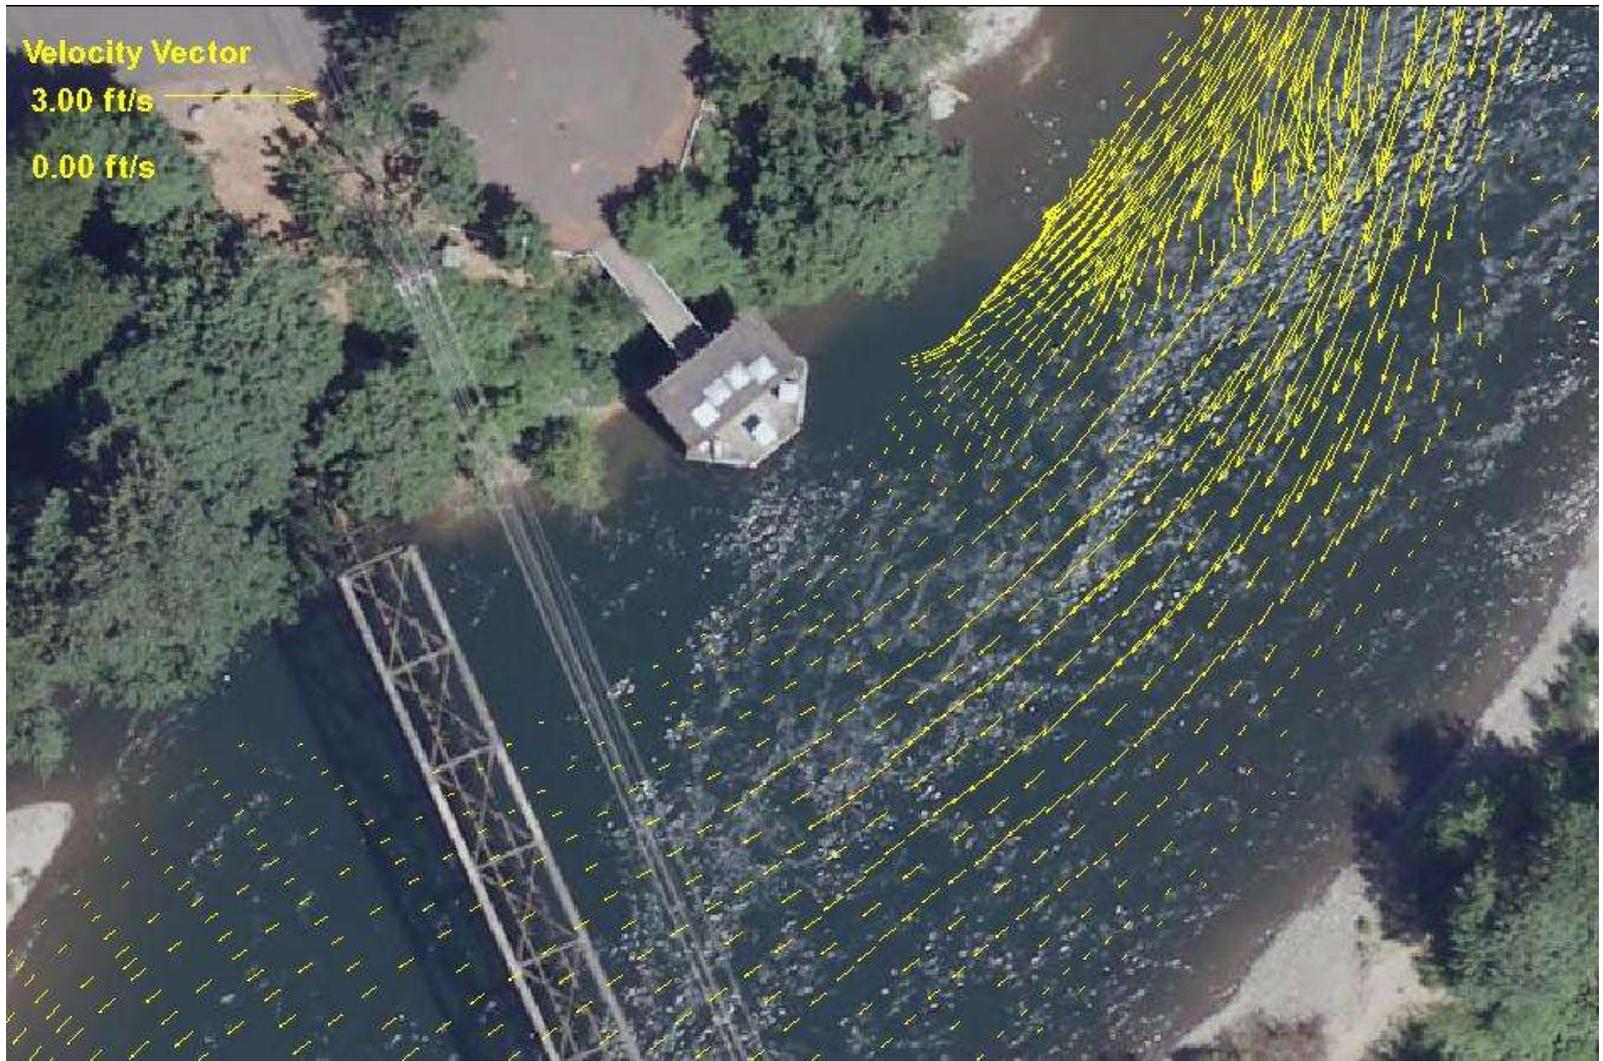
Run 3: New bathymetry, low flow, maximum withdrawal (Sweeping Velocity = 0.51 ft/sec)

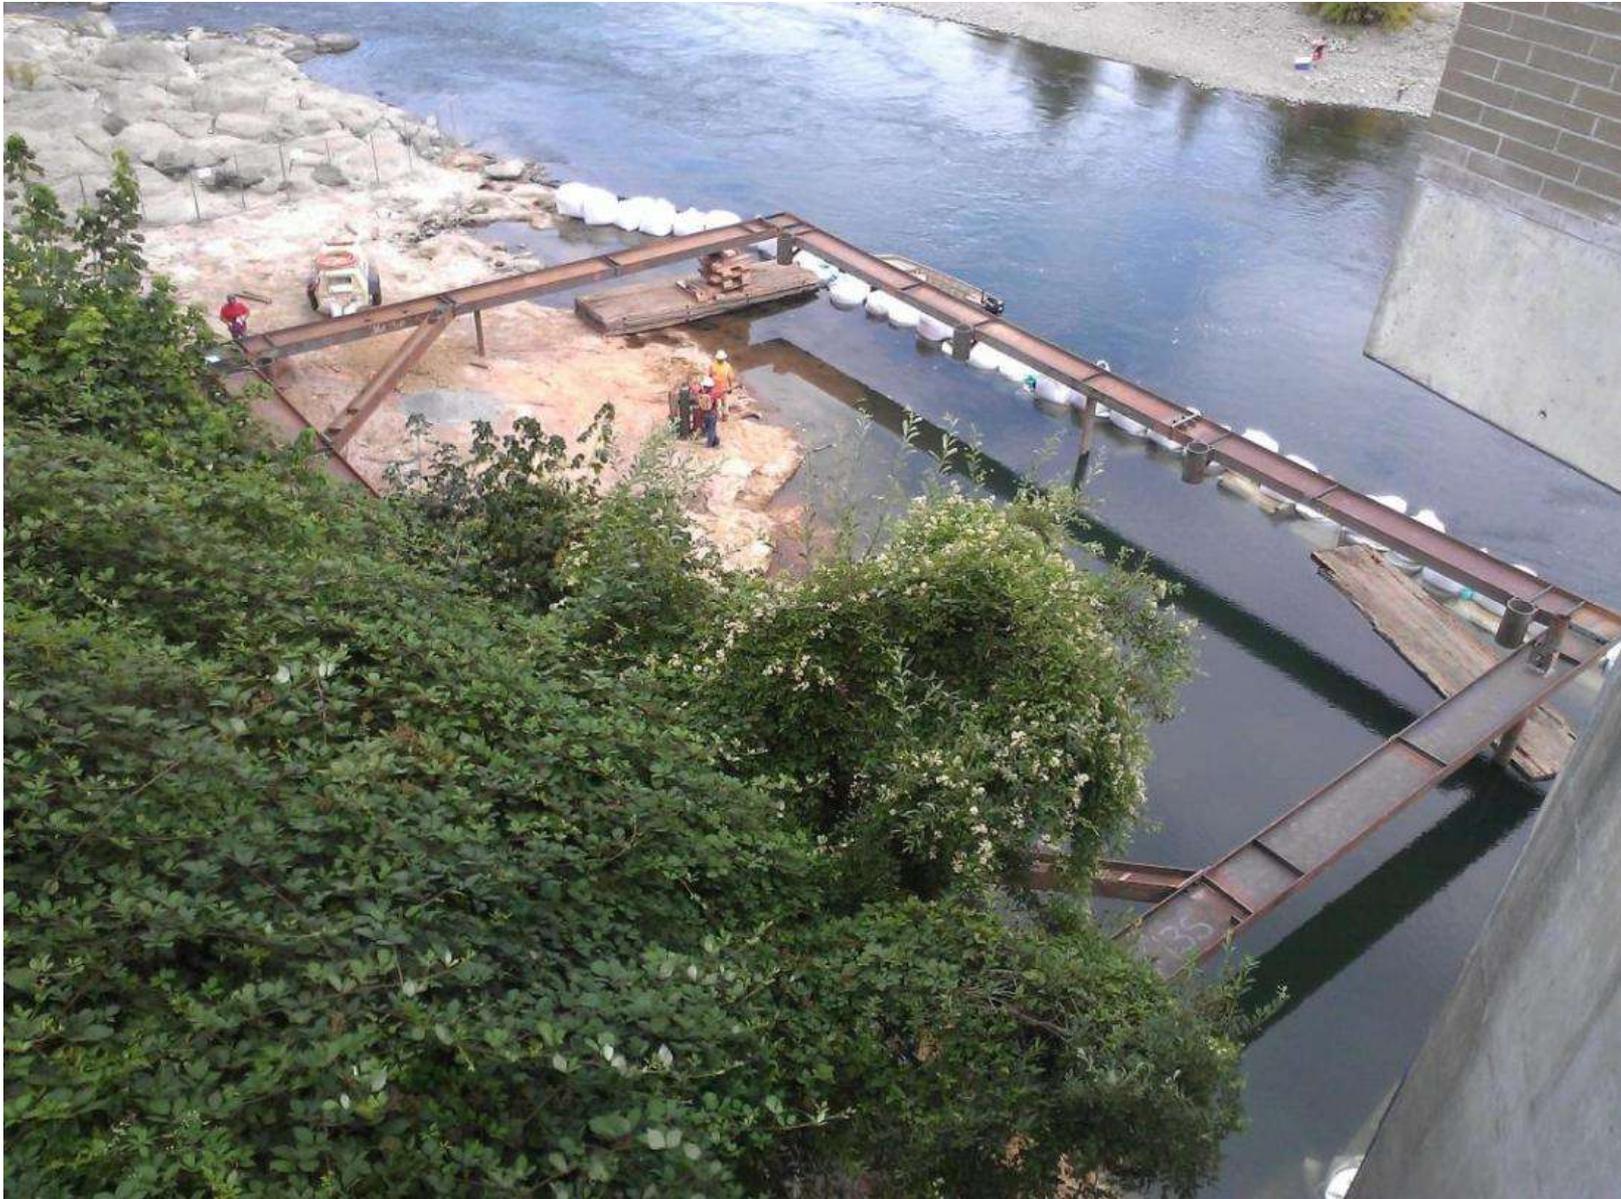
Lower water ring of cofferdam

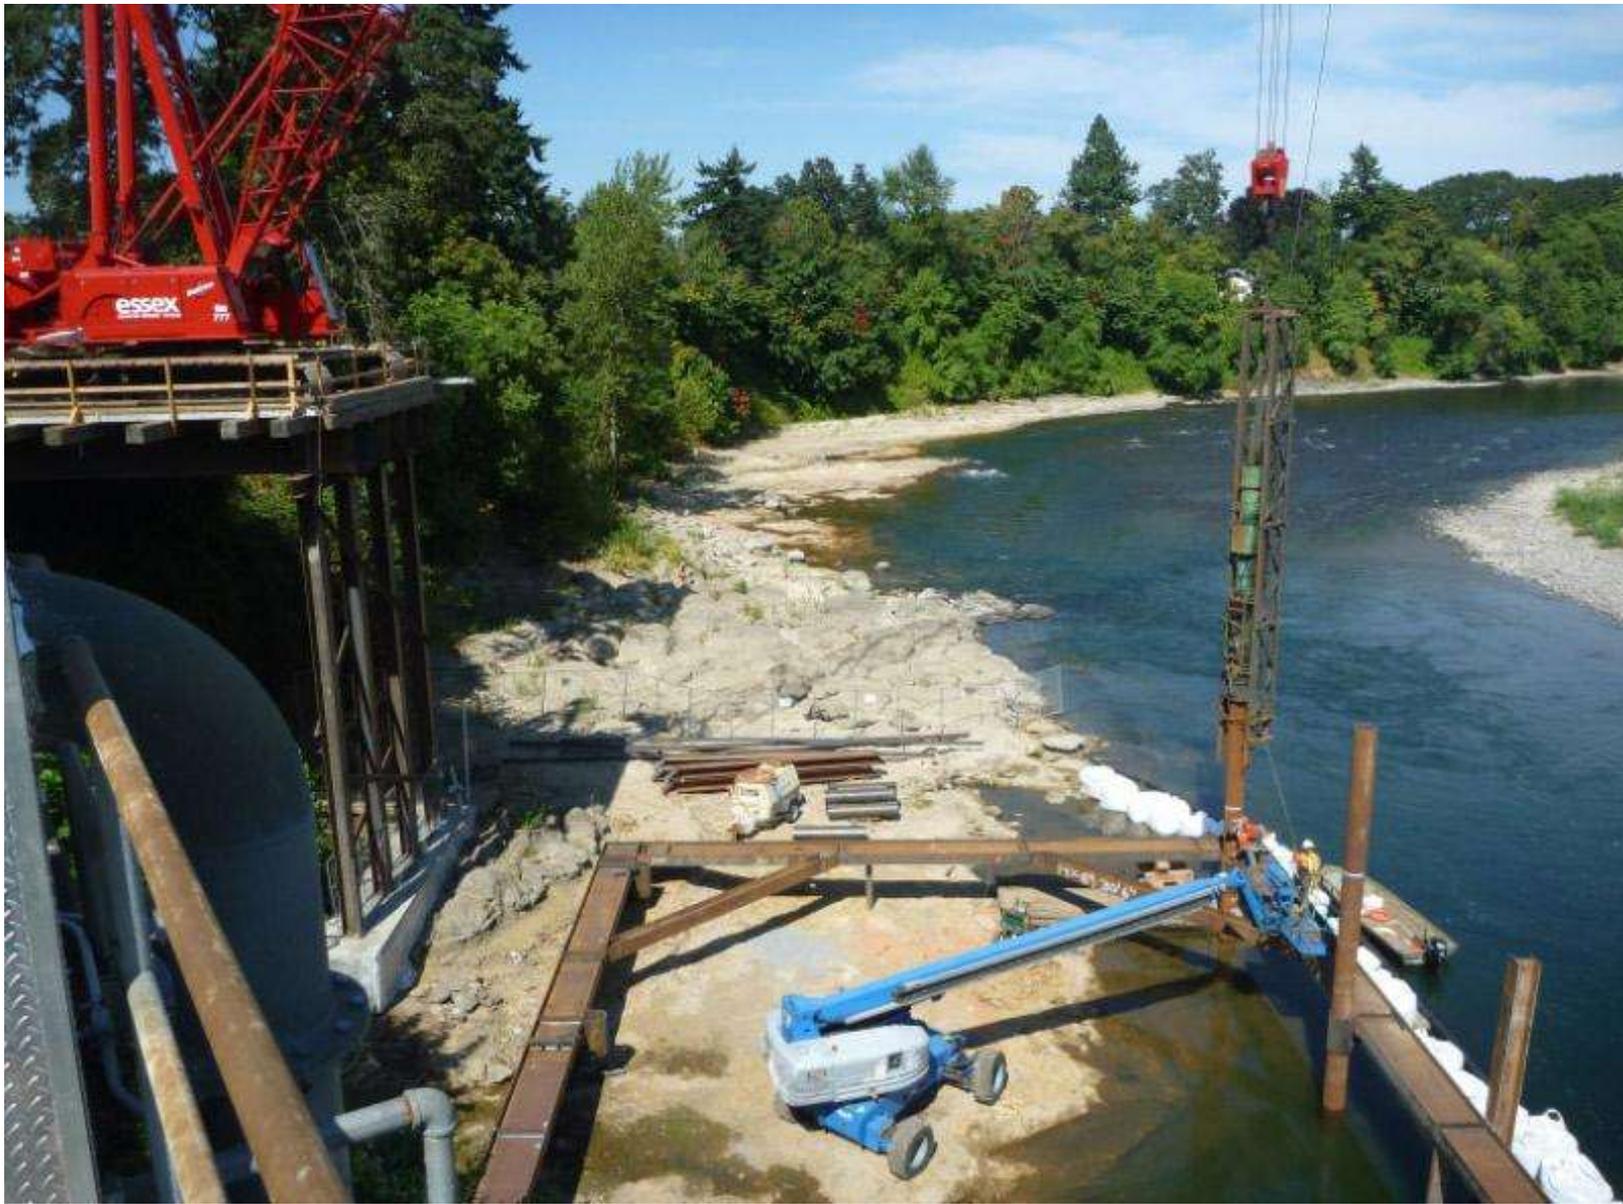
Spud pile installation

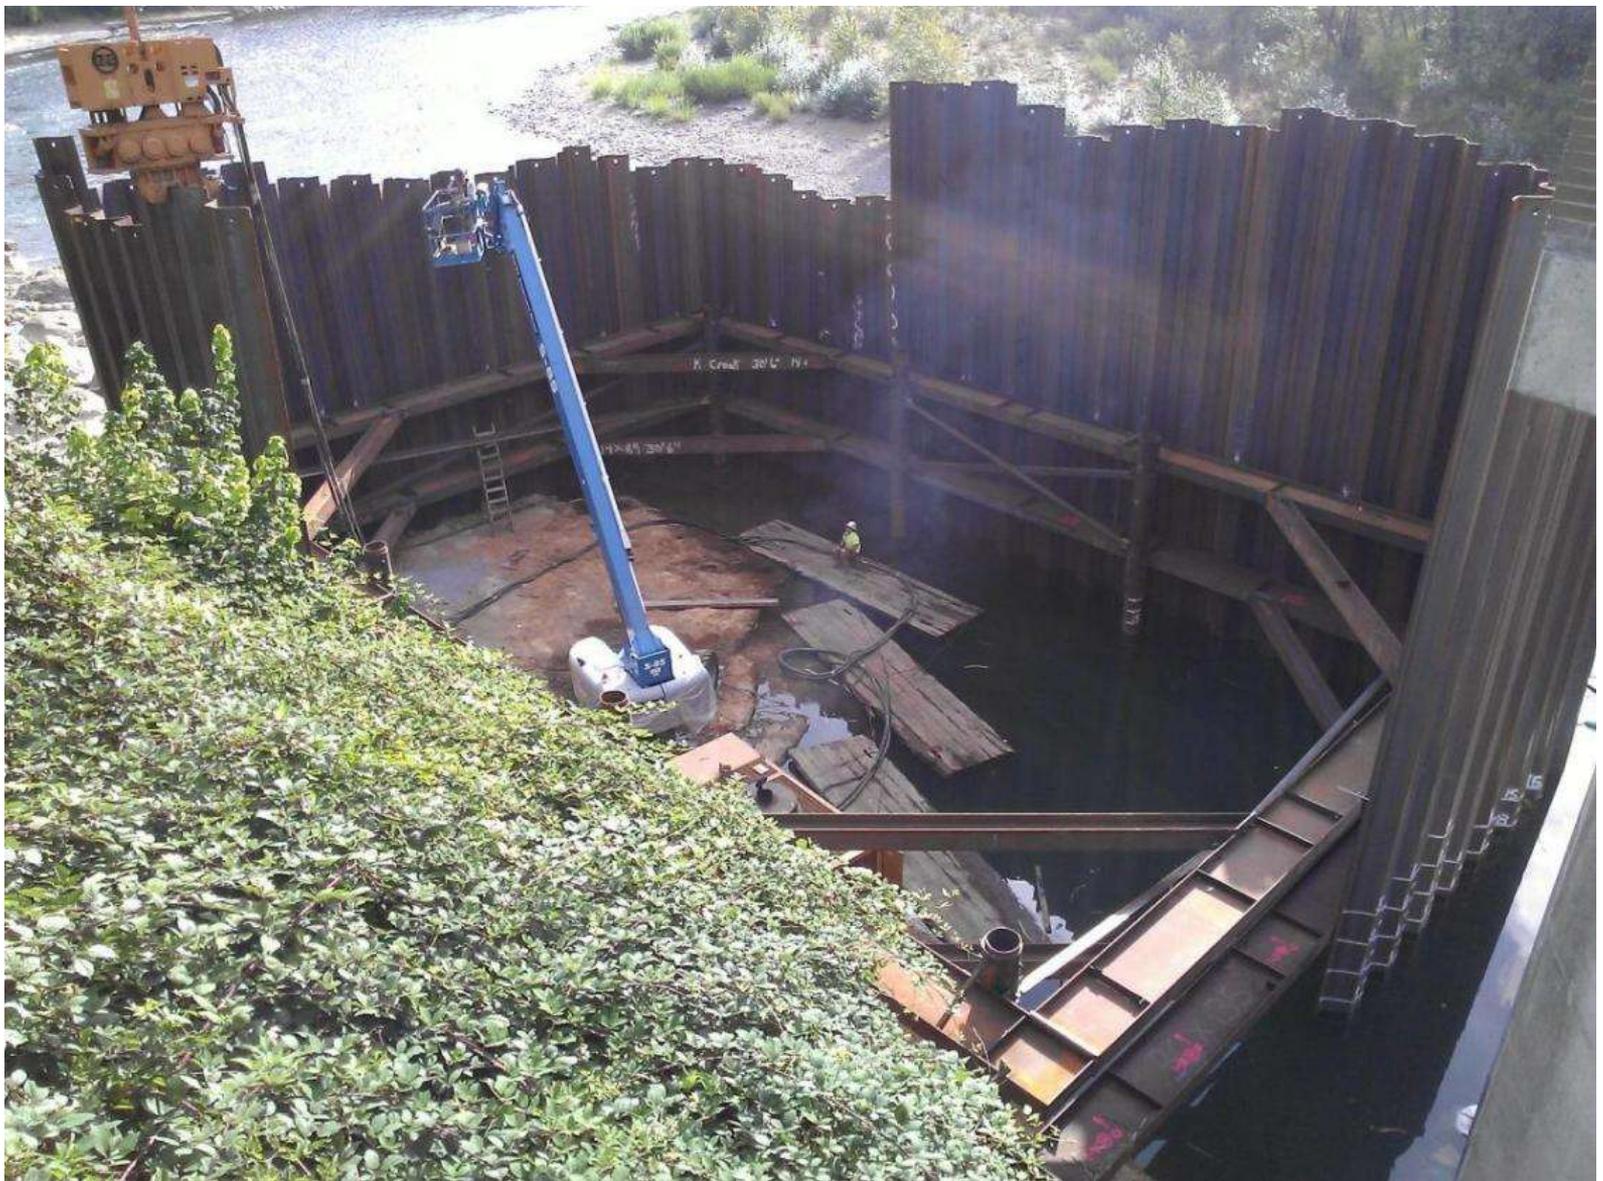
Driving sheet piles

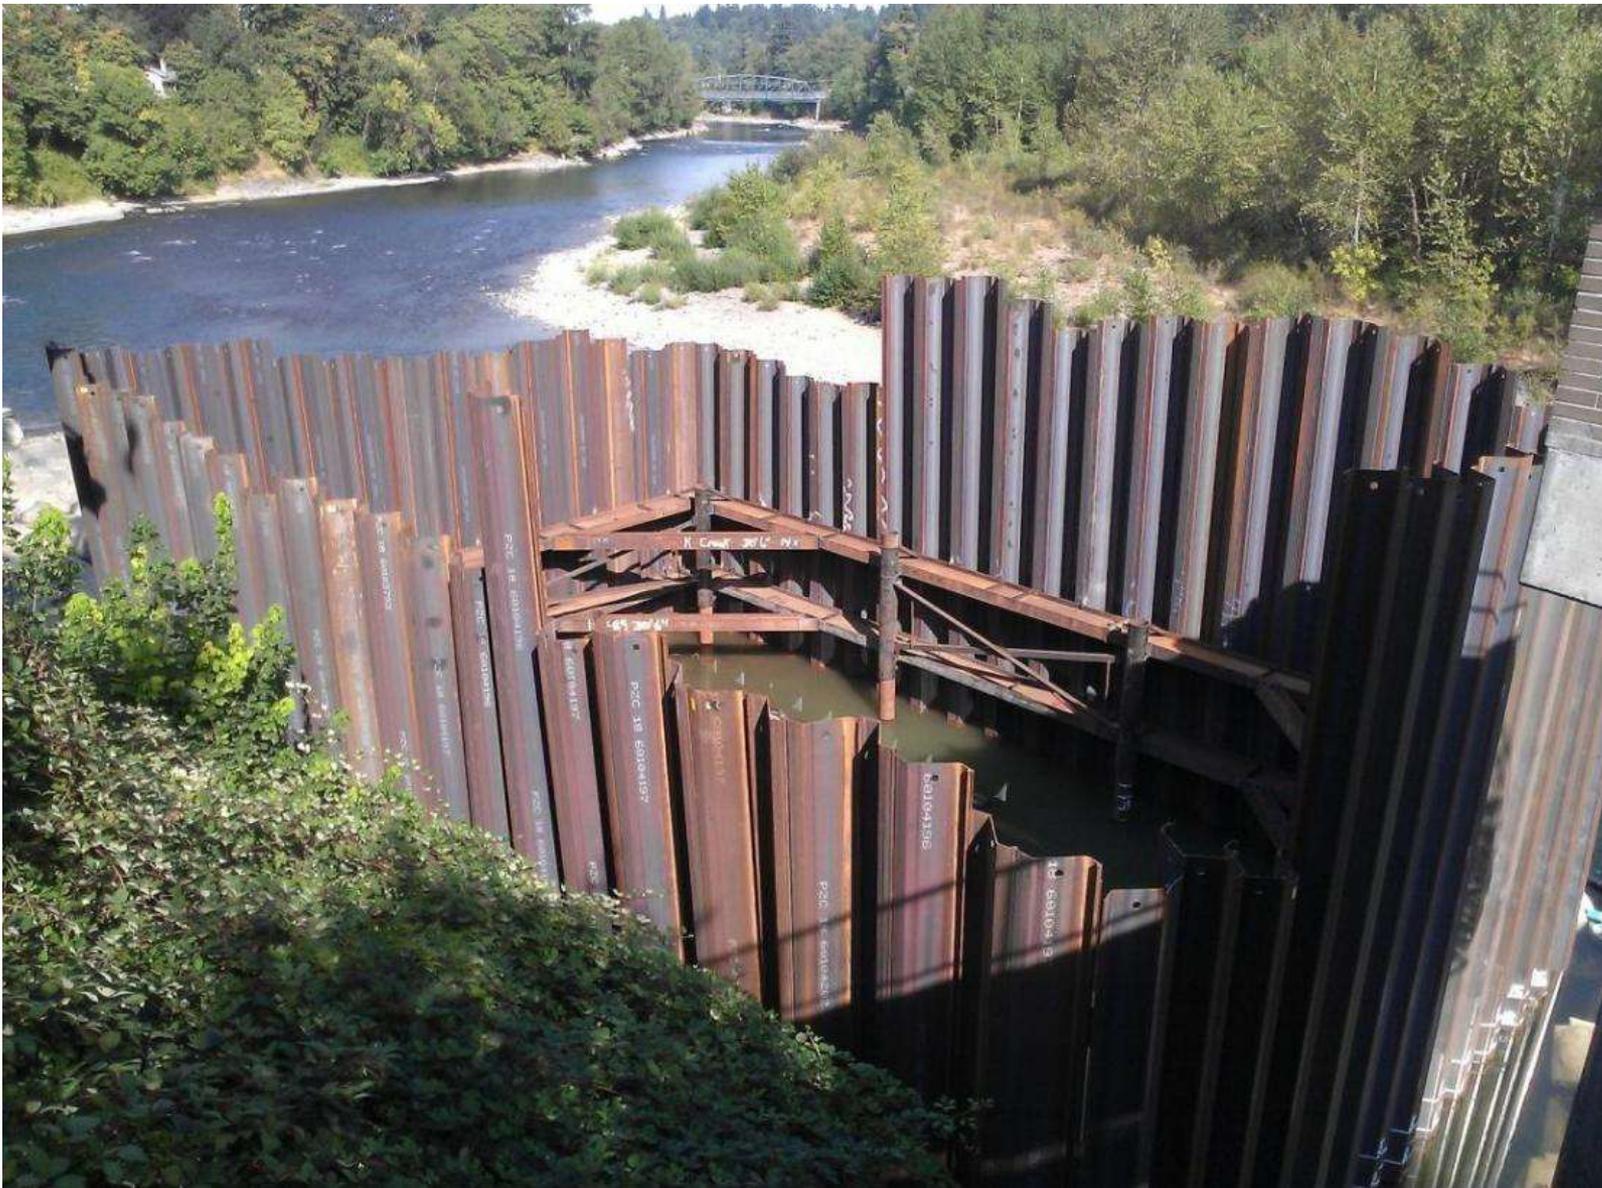
Completed cofferdam before dewatering

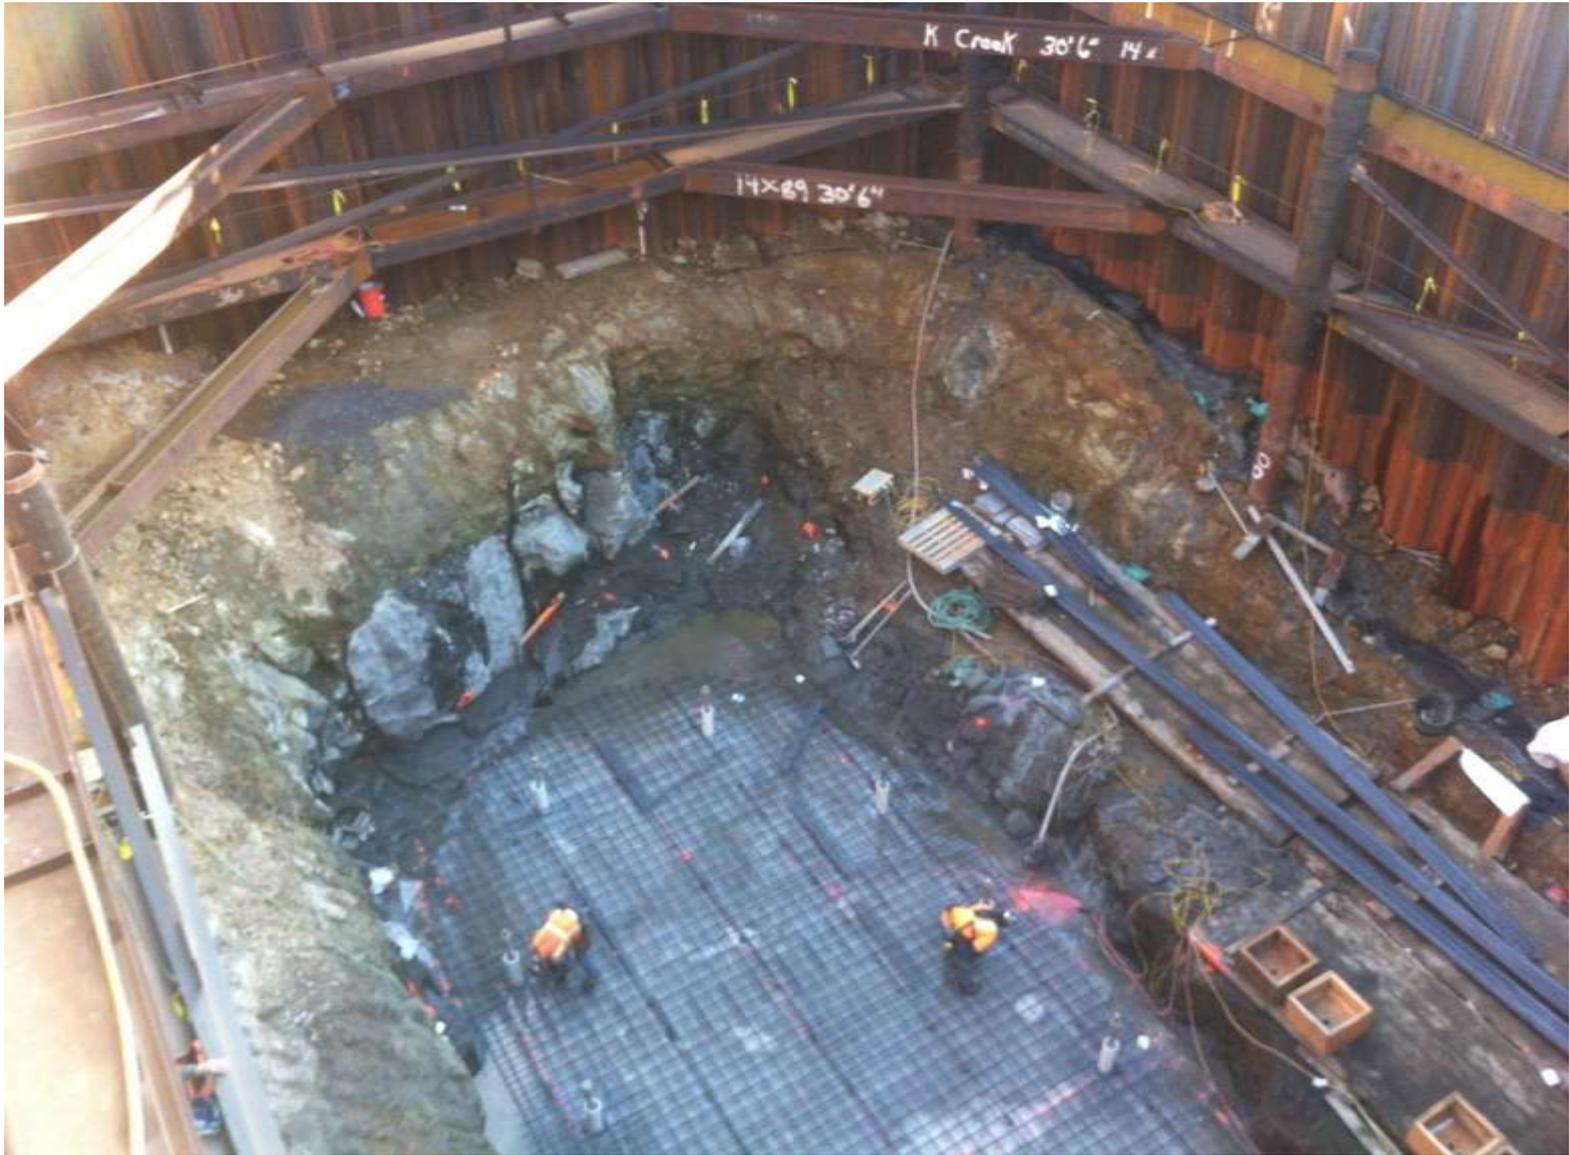
Preparing foundation rebar
