# **Bellevue Utilities Asset Management Approach**

**Pacific Northwest Section  
American Water Works Association**

**April 29, 2015**

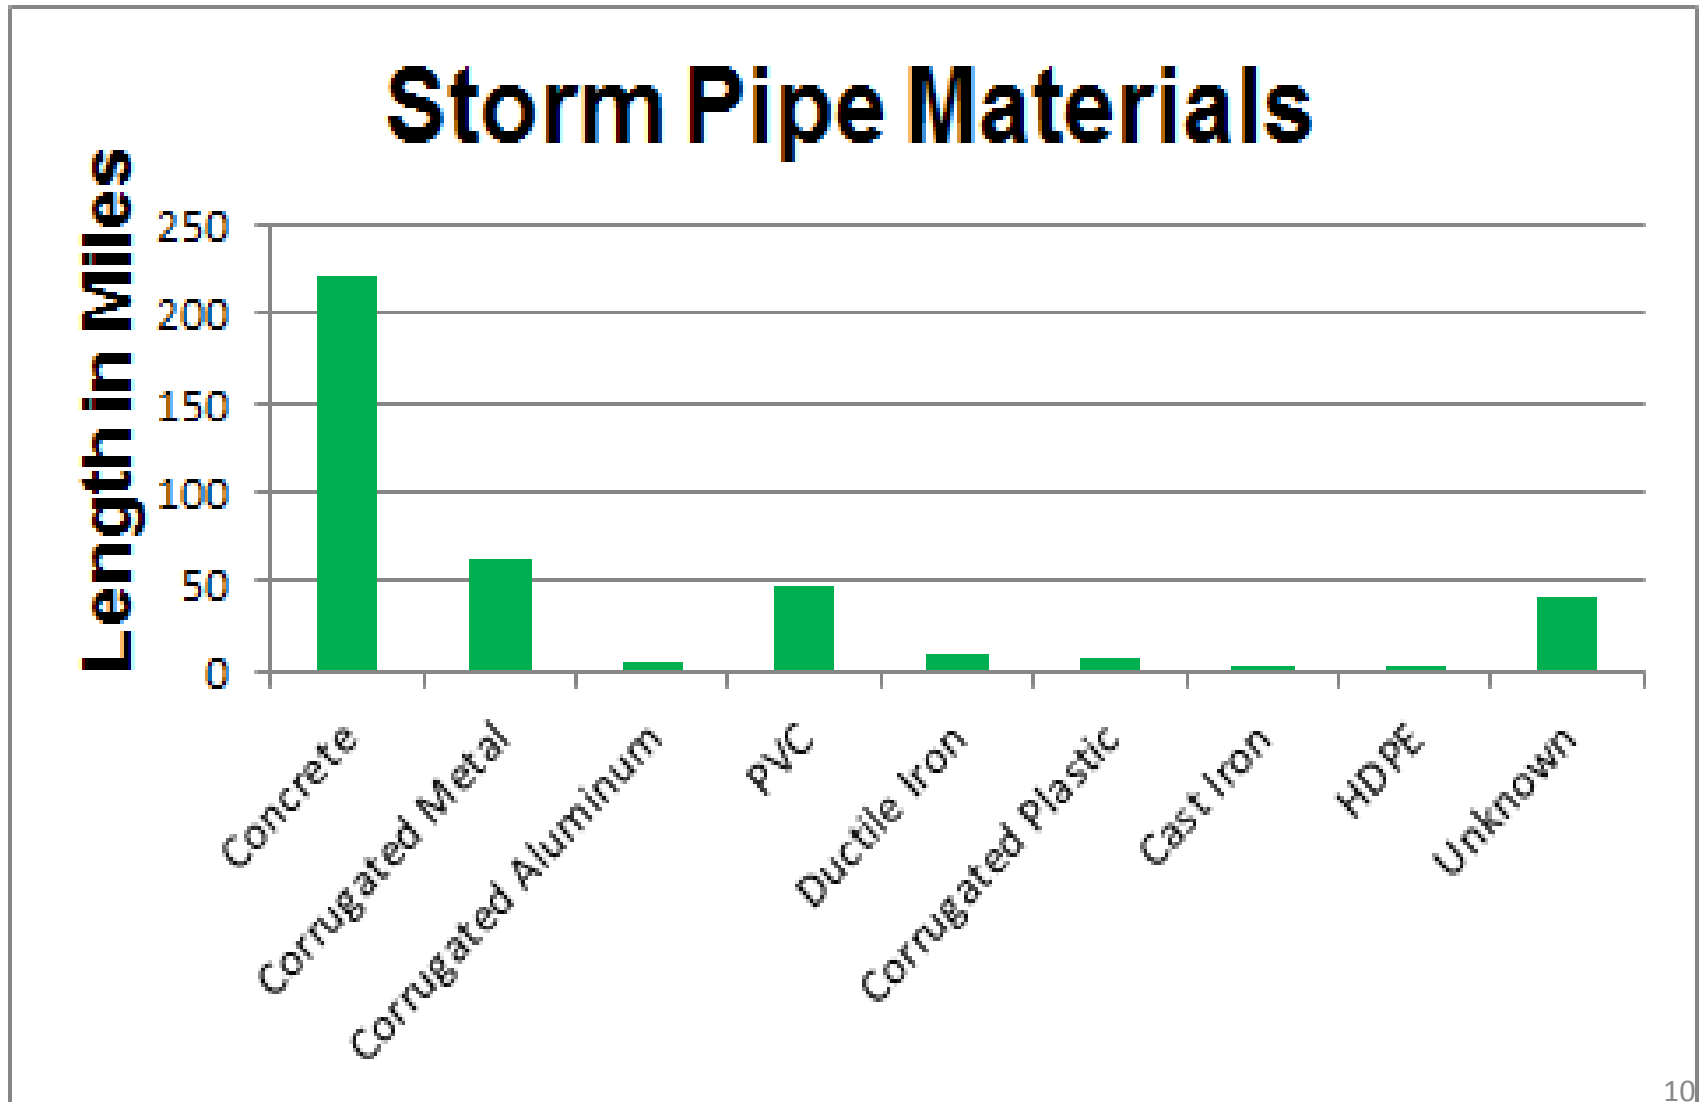
# Stormwater Pipe Data Collection

- Stormwater conveyance
  - 400 miles of stormwater Pipe (CCTV and defect repair)
  - 86 (?) miles of ditches
  - A couple hundred steam culverts
- 19188 catch basins and 2283 manholes
- 118 oil/water separators
- 11 regional detention ponds

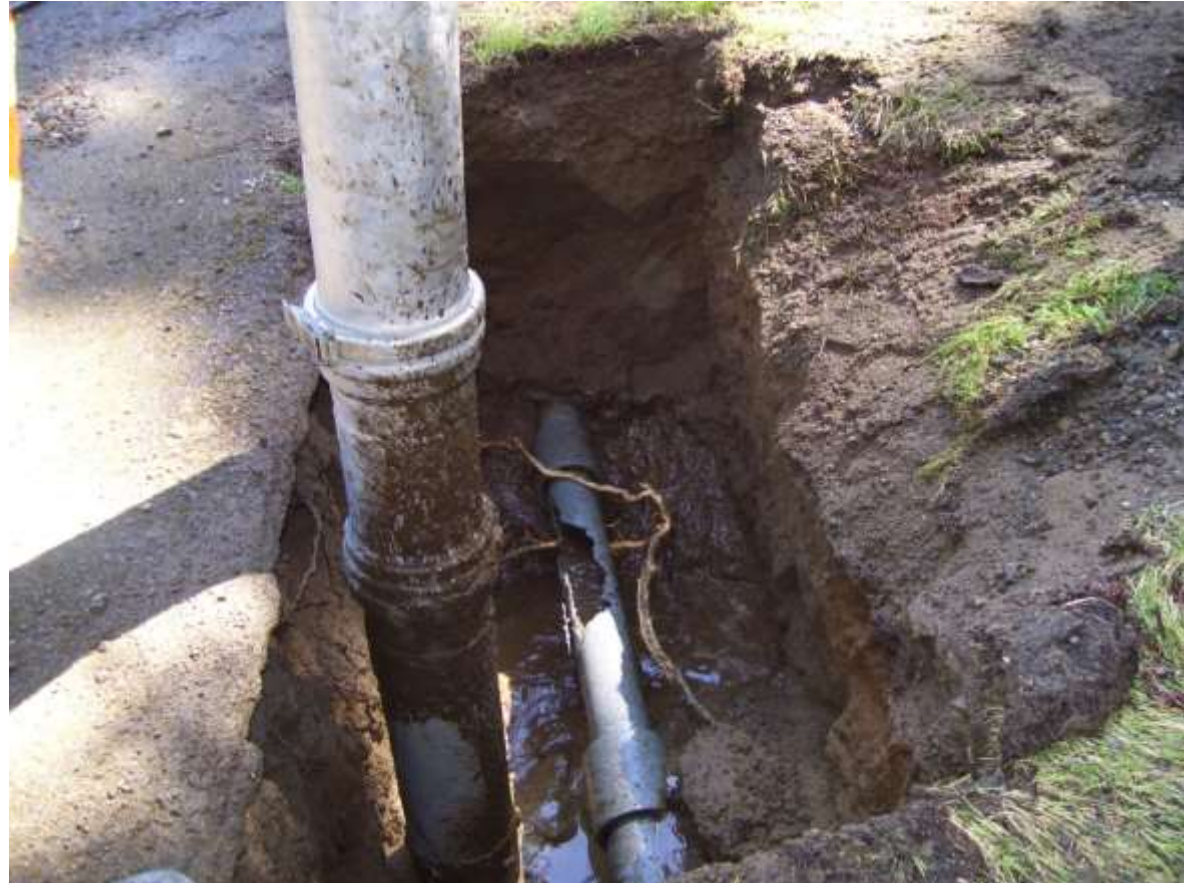
# Water Utility Condition Assessment

- Field observation (e.g., main observation reports)
- Failure tracking
- Laboratory testing

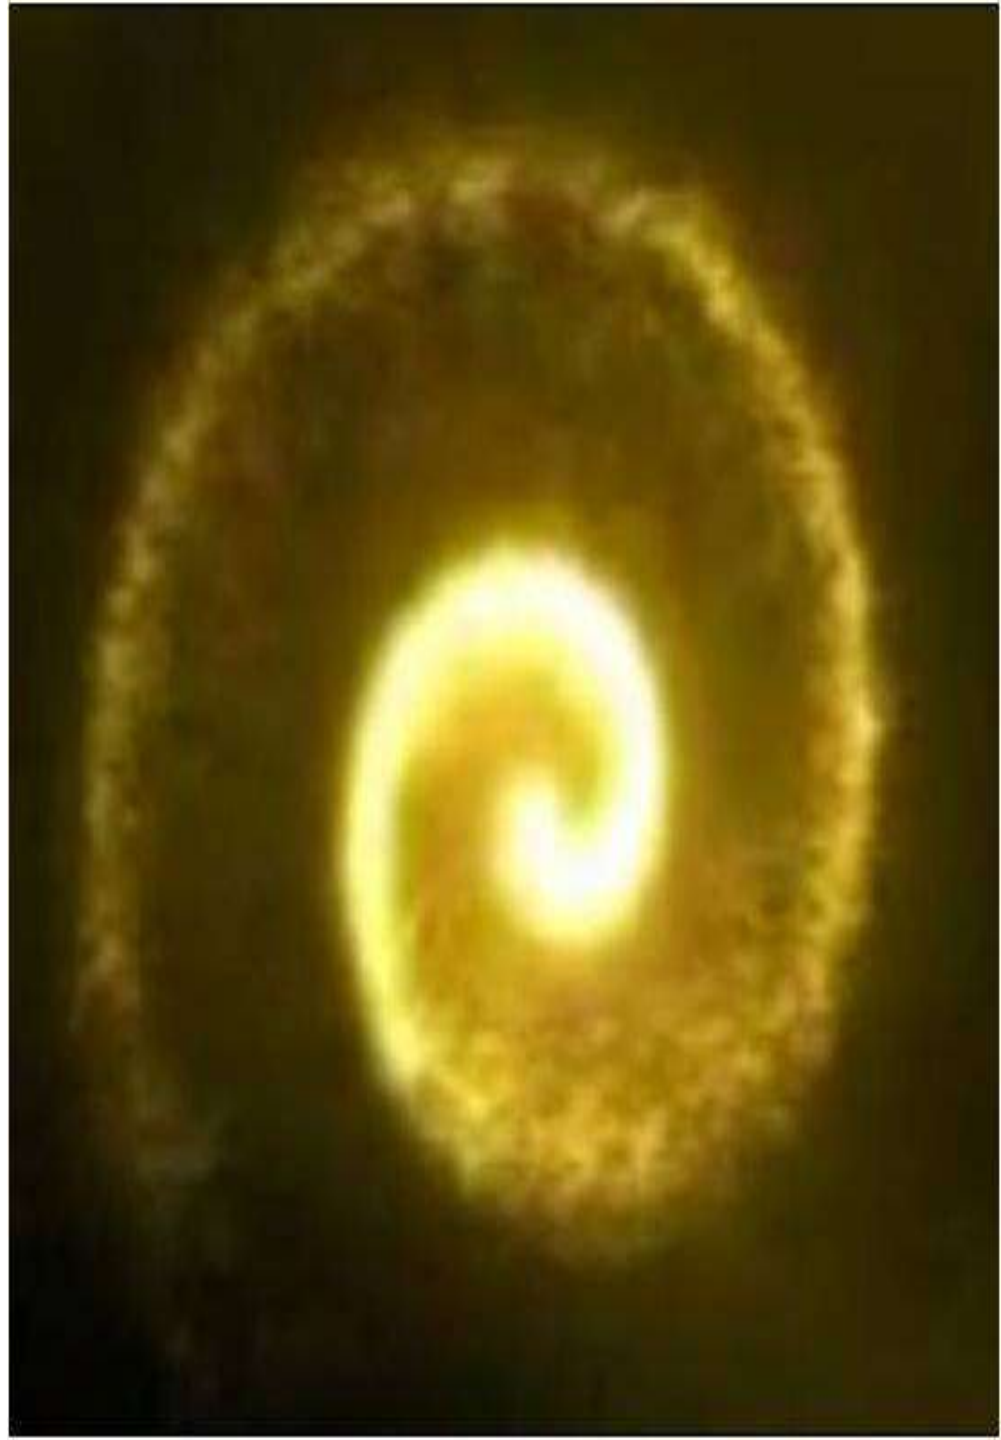
## Significant Sewer Defects Identified

# Sewer Death Spiral

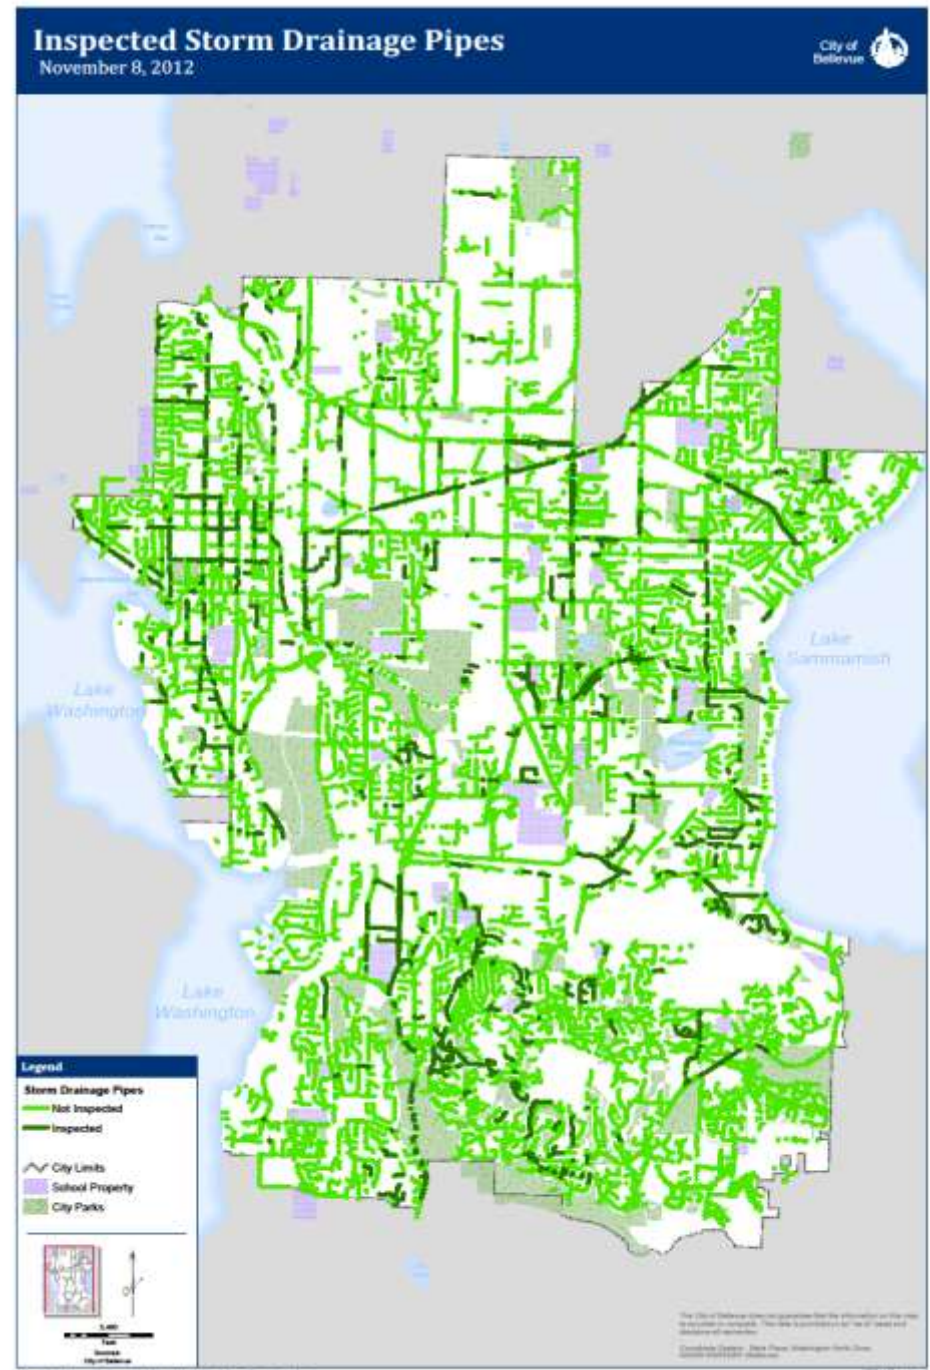
# Program Update: Stormwater System

- CCTV Pipeline Condition Assessment
- Culvert Inventory and Condition Assessment
- Storm Pipe Data Collection

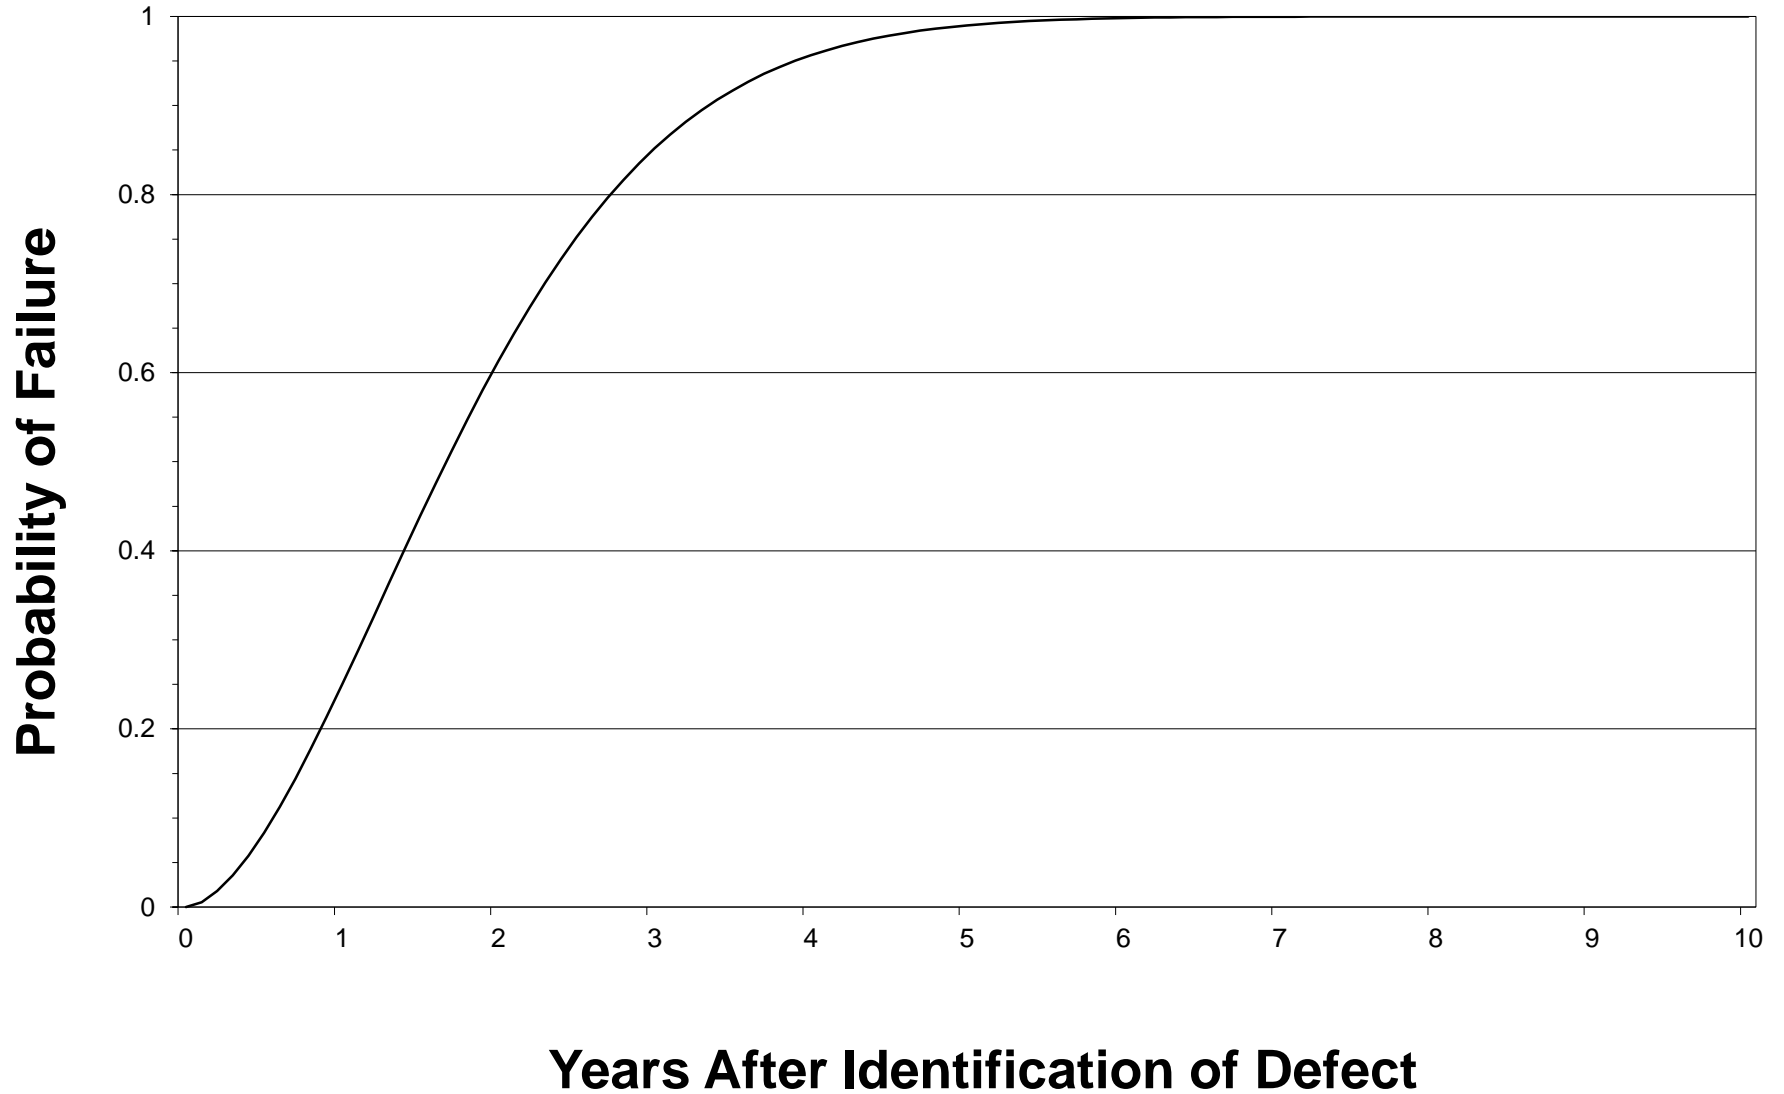
# High Severity Defect Probability of Failure

## Failure Probability for Unrepaired Defects

Given that a defect has not “failed” by the end of year  $t$ , the probability of failure in the next year,  $f_T(t)$ , is

Where  $F_T(t)$  and  $F_T(t+1)$  are the Weibull cumulative probabilities of failure at time  $t$  and time  $t+1$

$F_T(t)$  = the probability that the defect results in failure by time  $t$

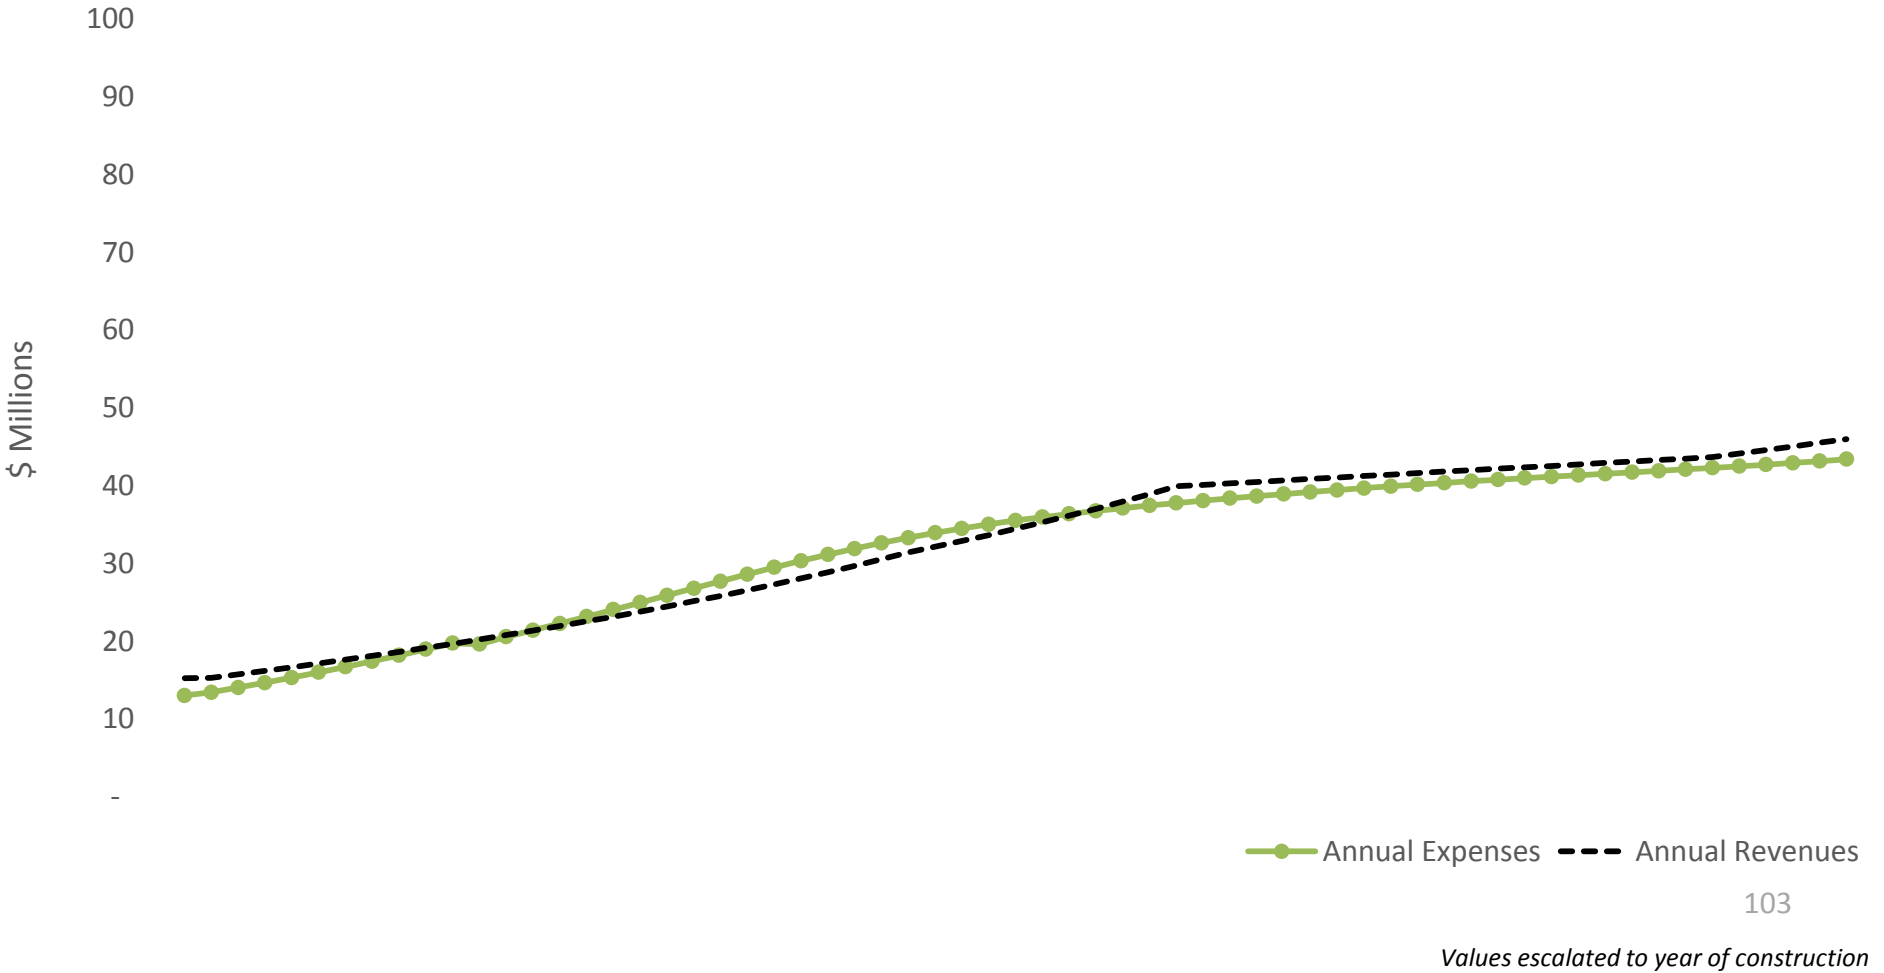
# Stormwater Utility – Funding vs Need

Values escalated to year of construction
