SEISMIC RETROFIT OF STEEL RESERVOIRS

Jon Conner, PE, SE, RH2 Engineering

SEISMIC RETROFITS

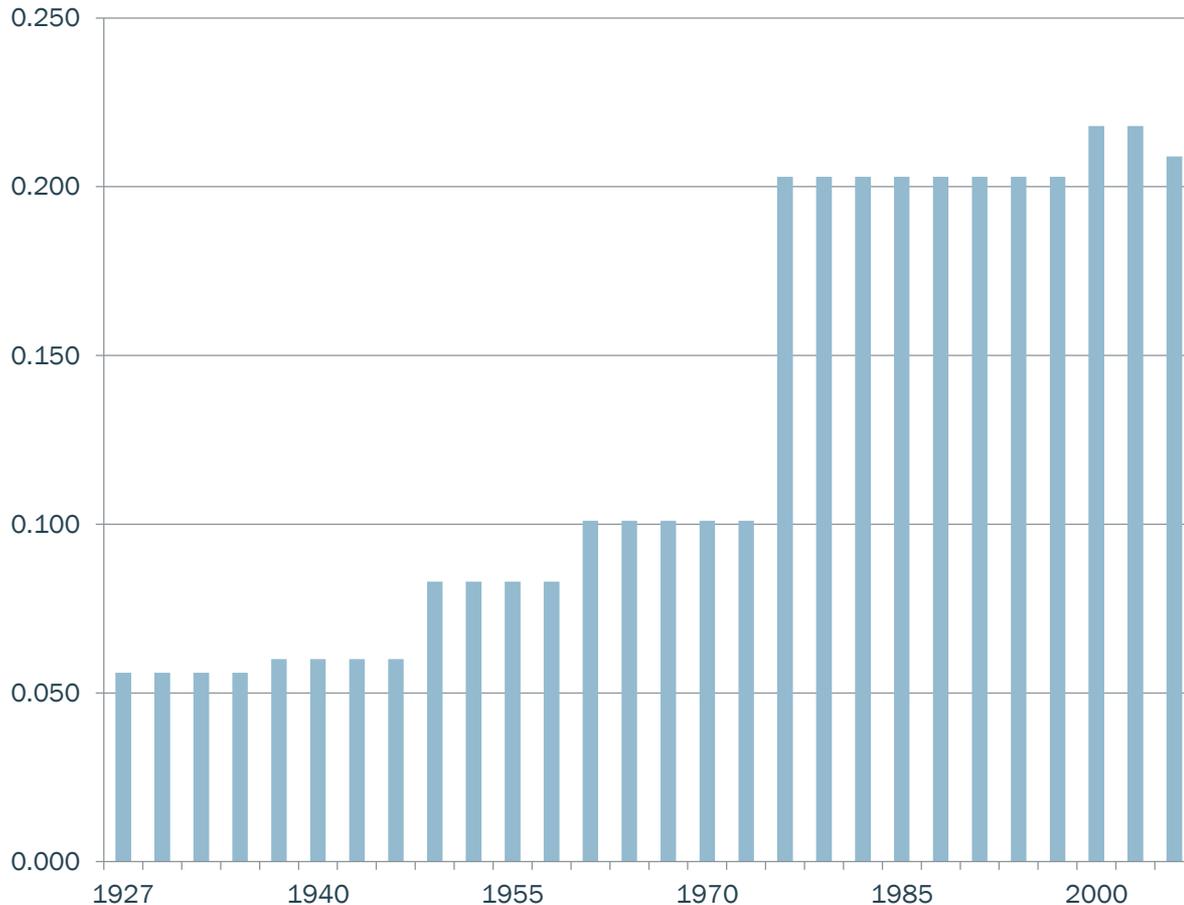
BASE SHEAR (% G) FOR WESTERN WA

1974: UBC adopted

1976: Importance Factor &
Drift Limits added

2000: IBC adopted, now
per USGS EQ info

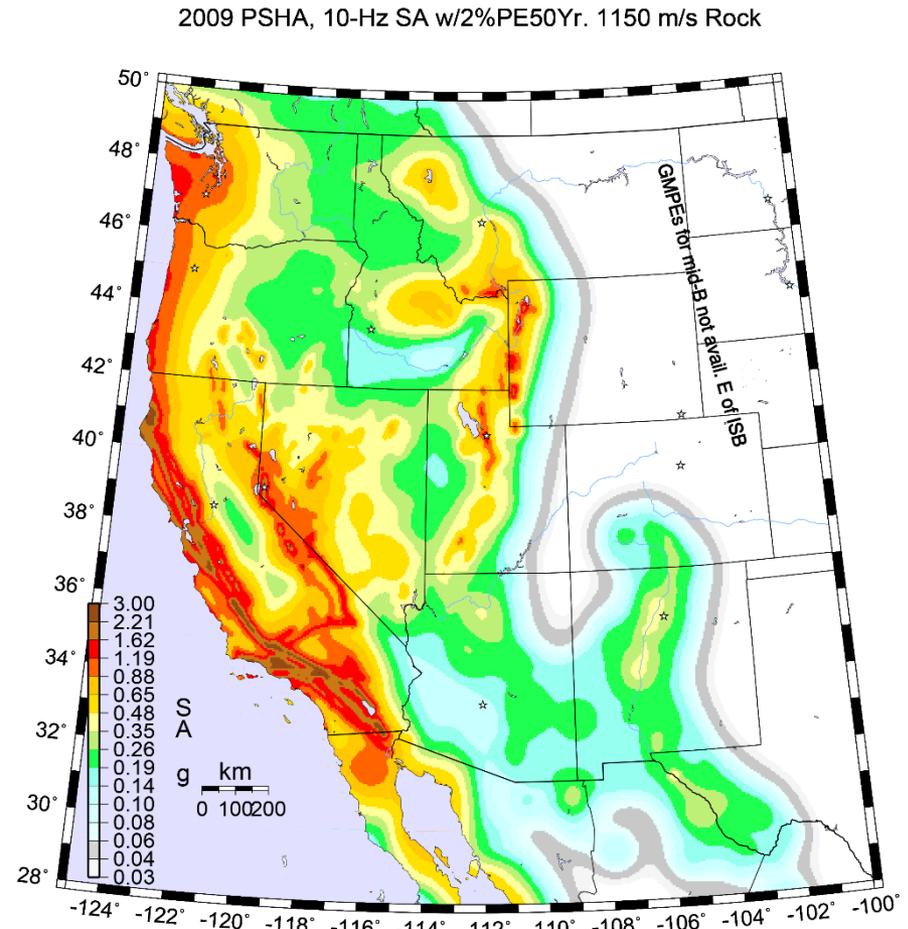
GMT 2010 Sep 23 10:11:00 USGS PSHA WUS crustal and subduction sources. Site Vs30 1150 m/s. 10 Hz SA with 2% in 50 yr PE.

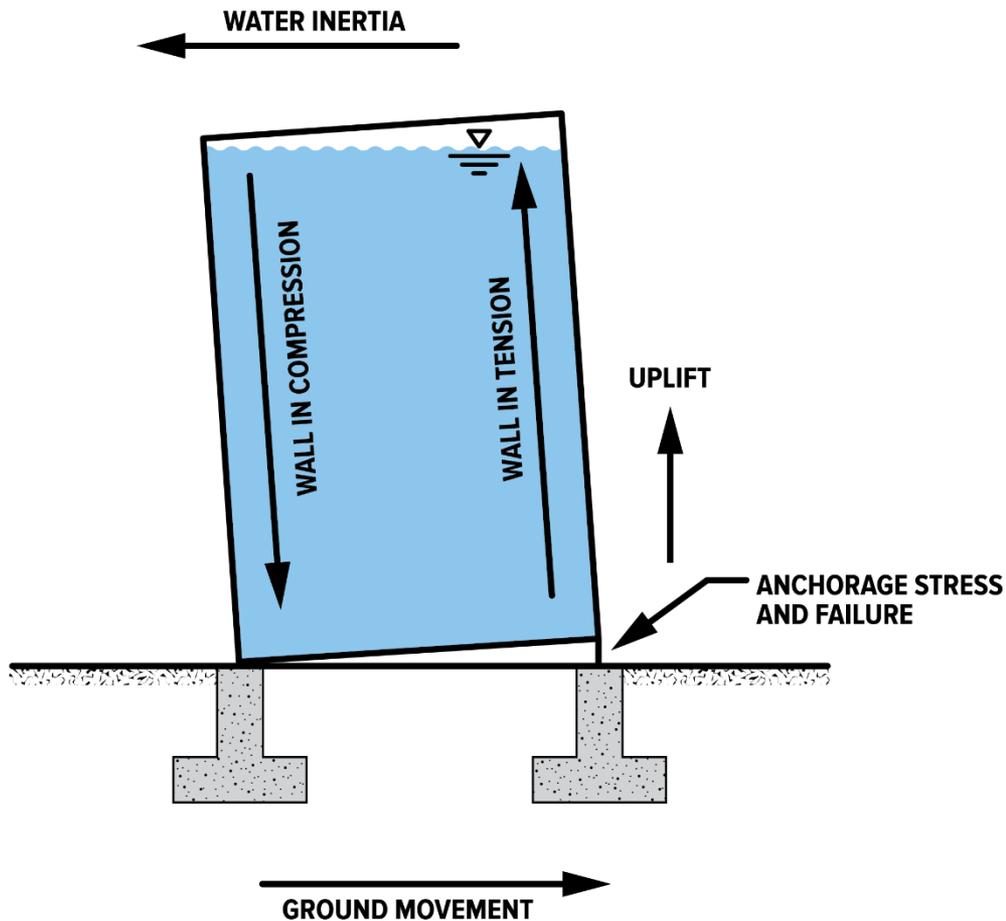
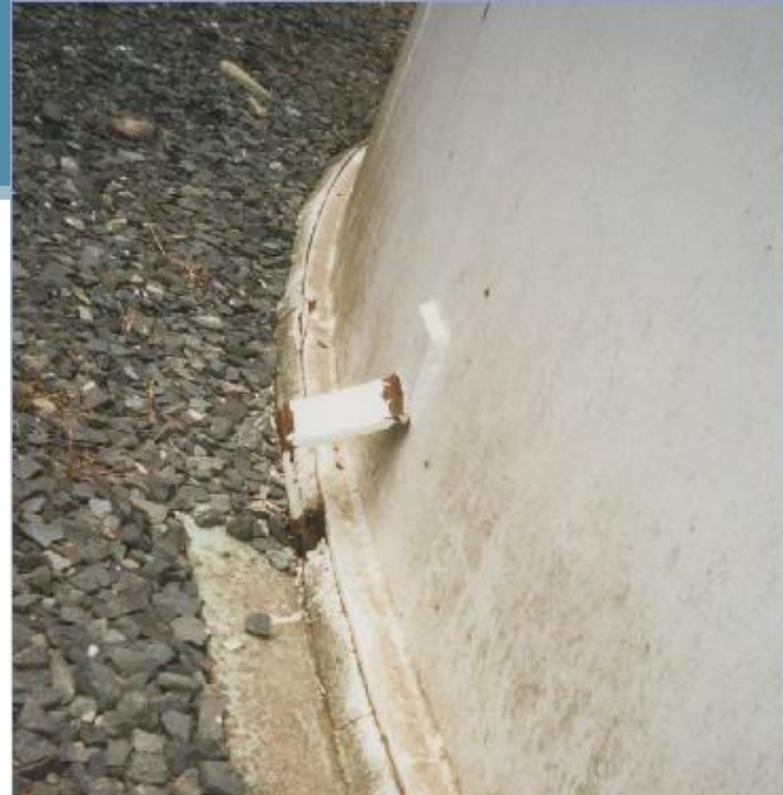
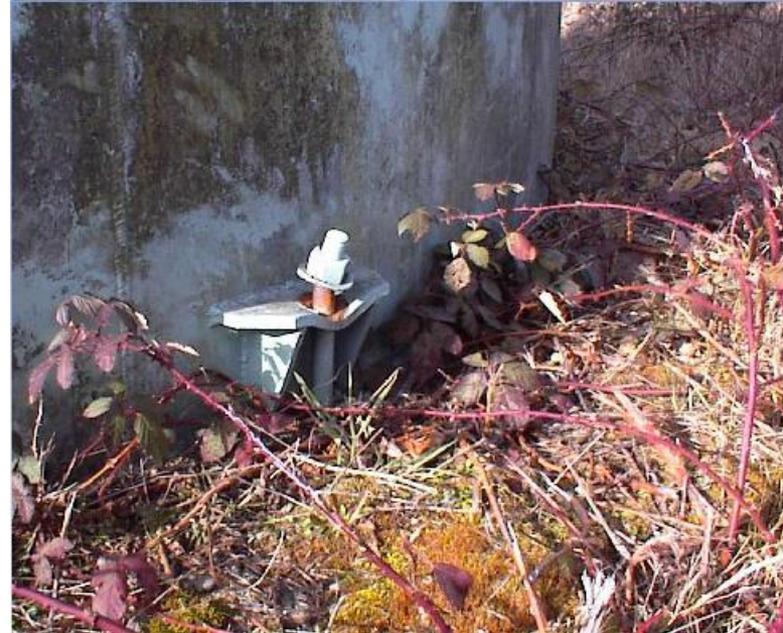
1. Anchorage failure

- Primary: Anchorage stress

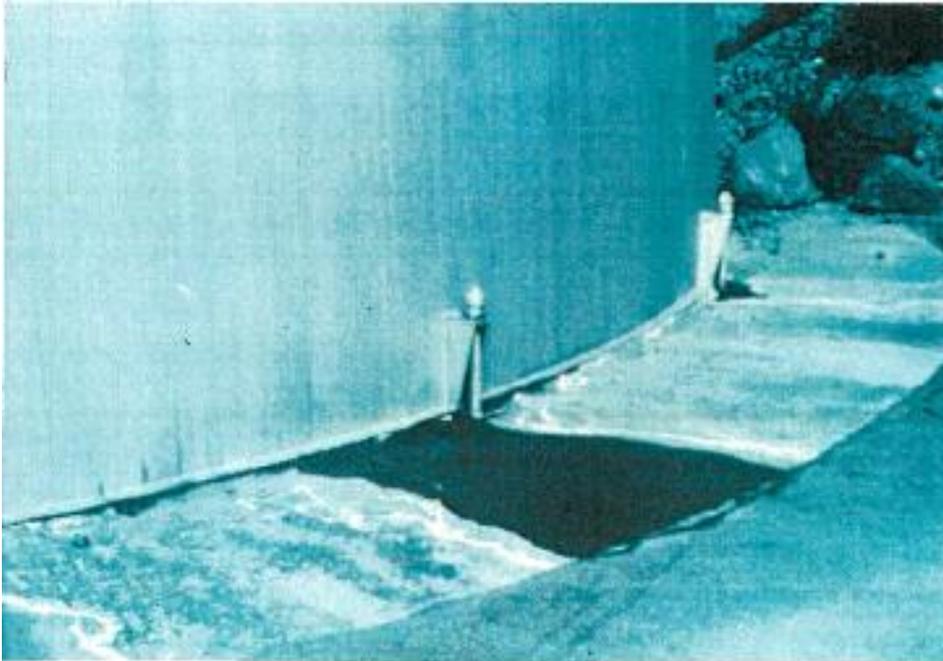
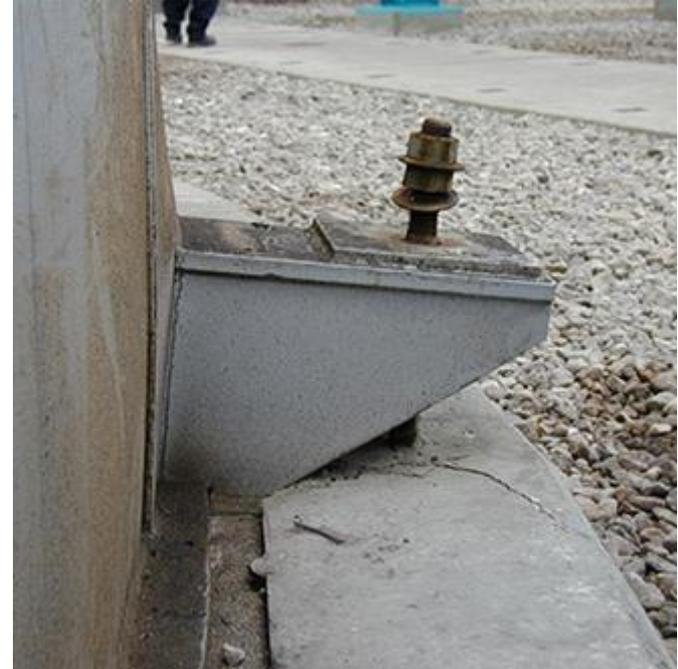
1. Anchorage failure

- Secondary: Floor cracking

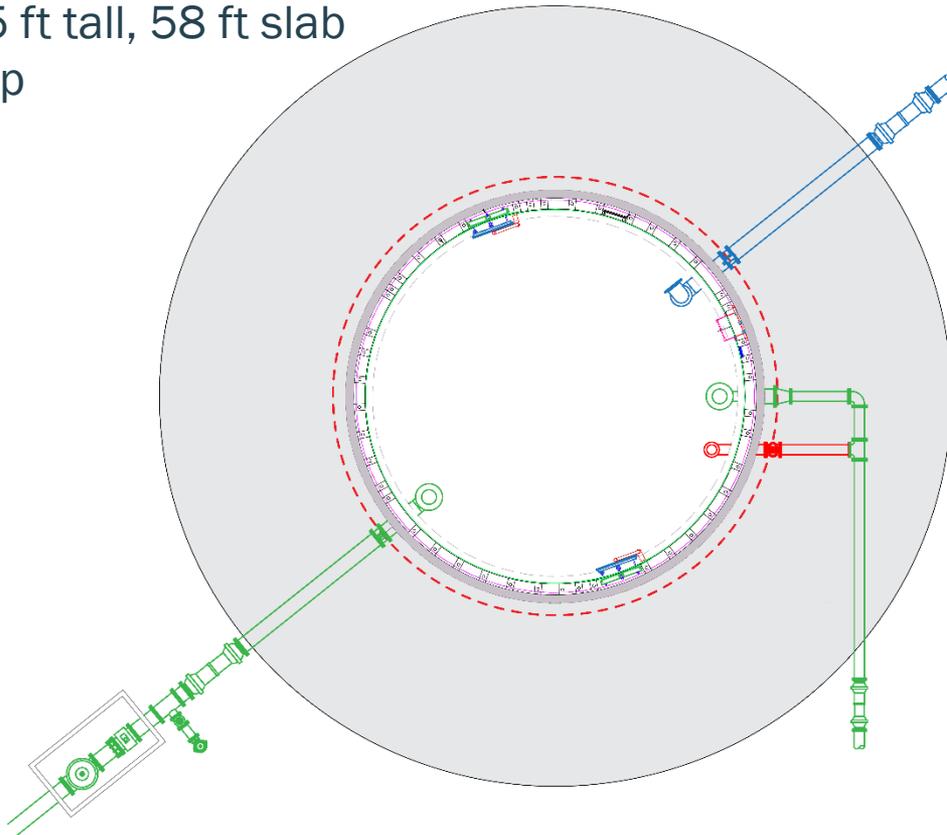
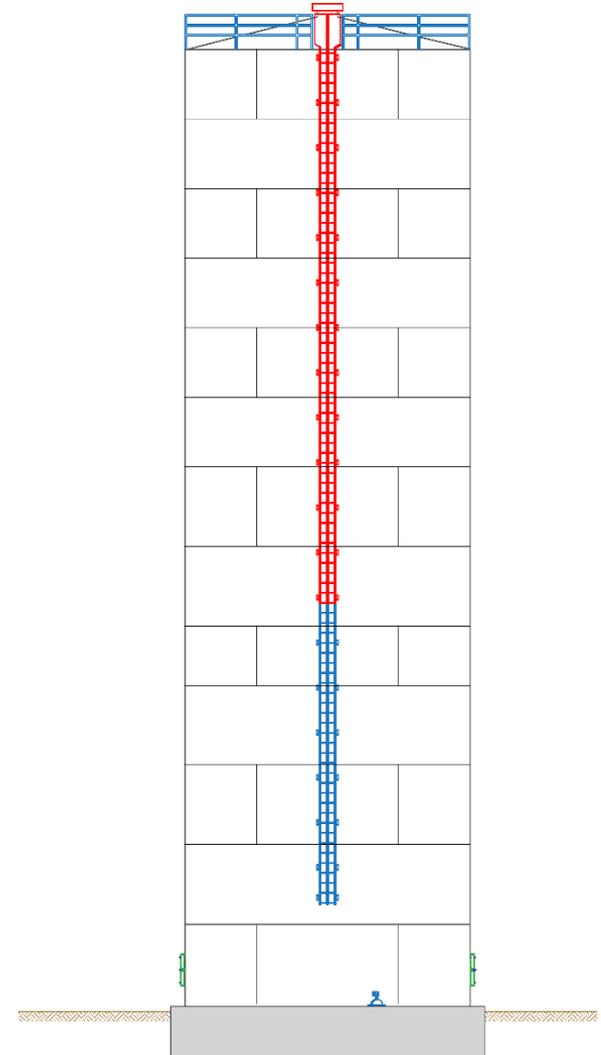
STEEL RESERVOIRS: INADEQUATE FOUNDATIONS

Original: 57 ft tall, 6 ft ringwall, 4 ft deep

New: 95 ft tall, 58 ft slab
8 ft deep

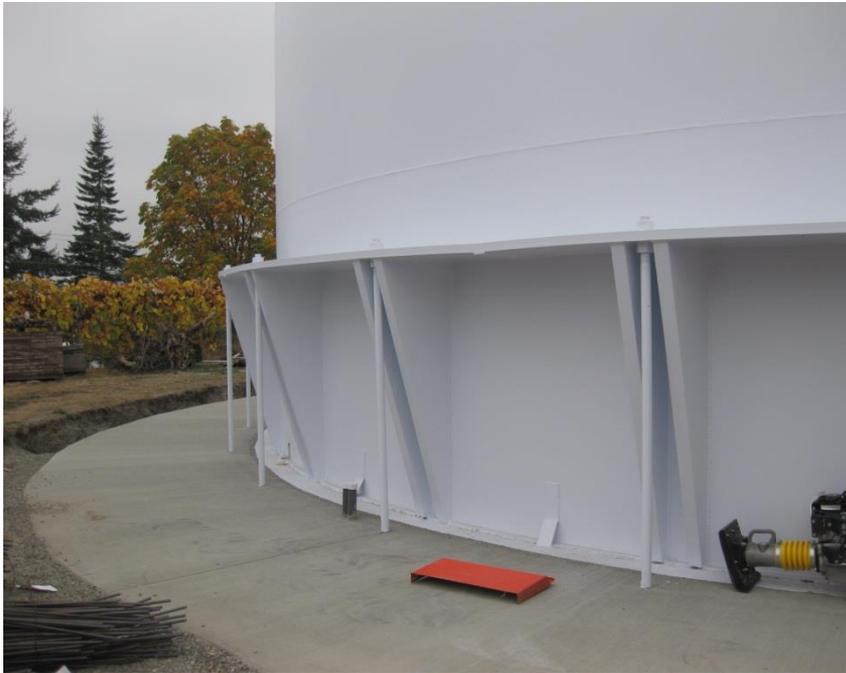
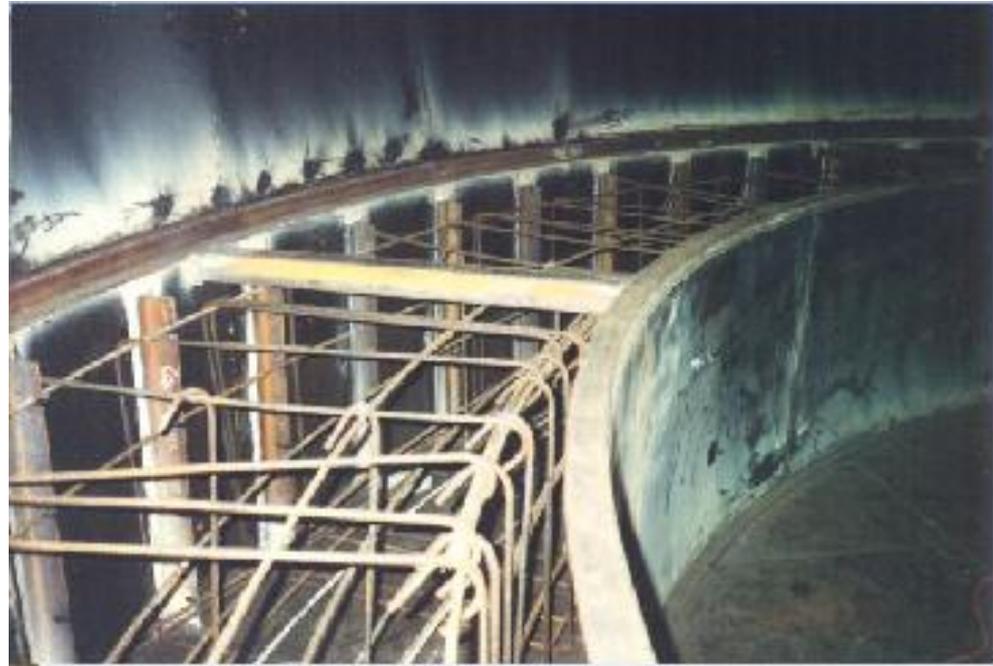
POTENTIAL BUCKLING SOLUTIONS

- Stiffen shell
- Add interior ballast ring
- Lower water level

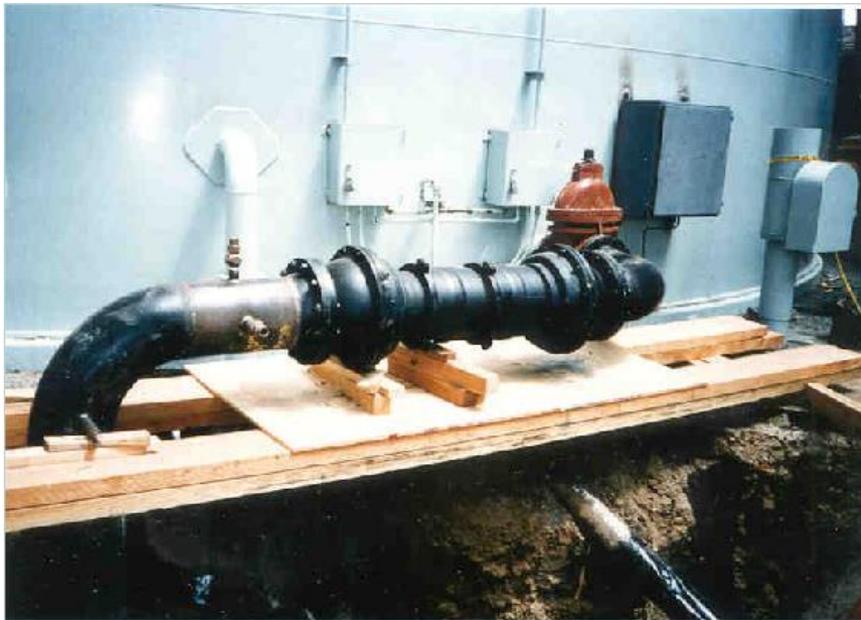
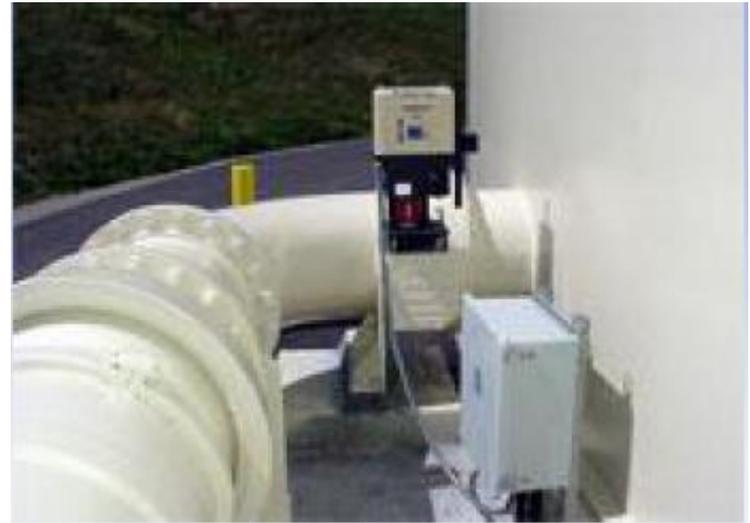
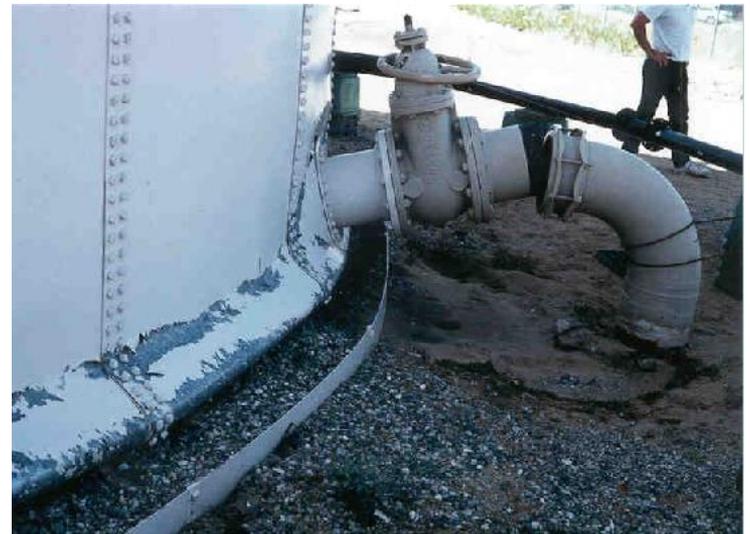
PIPING CONNECTIONS

- Allow for relative displacements
- Prepare for emergency shut down
- Isolate damaged sections

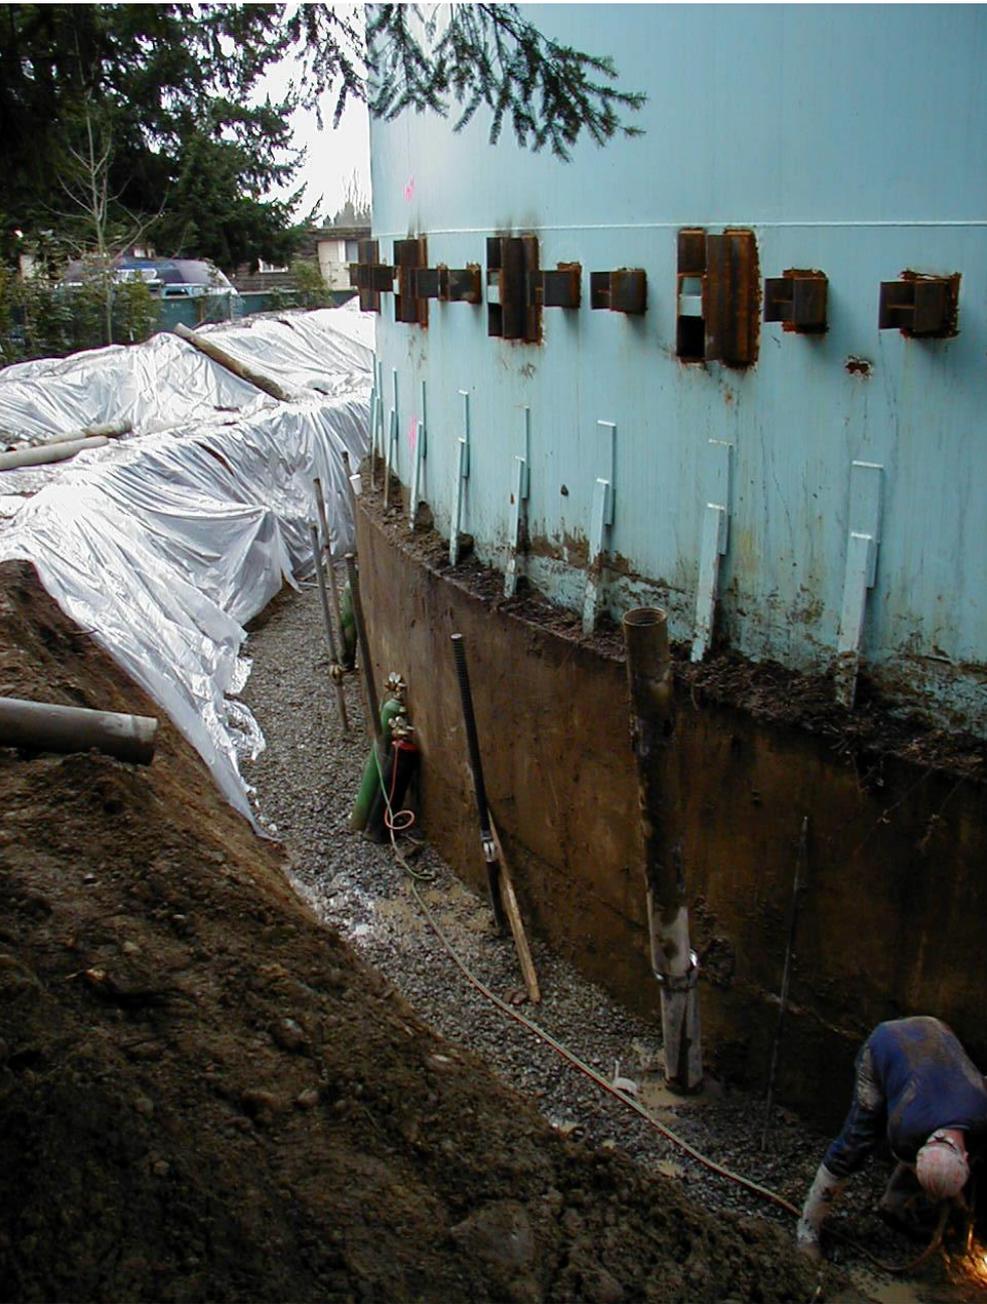
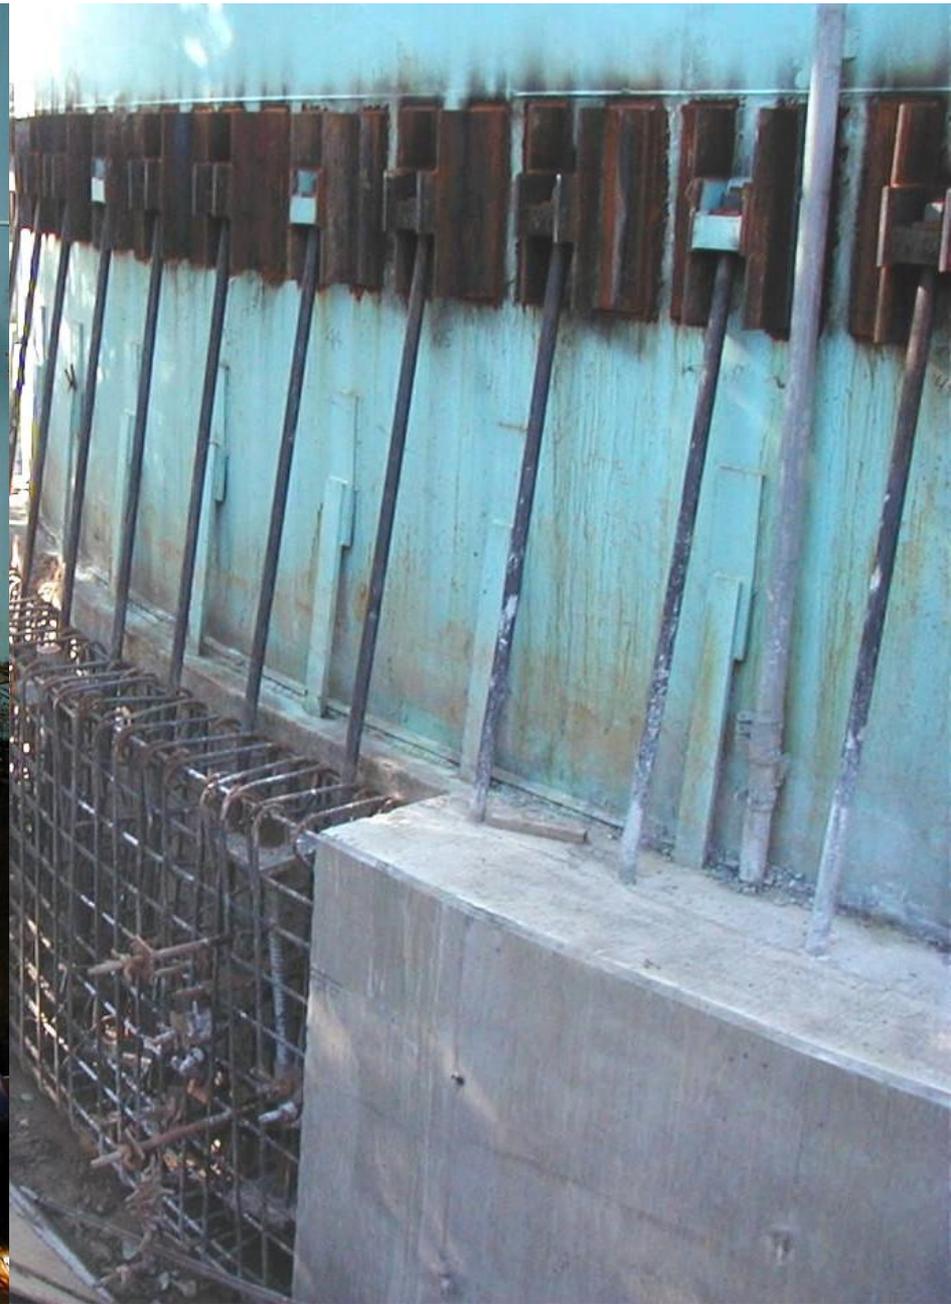
FOUNDATION RETROFIT OPTIONS

- Micropiles
 - Useful where site constraints make it difficult to expand the existing foundation
 - Expensive – can be up to \$10,000 per pile depending on depth
 - Piles provide both uplift resistance and bearing capacity

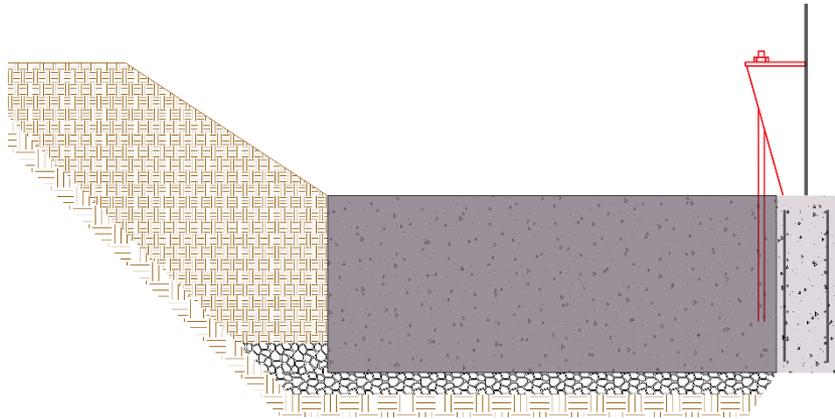
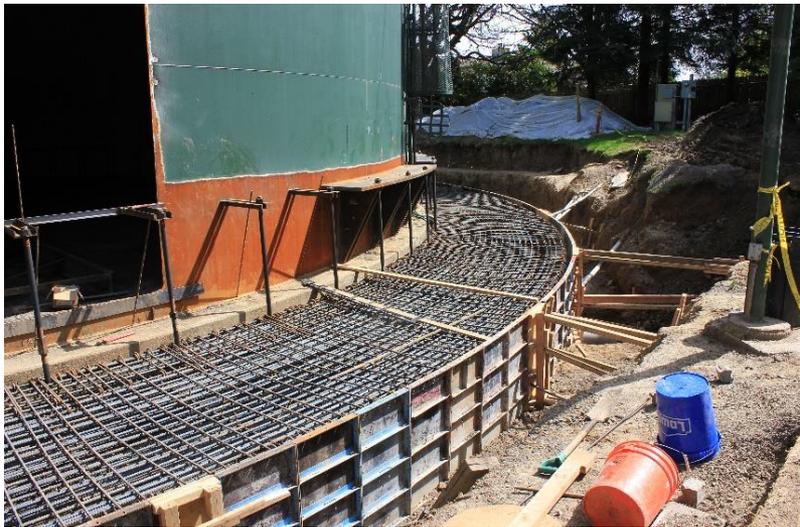
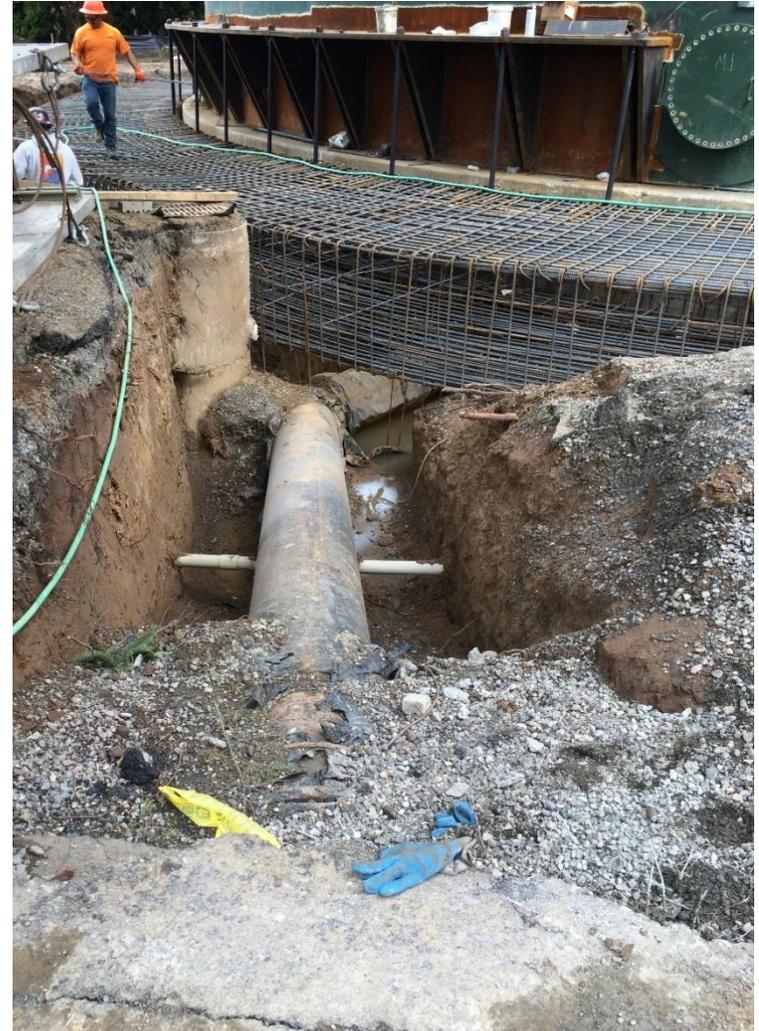
FOUNDATION RETROFIT OPTIONS

- Slab/Ringwall Expansion
 - Useful on large sites that can accommodate a larger foundation
 - Added weight helps resist overturning
 - Added surface area reduces soil bearing pressures
 - The existing foundation may be overstressed

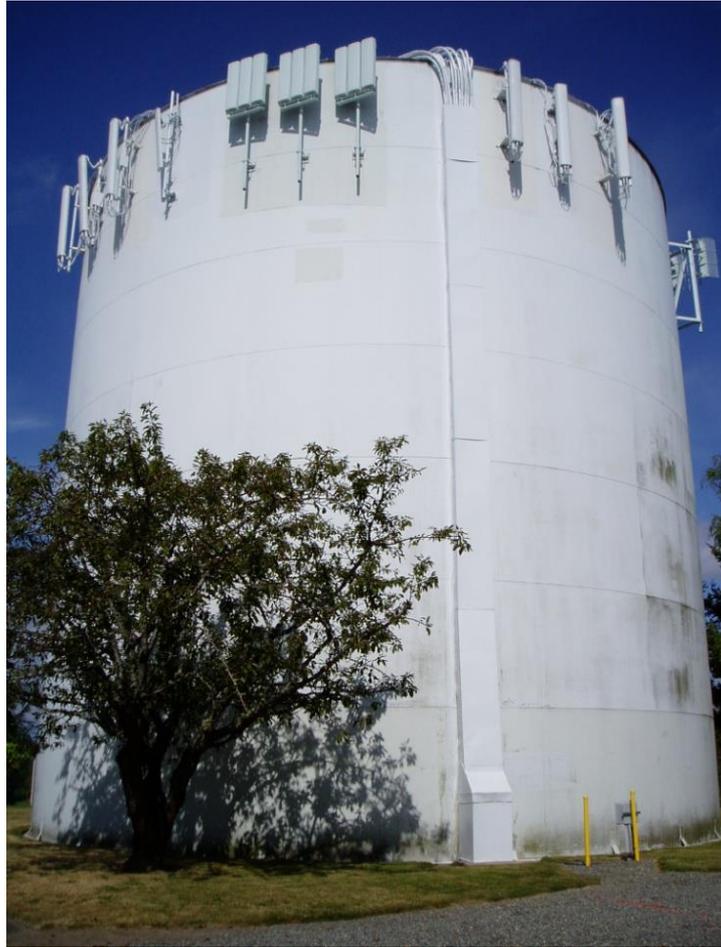
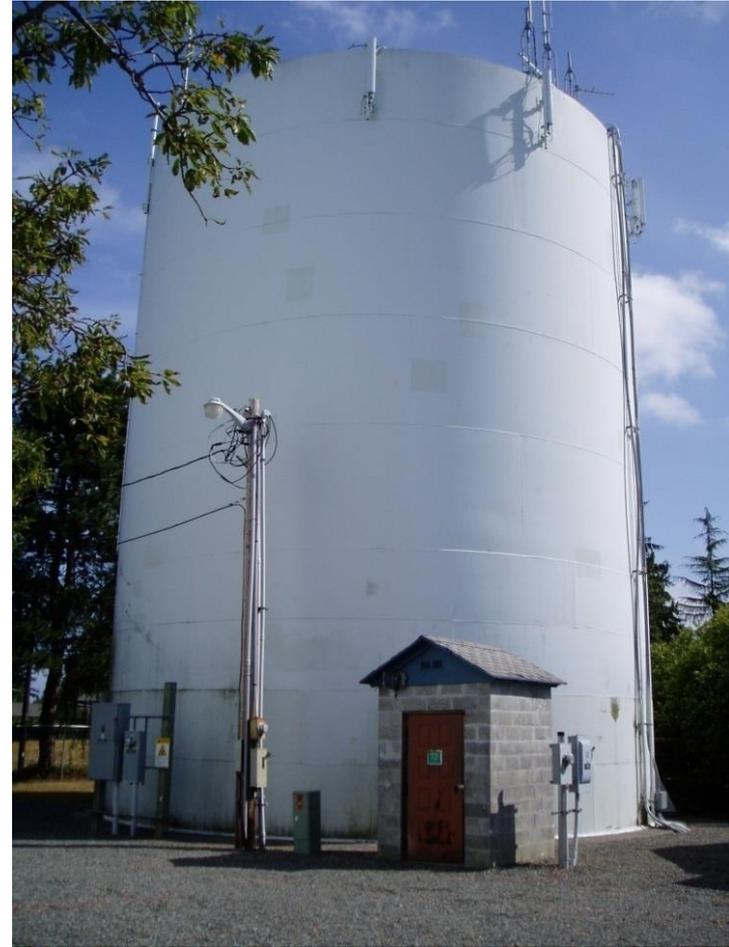
SOUTH RESERVOIRS

MT. VIEW-EDGEWOOD WATER CO.

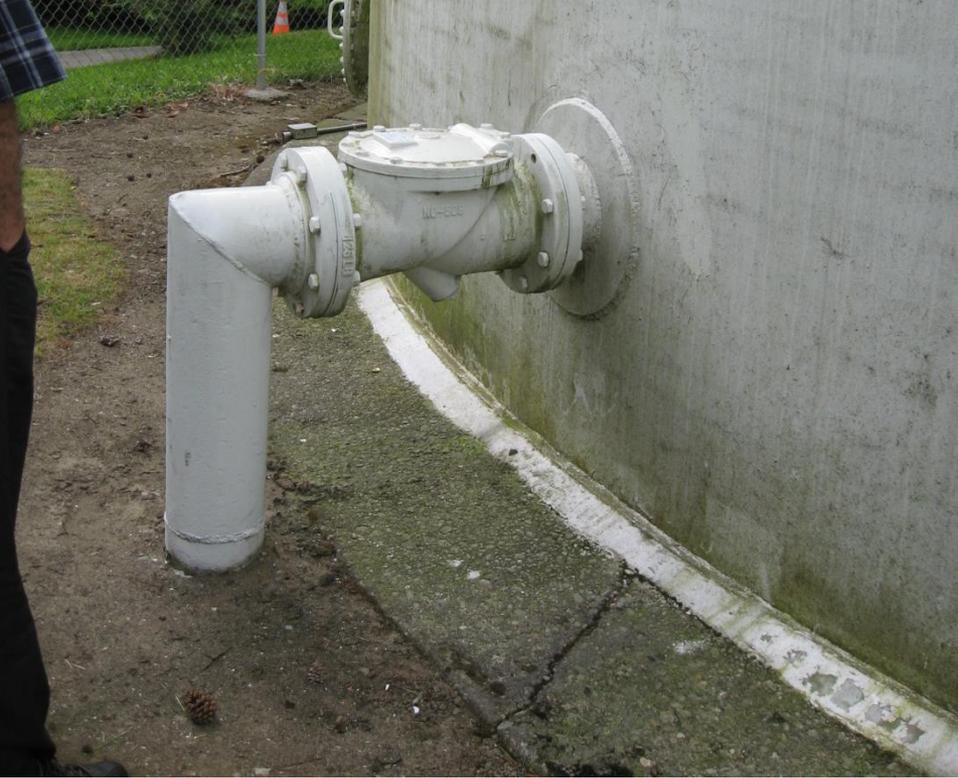
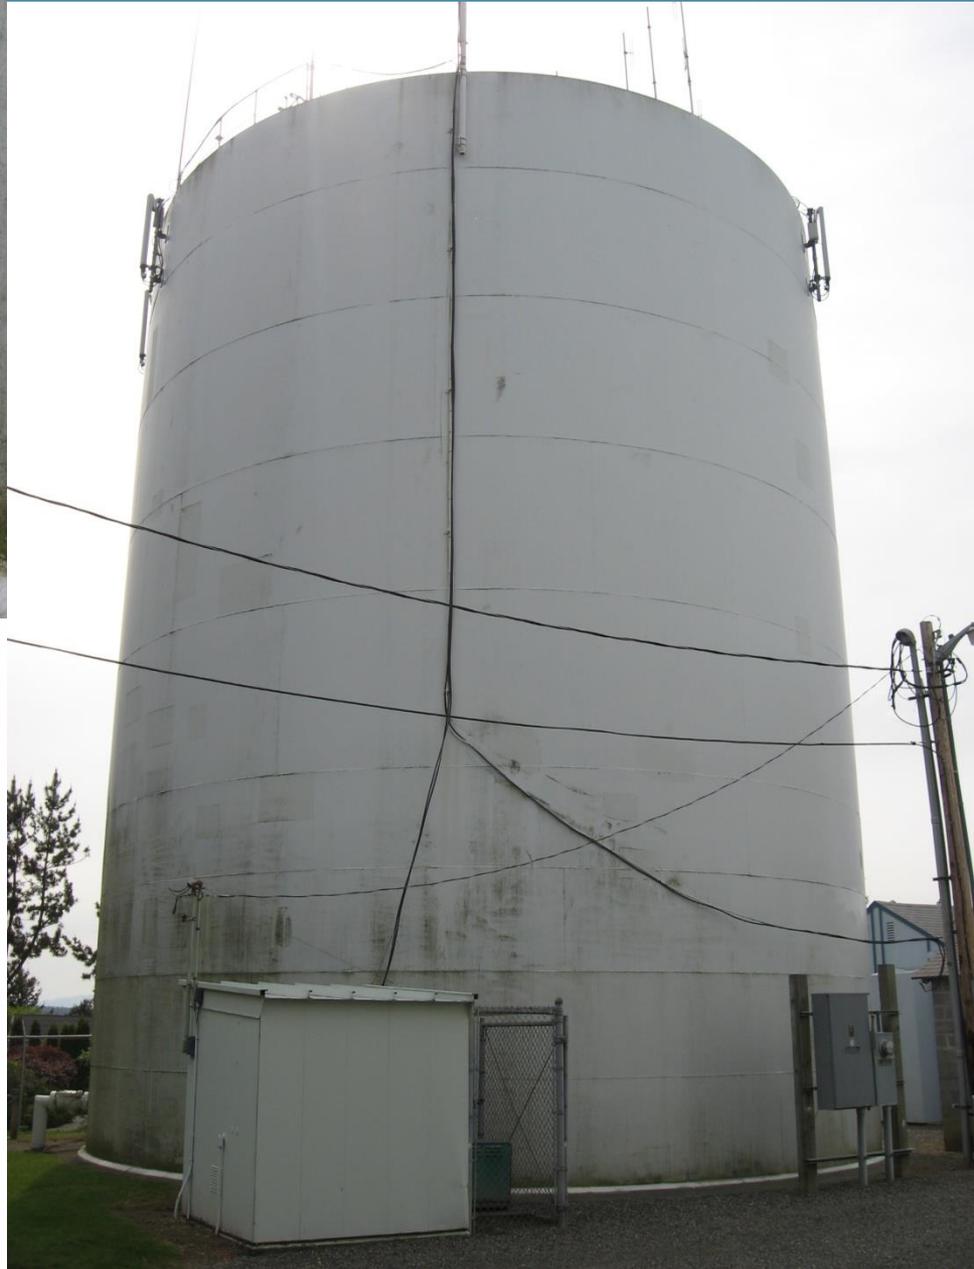
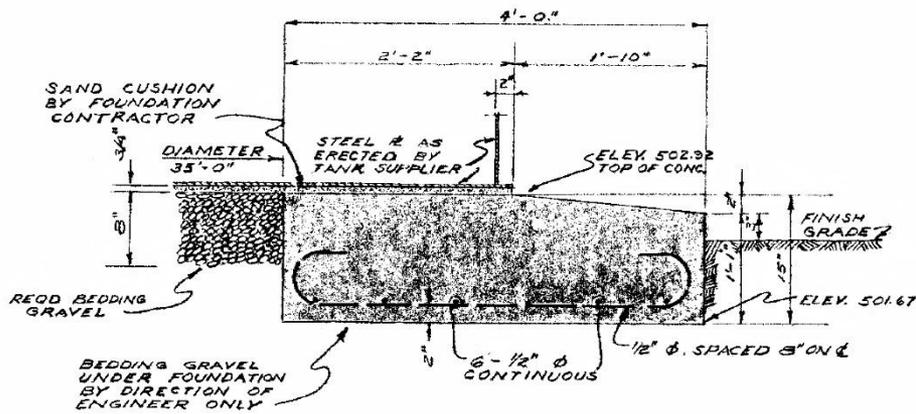
EAST RESERVOIR

SECTION A-A
SCALE: 1" = 1'-0"

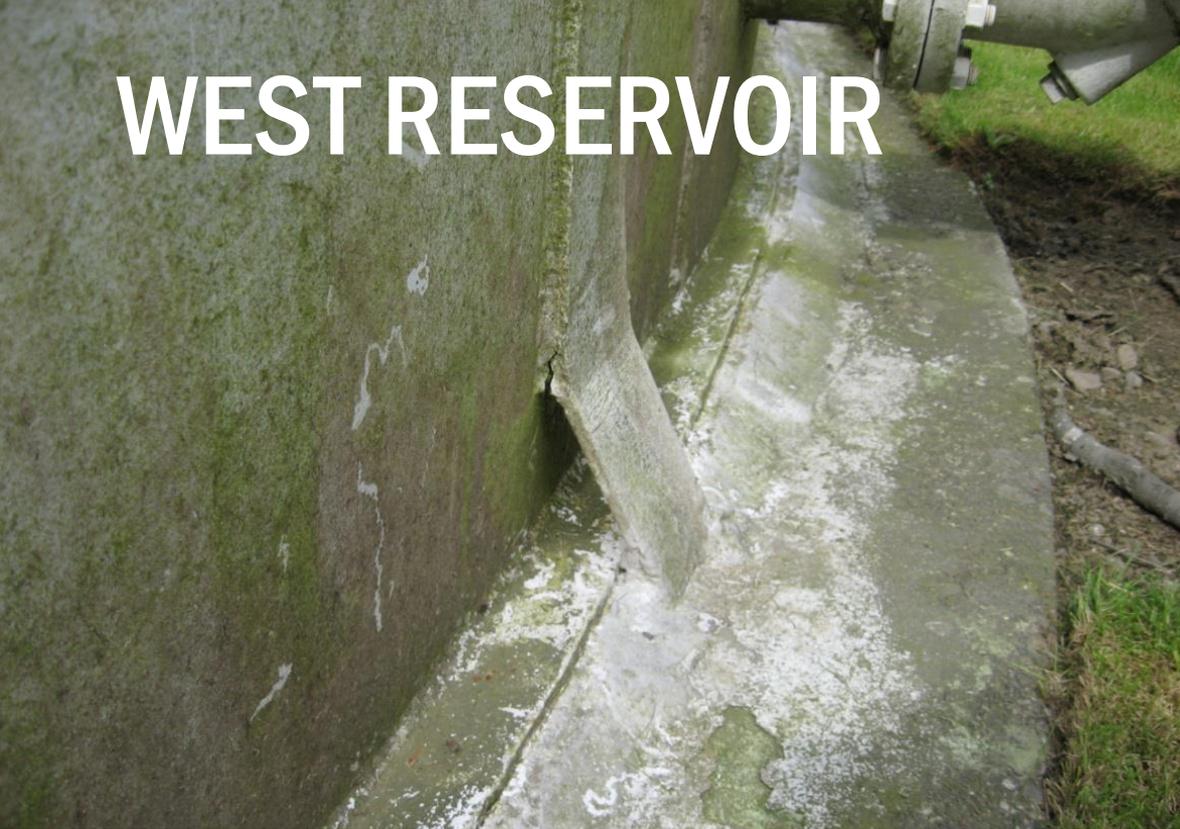
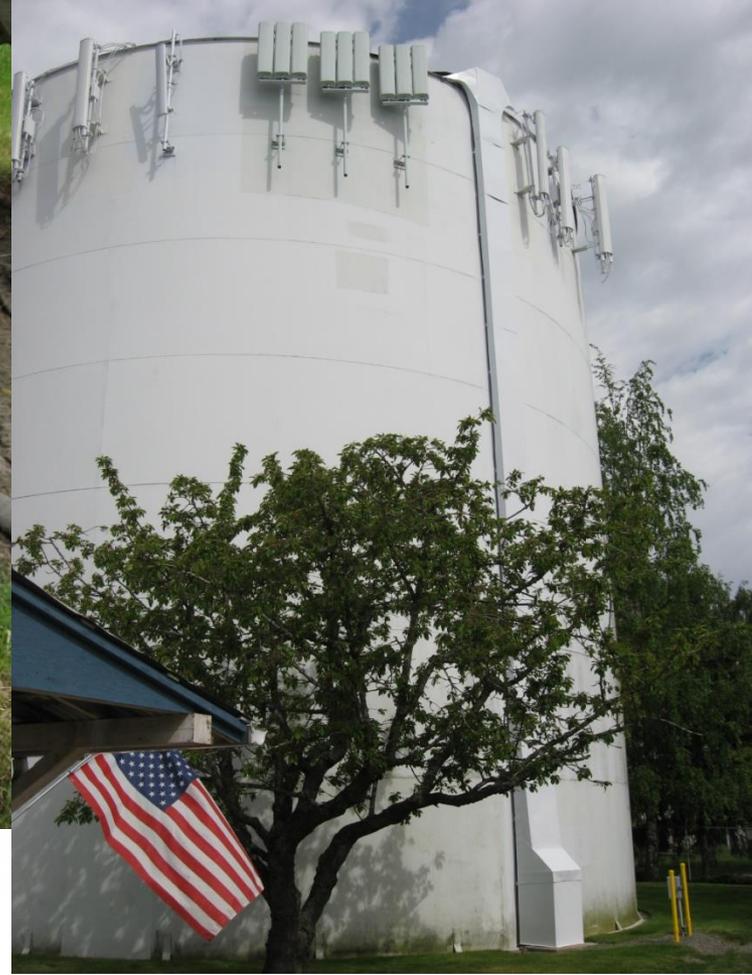
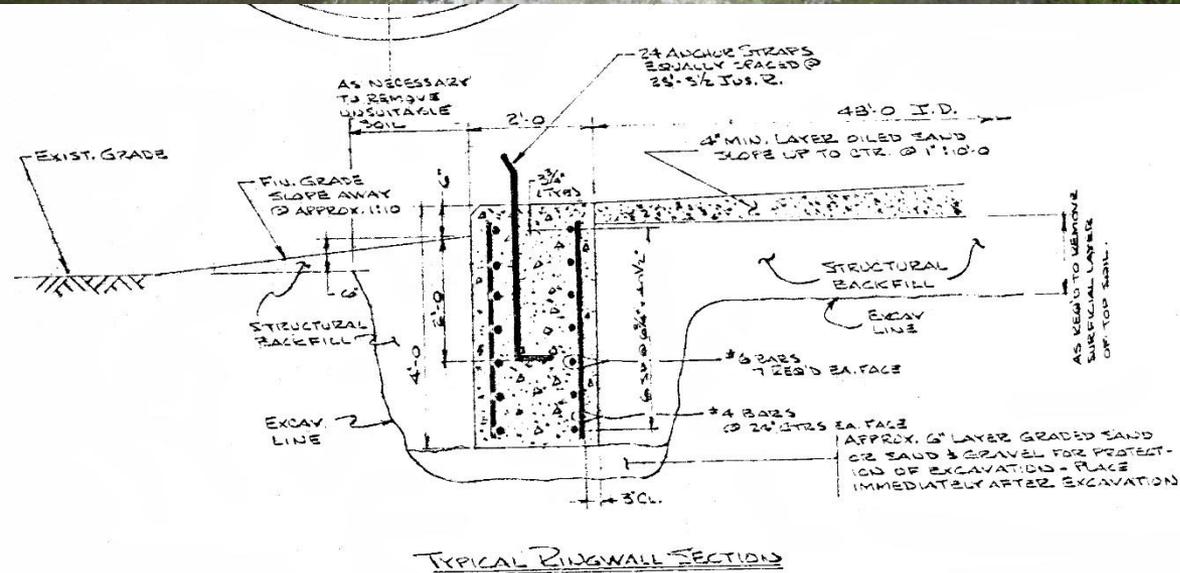
WEST RESERVOIR

- Small Foundation = high bearing pressure
- Anchor Straps

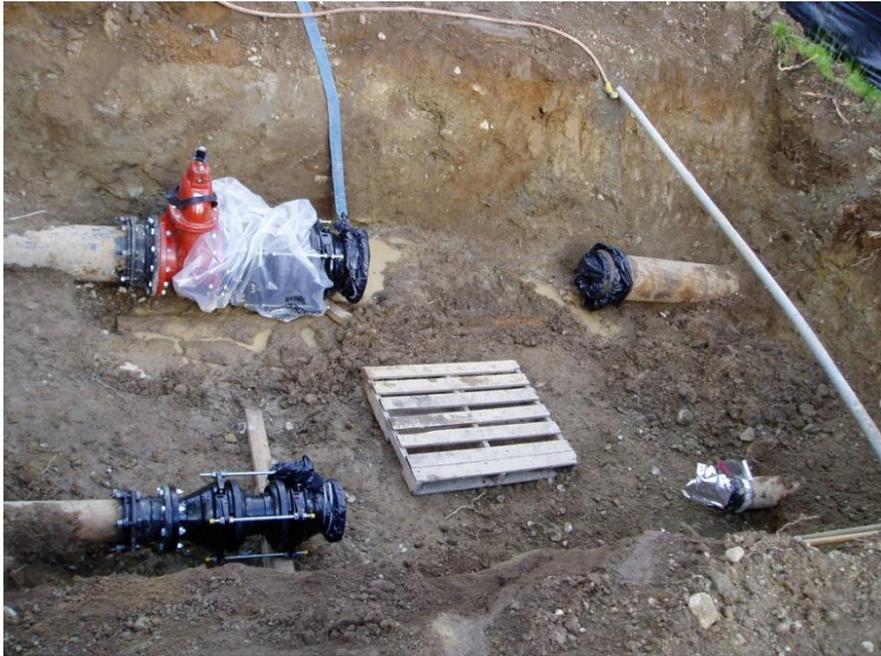
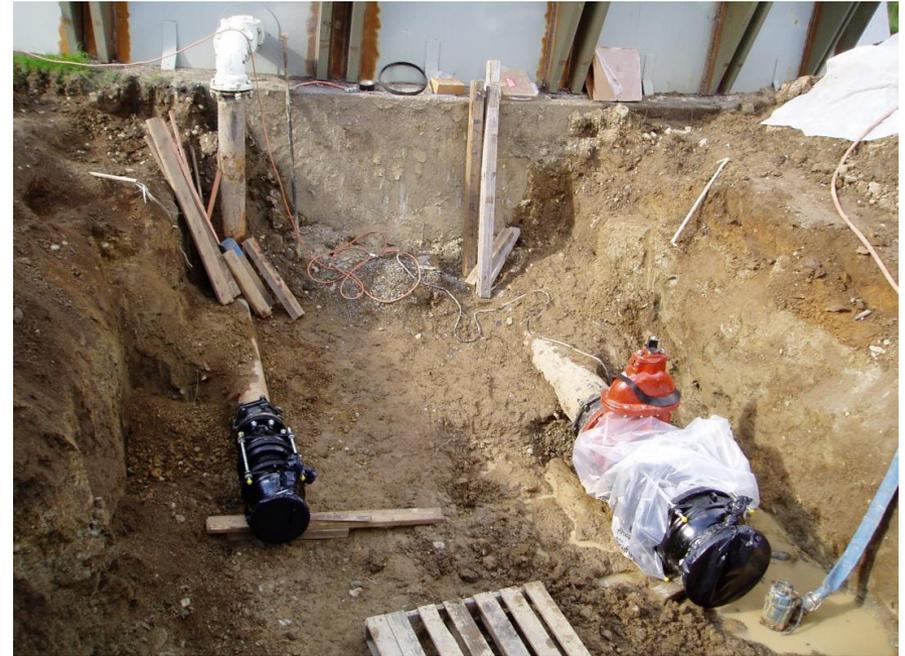
PIPING MODIFICATIONS

- Expansion joints on inlet, outlet, and drain
- New valves
