# Shaking Things Up – Innovative Seismic Risk Planning

City of Bellevue

February 25, 2021 – Doug Lane, PE, and Matt Maring, PE, PMP

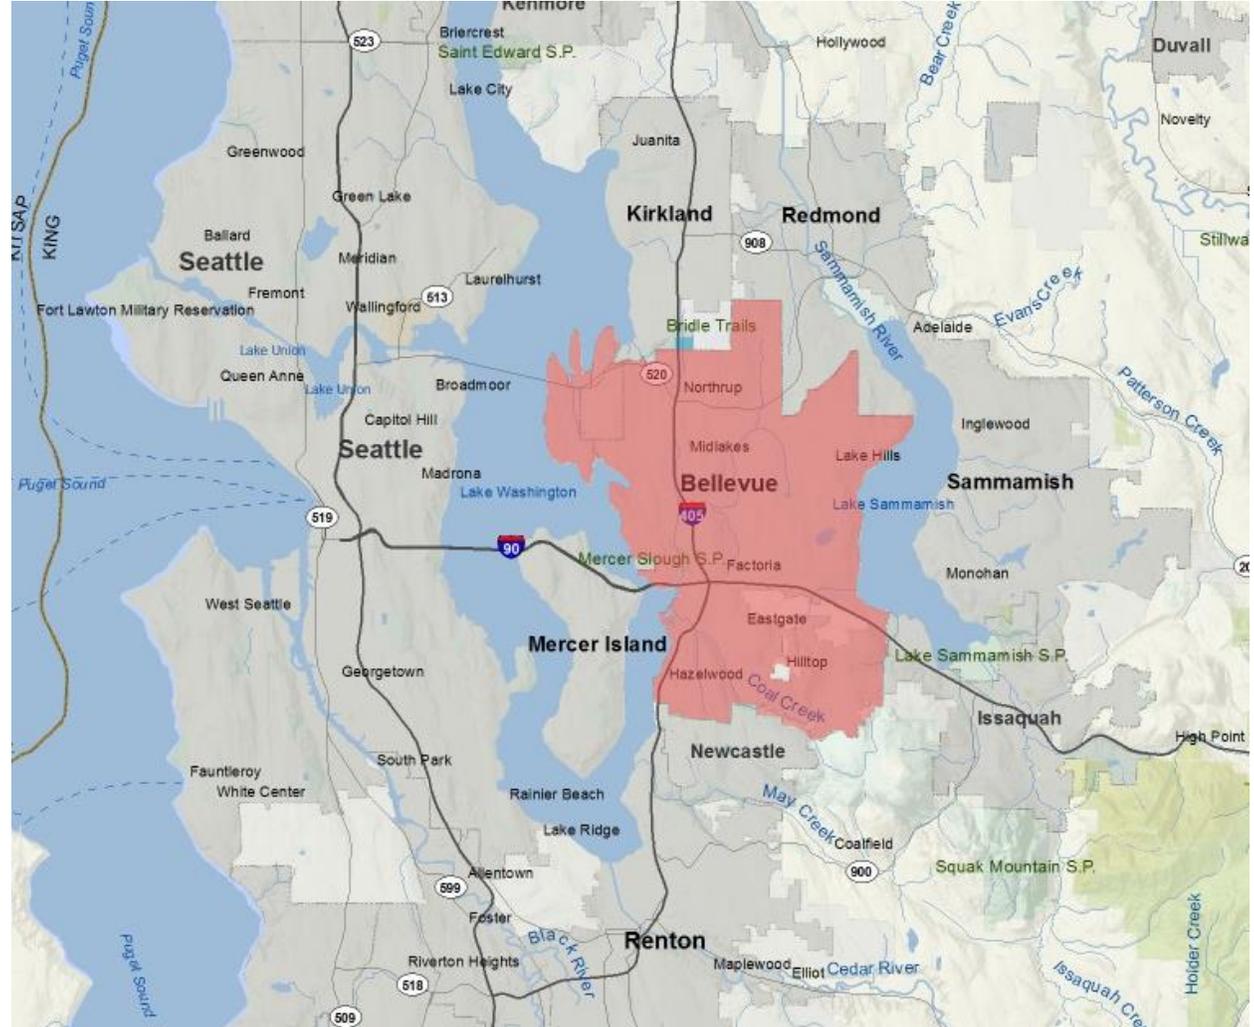
# Bellevue Service Area and Water System

- 150,000+ Population
- 140,000+ Jobs
- 14 Regional Water Supply Inlet Stations
- 72 Pressure Zones
- 24 Storage Tanks
- 22 Pump Stations
- 148 PRV Stations
- 620 Miles of Water Mains
- 20-1440 ft Surface Elevations

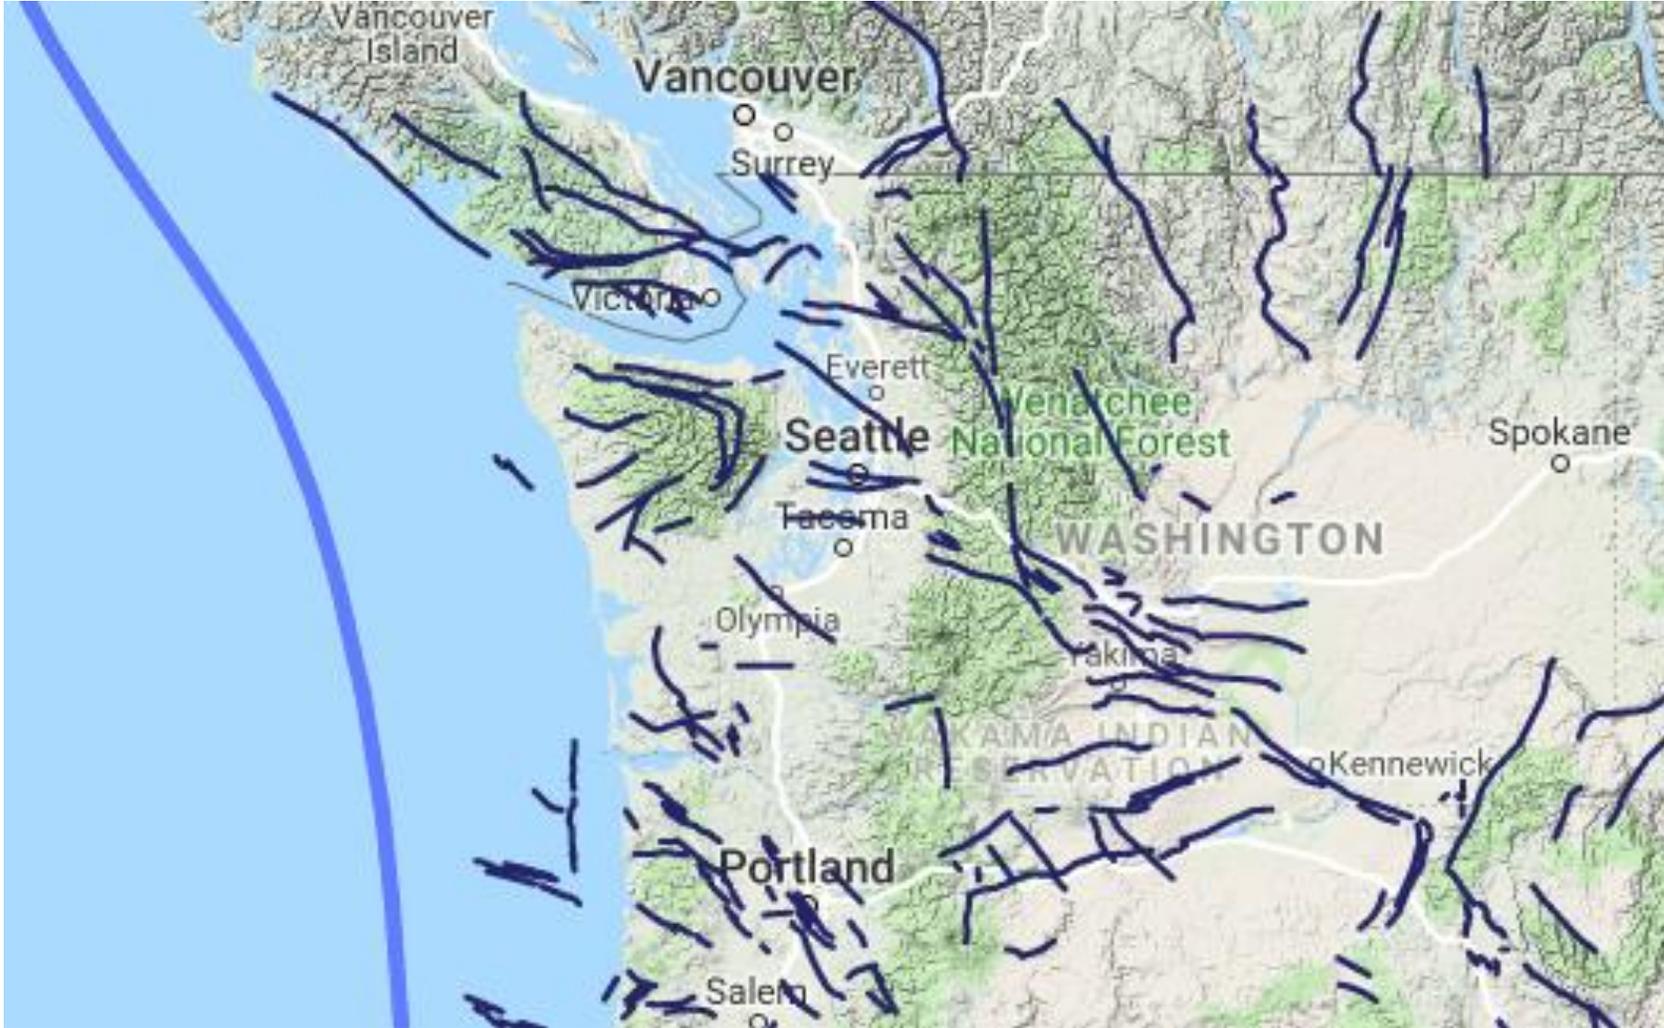
# Pacific Northwest Faults and Bellevue Seismic Risks

- Cascadia Subduction Zone (CSZ)
- Seattle Fault Zone (SFZ)
- South Whidbey Island Fault (SWIF)

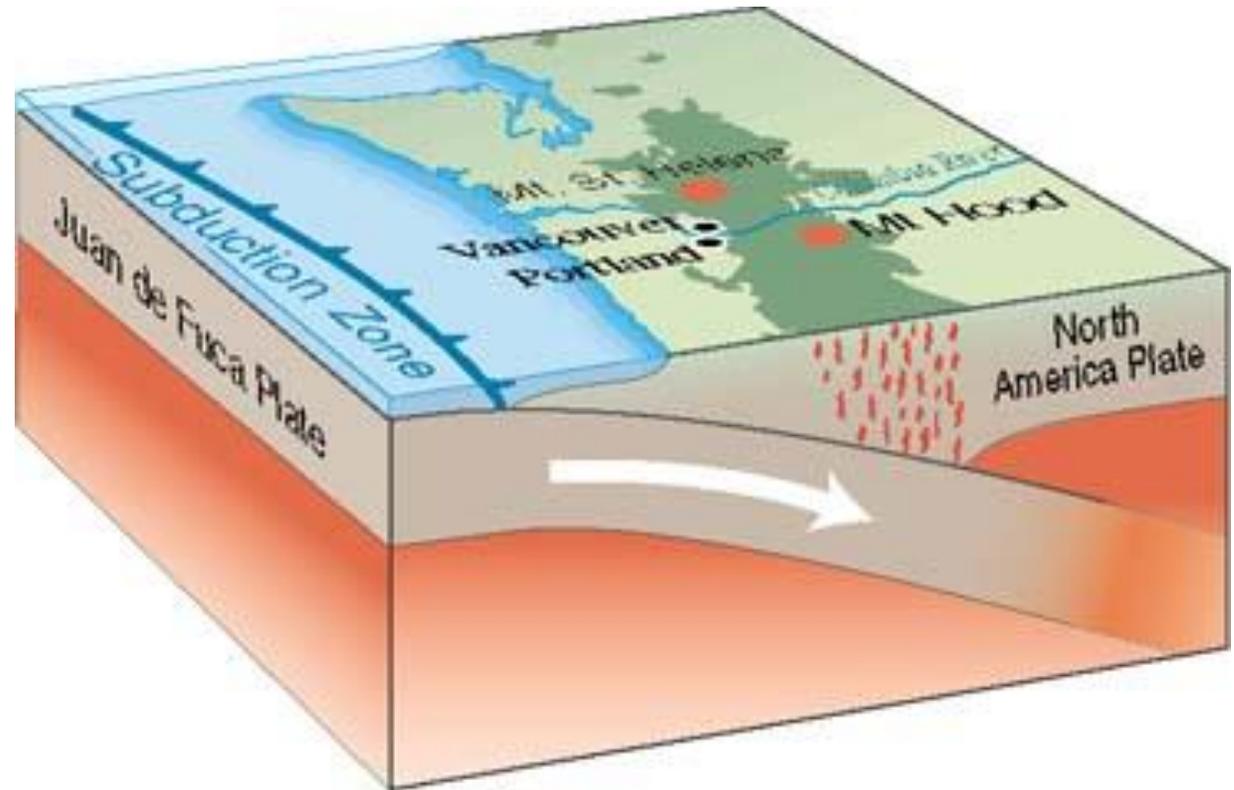
# Cascadia Subduction Zone Earthquake

- Ostensibly “The Big One”
- Magnitude 9.0
- ~500 year event
- Longer (~3 minutes) duration
- Pacific Ocean epicenter
- Broad regional impacts

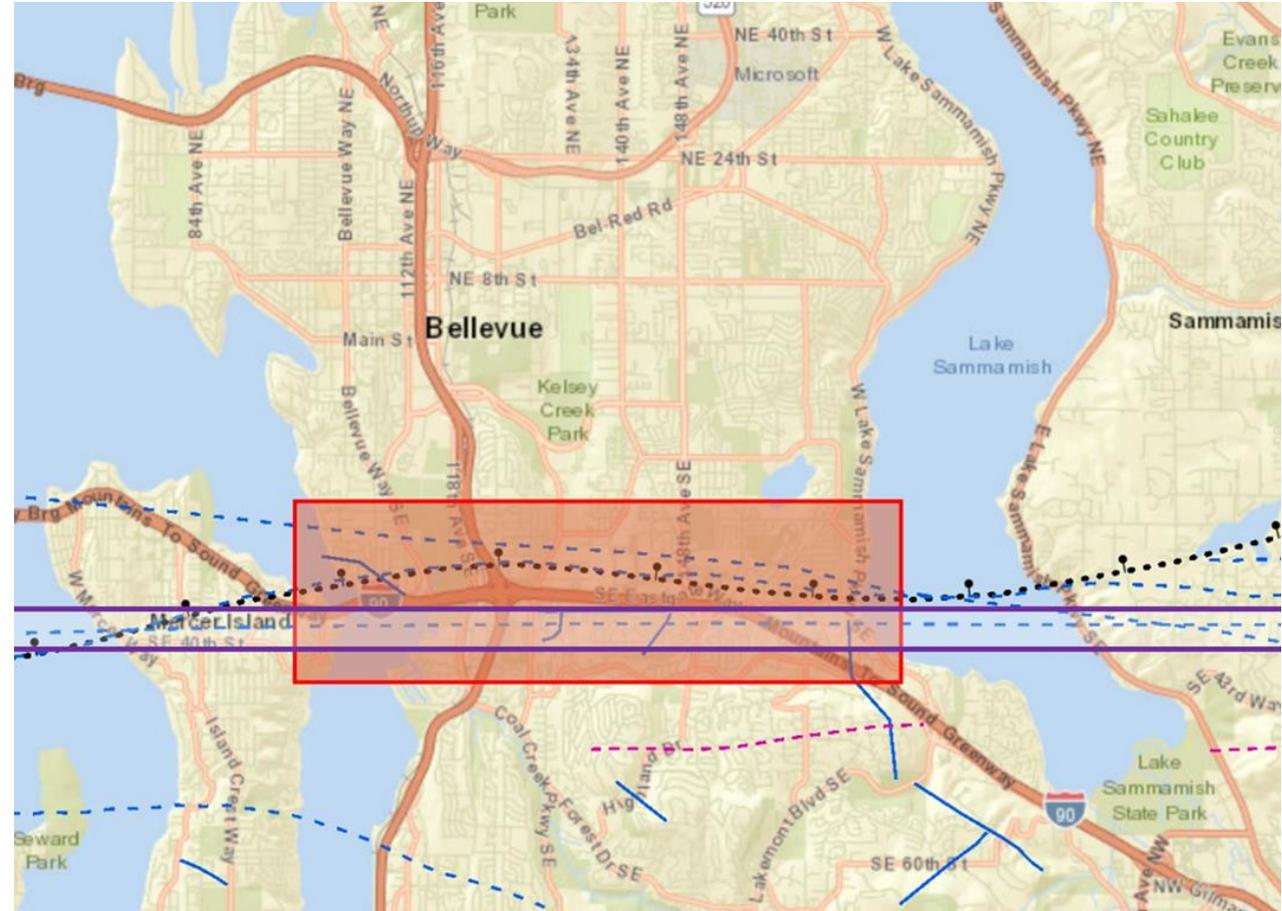
# Seattle Fault Zone Earthquakes

- The actual “Big One”
- Magnitude 6.6 (800+ year) to Magnitude 7.2 (4,000+ year)
- Short duration
- Shallow fault
- Epicenter near or under Bellevue
- Severe localized impacts

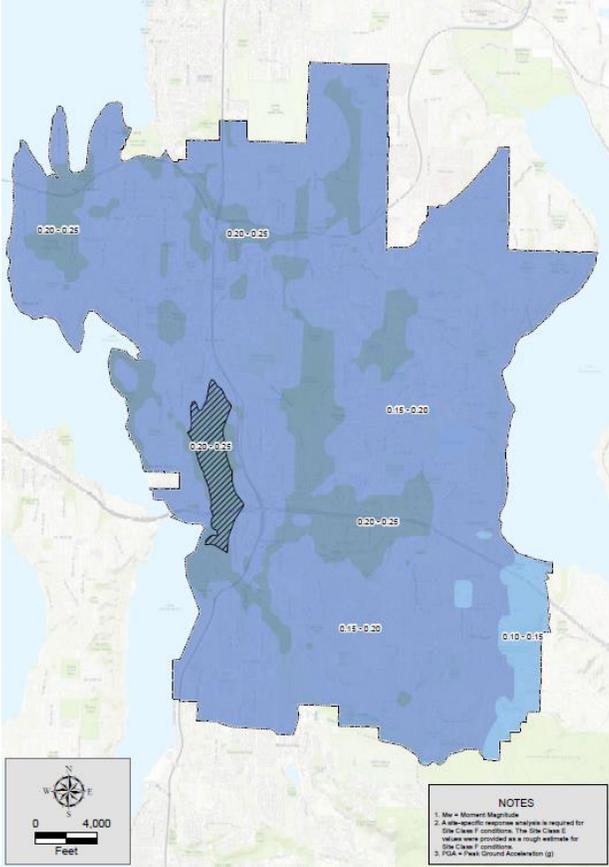
## Cascadia Subduction Zone (CSZ) Mw 9.0

# Seismic Event Peak Ground Acceleration (PGA)

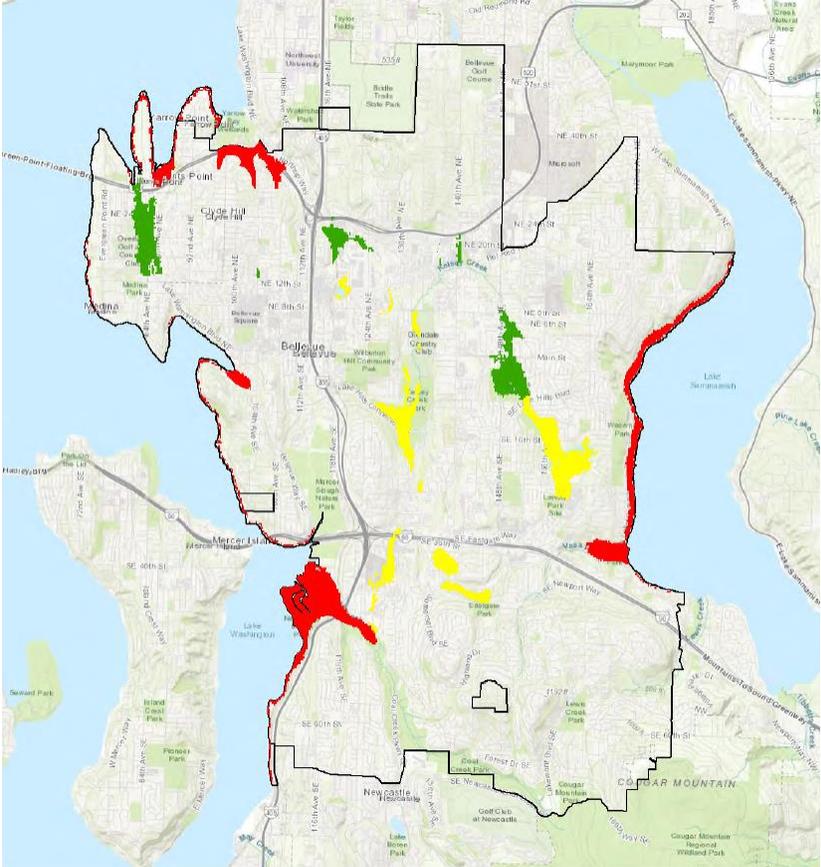
## Liquefaction and Subsidence Hazards

# Geotechnical Vulnerabilities – Seattle Fault Zone East

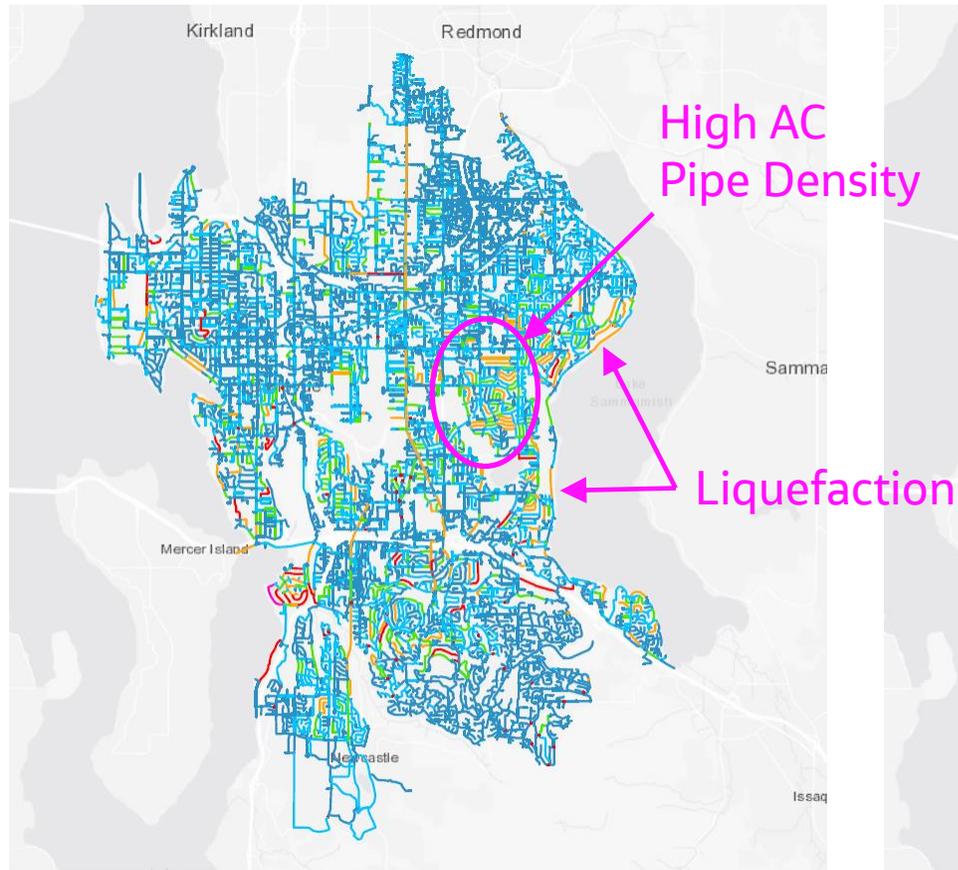
## Leak Probability and Distribution

# ALA Pipe Failure Probabilities - Existing System, Seattle Fault Zone East

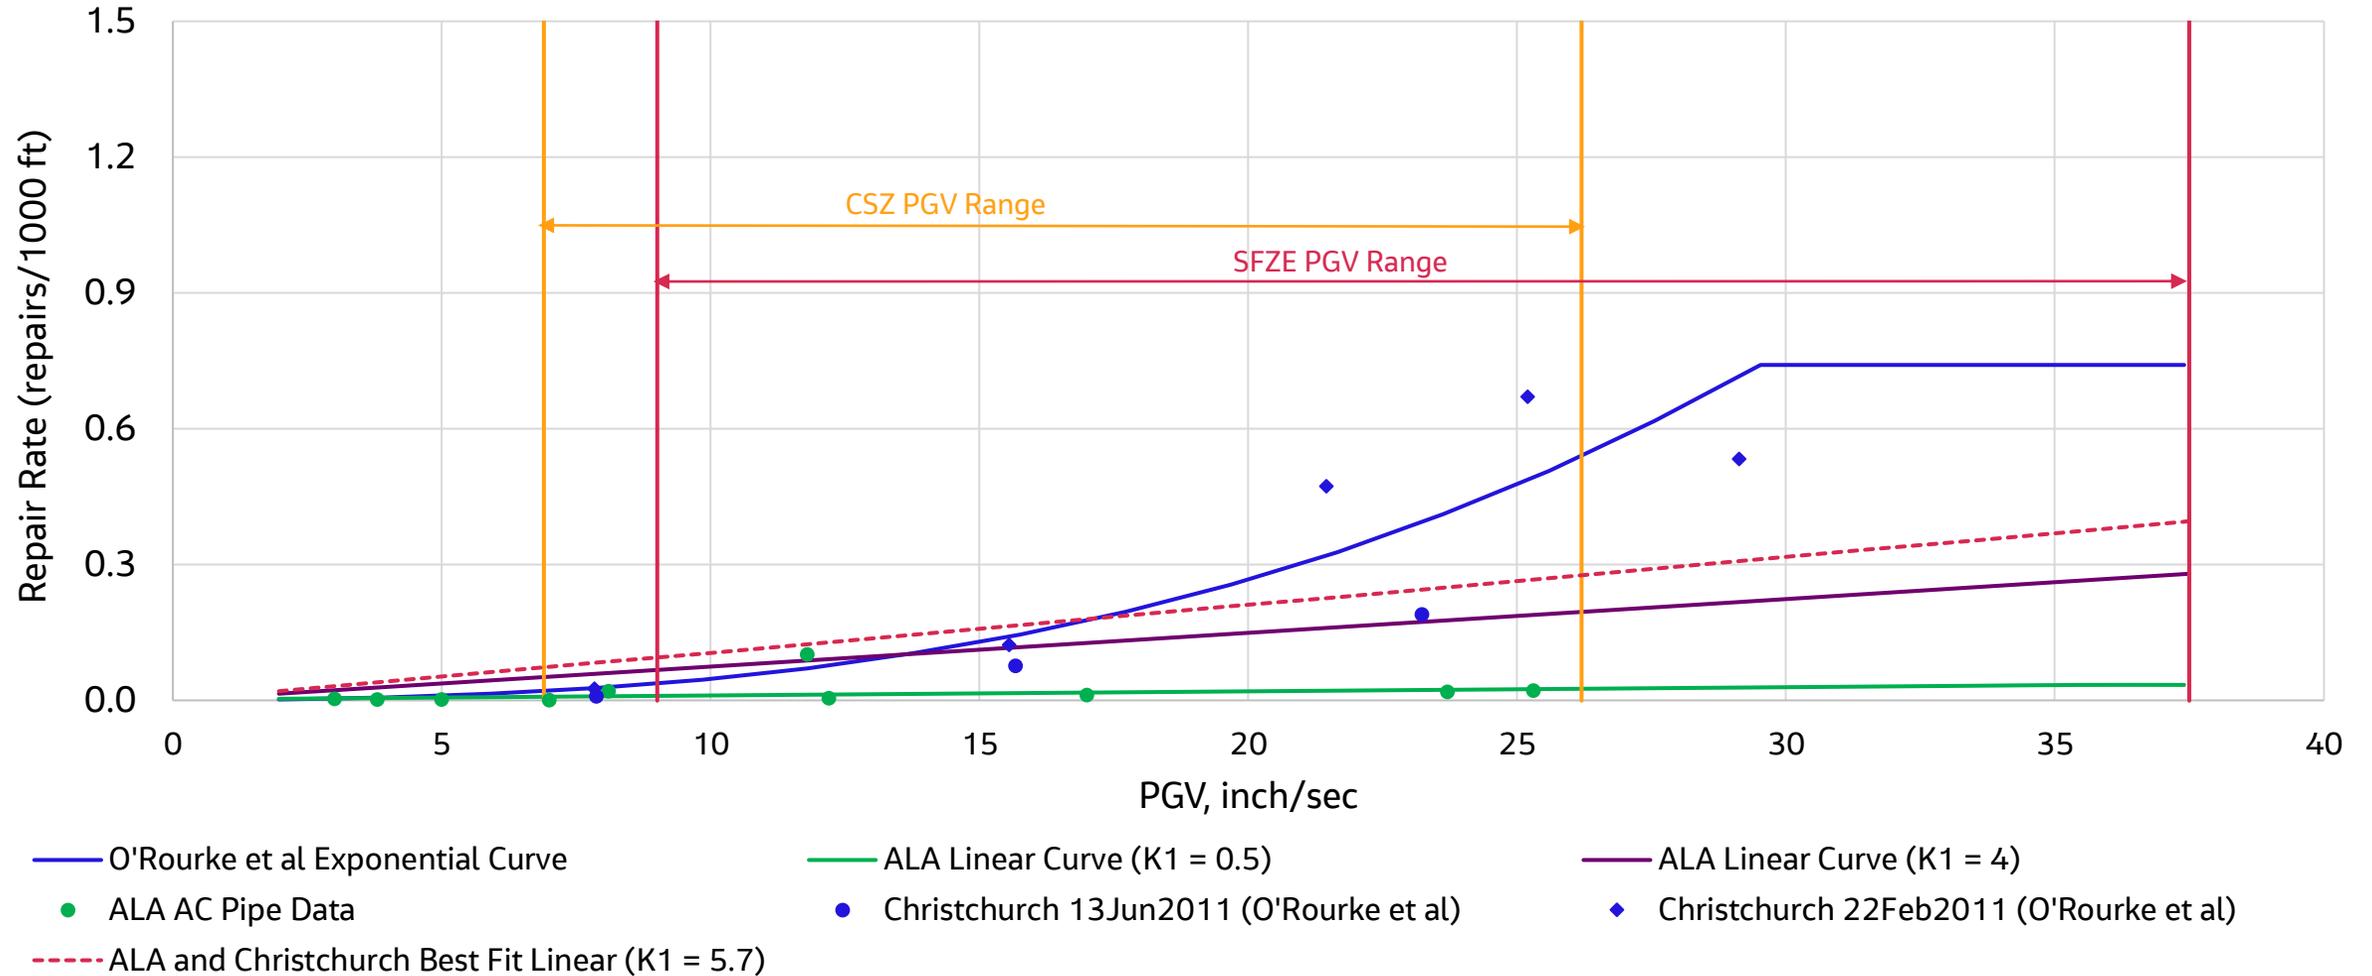
# AC Pipe Fragility Factors Updated based on 2011 Christchurch NZ Data

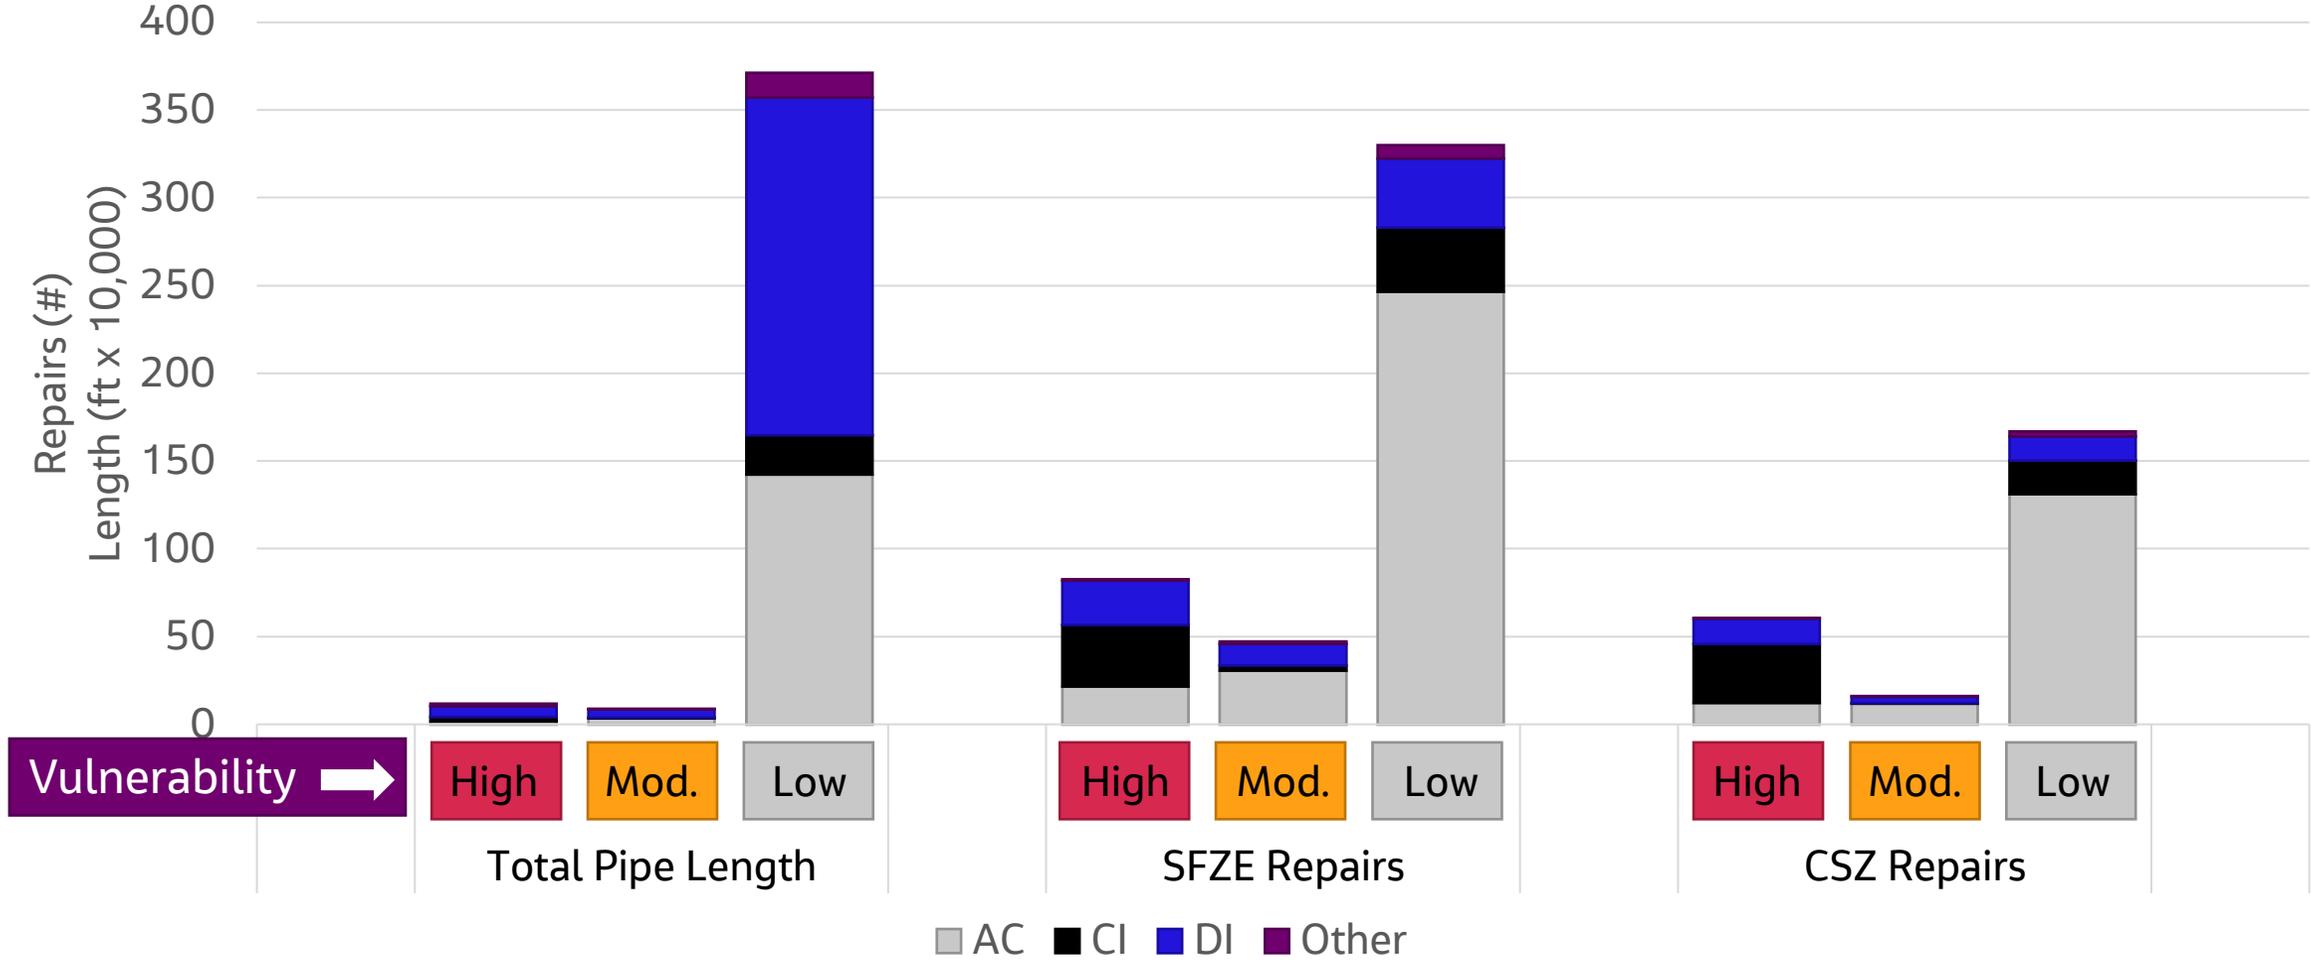
# Pipe Repairs by Material and Vulnerability Rating – Existing System

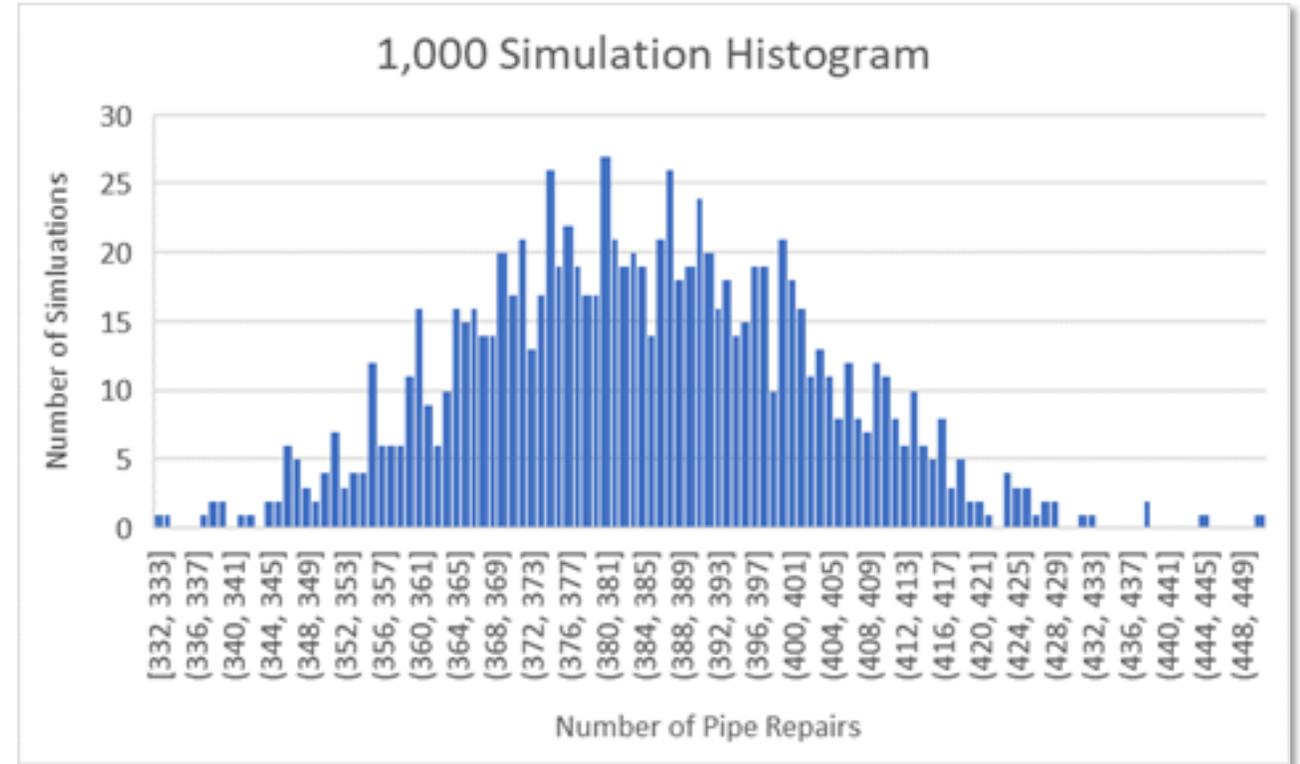
# Monte Carlo Failure Analysis Modeling

- System performance modeled based on ALA and Hazus failure probabilities estimated according to:
  - Projected seismic event severity
  - Materials and condition
  - Geotechnical factors
- Initial 1,000 simulation analysis approached typical “normal” statistical distribution
- 10,000 simulation analysis provides smoother distribution for use in multi-break system modeling analysis

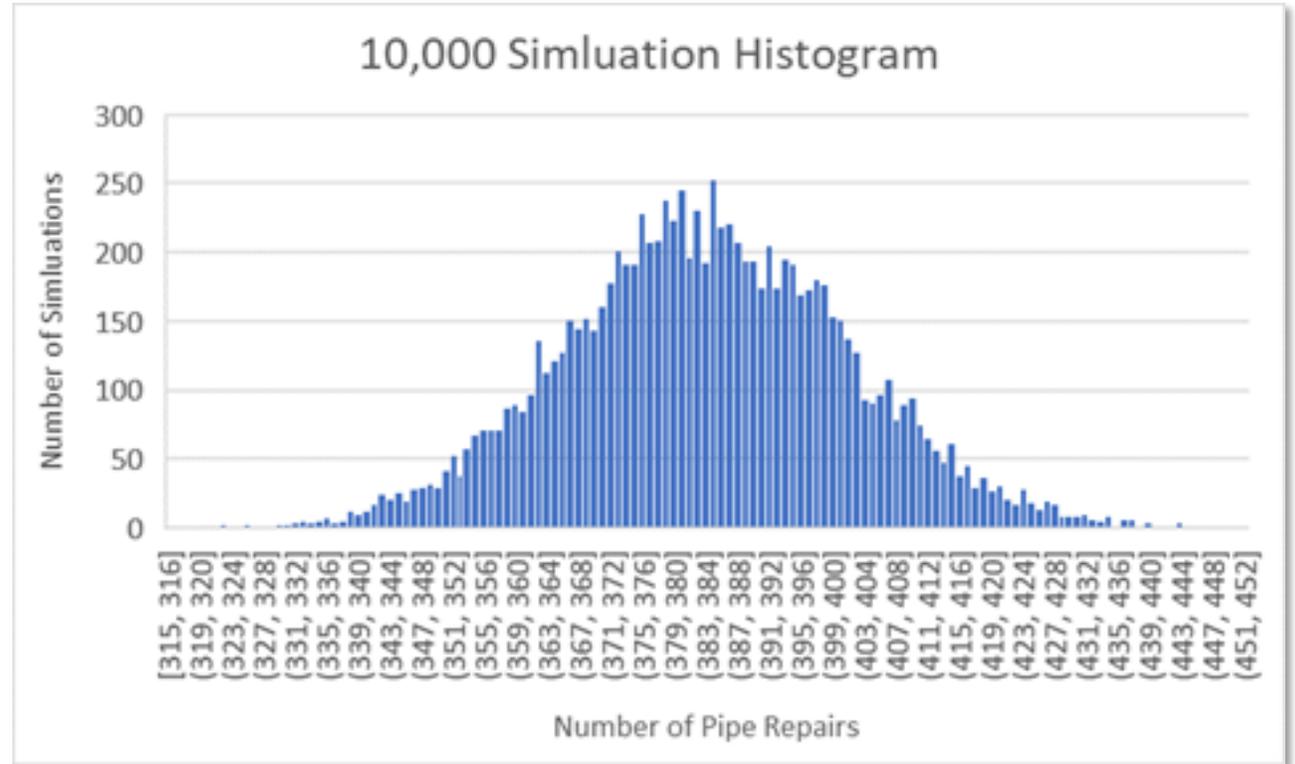
# Monte Carlo Failure Analysis Modeling

- System performance modeled based on ALA and Hazus failure probabilities estimated according to:
  - Projected seismic event severity
  - Materials and condition
  - Geotechnical factors
- Initial 1,000 simulation analysis approached typical “normal” statistical distribution
- 10,000 simulation analysis provides smoother distribution for use in multi-break system modeling analysis

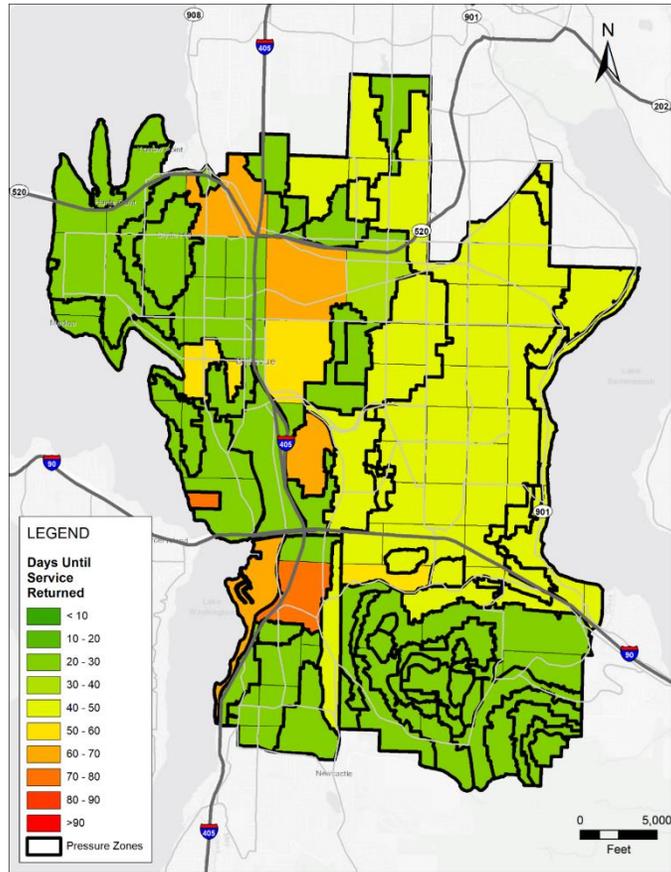
Cascadia Subduction Zone  
Mw 9.0

# Estimated Water Service Restoration Times – Existing System

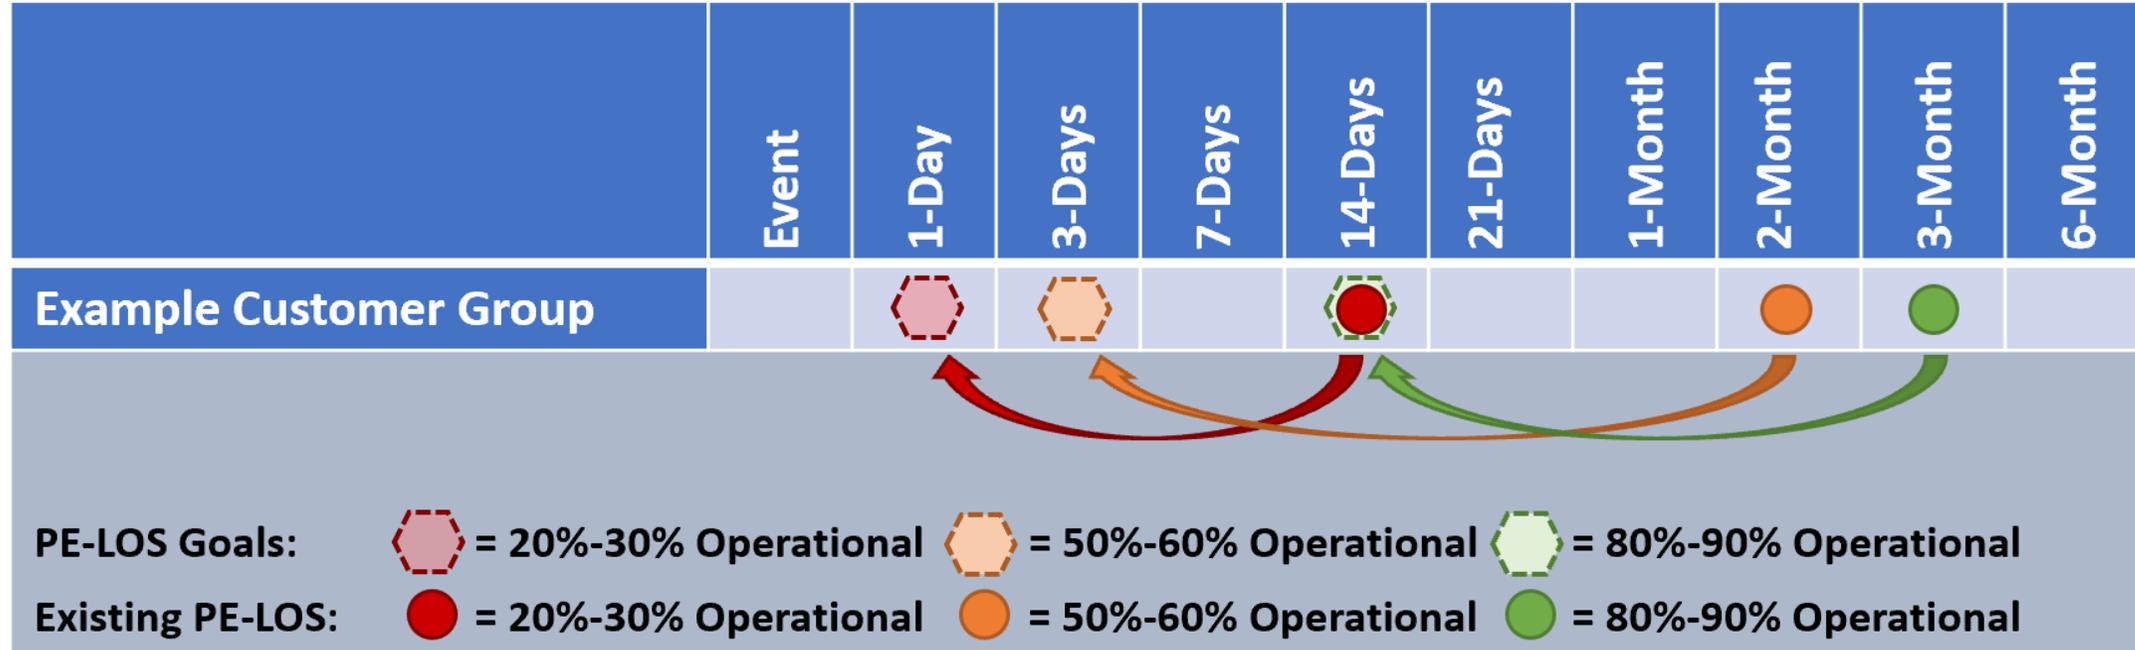
# Post-Event Level of Service (PE-LOS) Goal "Target" Charts

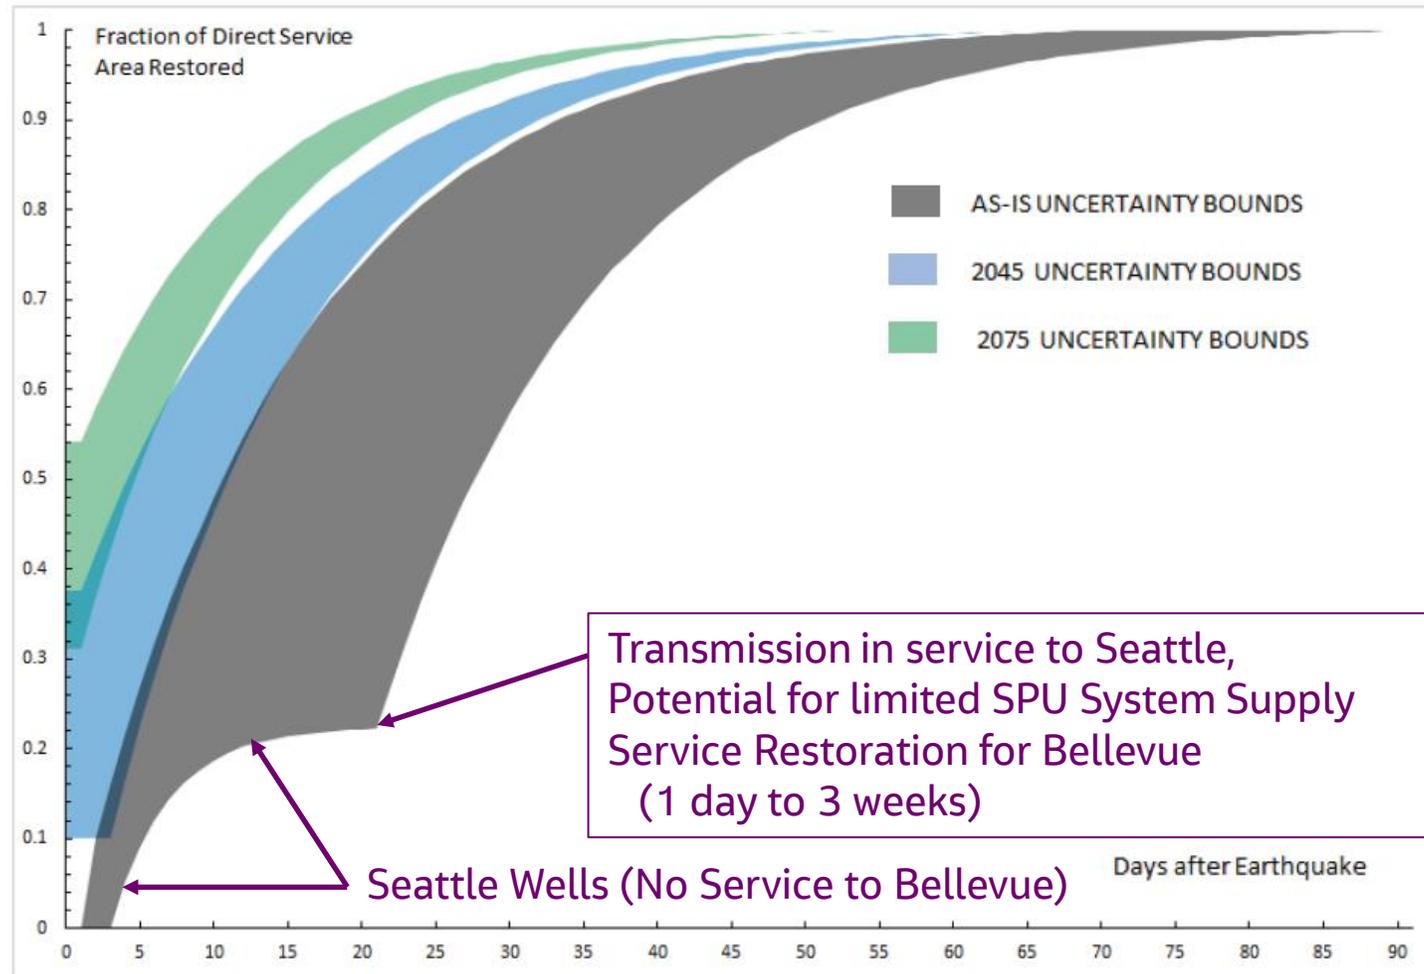
Figure ES-3. Retail service area restoration estimates after catastrophic earthquakes: current condition, after 20+ years of seismic upgrades, and after 50+ years of seismic upgrades

Source:  
SPU 2018  
Seismic Study

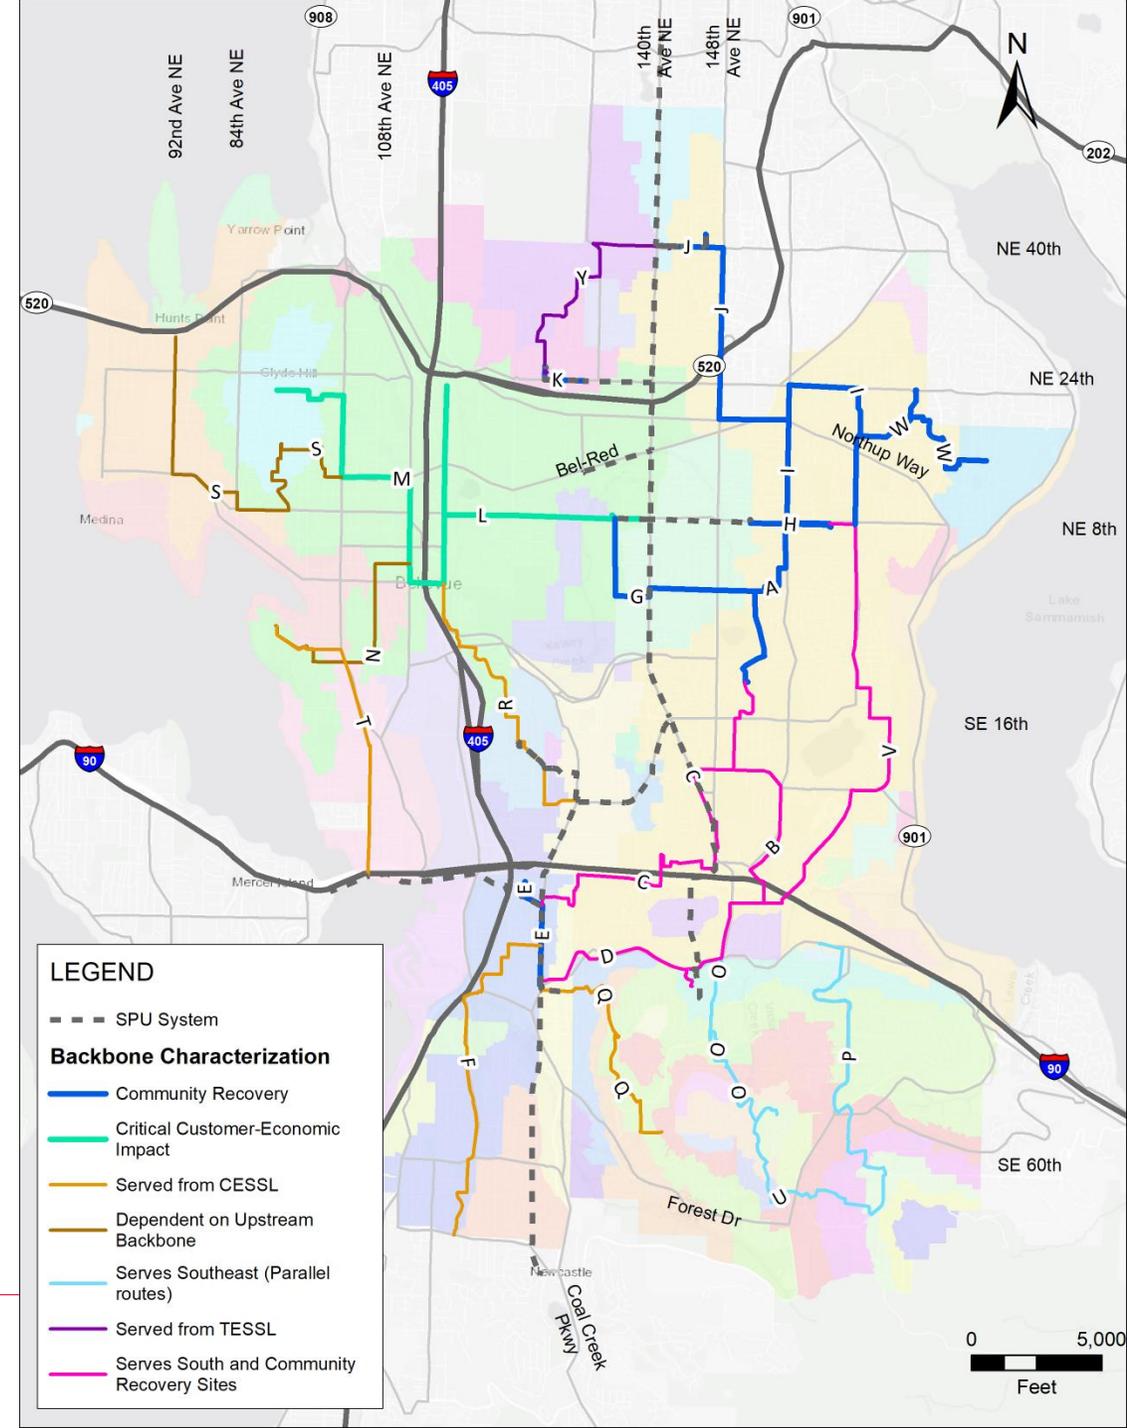
# Resilient Seismic Backbone Pipelines

- Supply source connections and delivery
  - Regional Supply System
  - Local Emergency Wells and Supplies
- Supply to critical customers
- Connections/customers served
- Coordinate with facility improvements to support delivery between pressure zone service areas

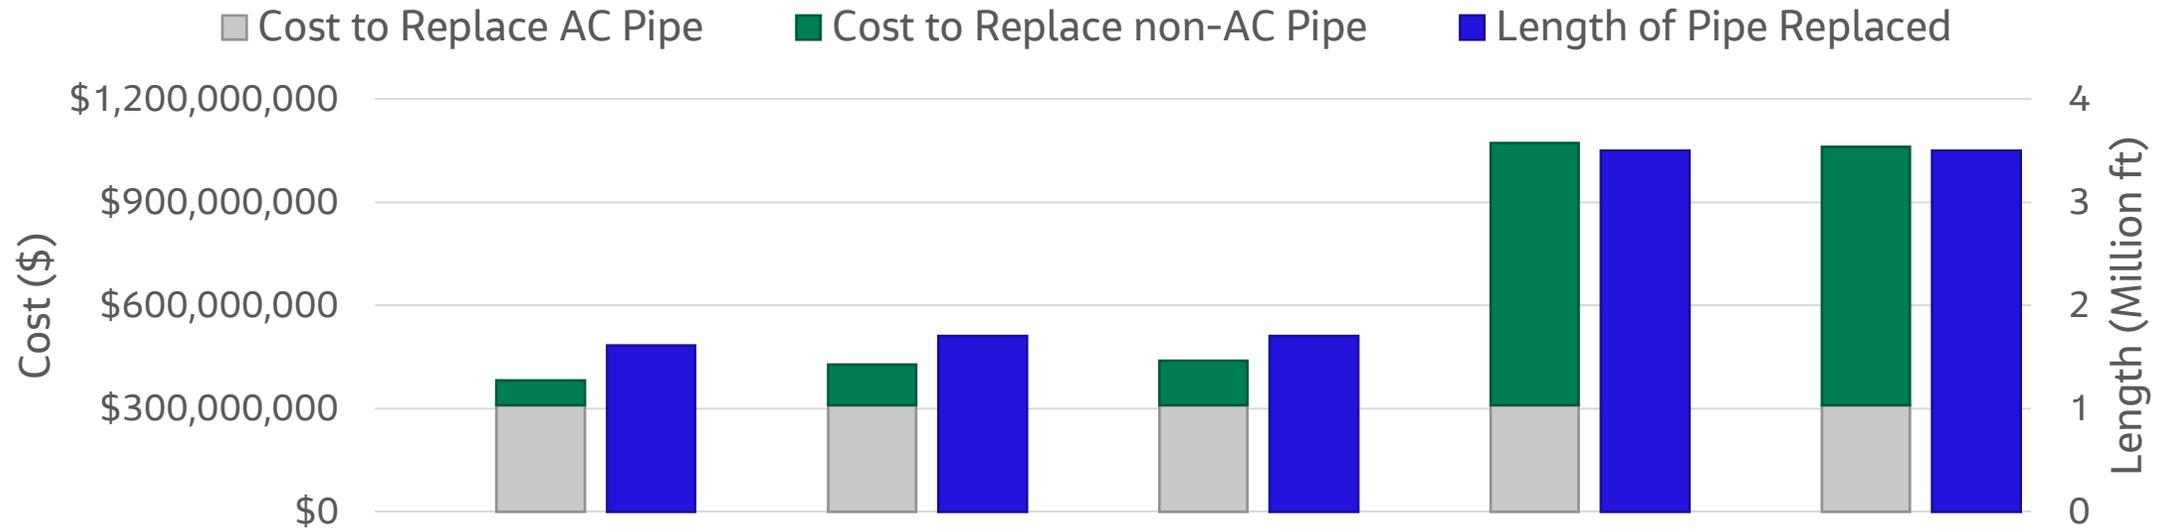
# Pipe Replacement Alternatives - Costs

Alt. 1	Alt. 2	Alt. 3	Alt. 4	Alt. 5
Vulnerability	Pipe Materials				
High	Unrestrained DI	ERDIP	ERDIP	ERDIP	ERDIP
Moderate	Unrestrained DI	Restrained DI	ERDIP	ERDIP	Restrained DI
Low	Unrestrained DI	Unrestrained DI	Unrestrained DI	Restrained DI	Restrained DI

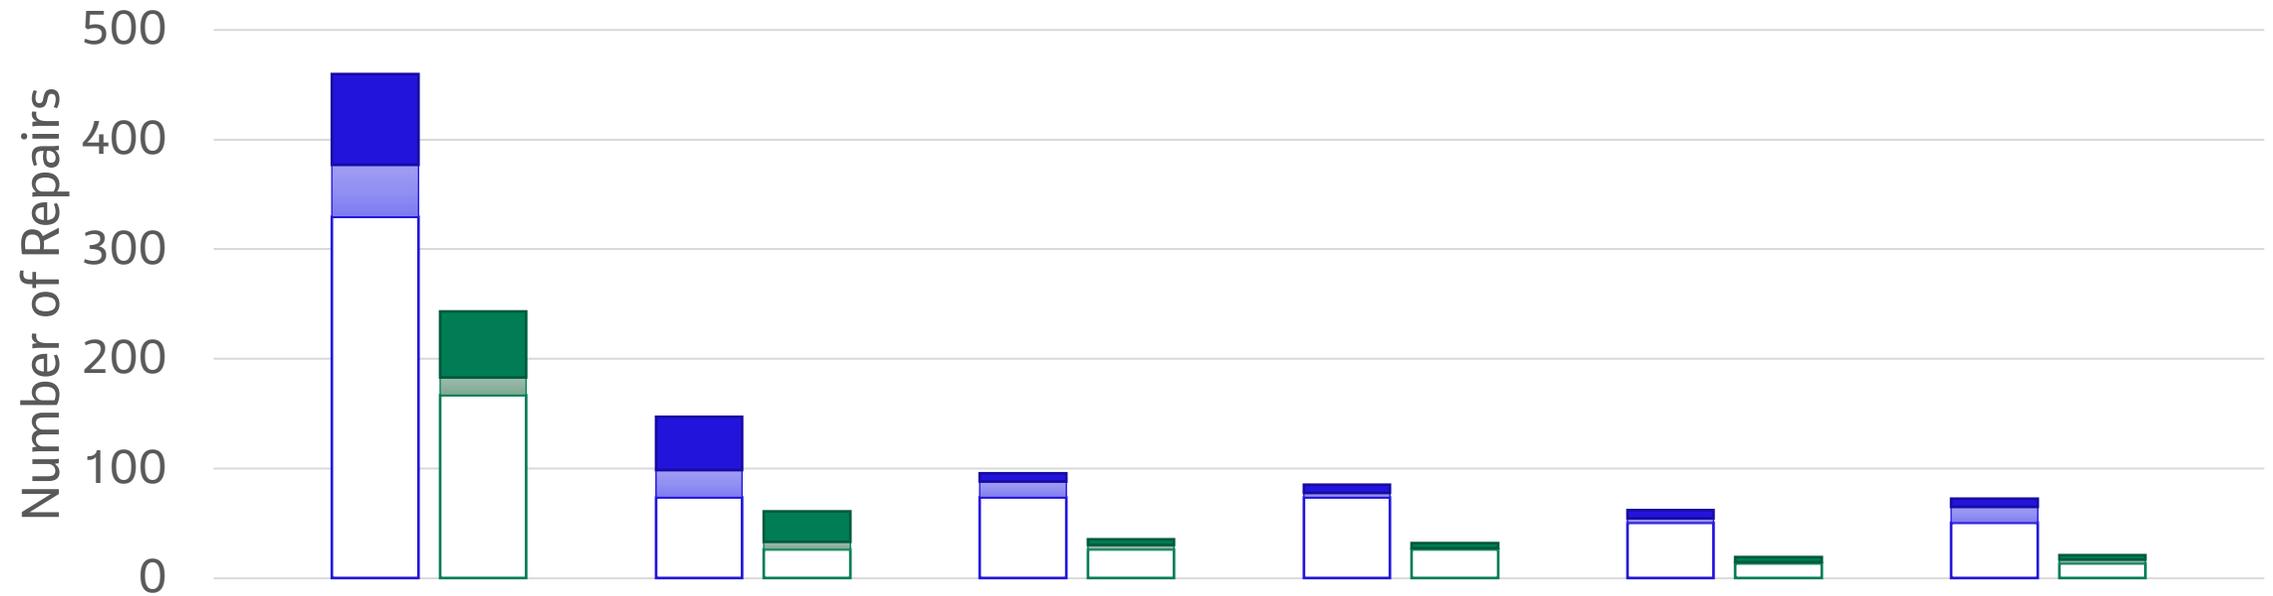
# Pipe Replacement Alternatives – Effects on Post-Event Pipe Repairs

Legend		Exist. System	Alt. 1	Alt. 2	Alt. 3	Alt. 4	Alt. 5
SFZE	CSZ	Vulnerability	Pipe Materials				
Blue	Green	High	Unrestrained DI	ERDIP	ERDIP	ERDIP	ERDIP
Light Blue	Light Green	Moderate	Unrestrained DI	Restrained DI	ERDIP	ERDIP	Restrained DI
White	White	Low	Unrestrained DI	Unrestrained DI	Unrestrained DI	Restrained DI	Restrained DI
