# Shaking Things Up – Innovative Seismic Risk Planning

City of Bellevue

February 25, 2021 – Doug Lane, PE, and Matt Maring, PE, PMP

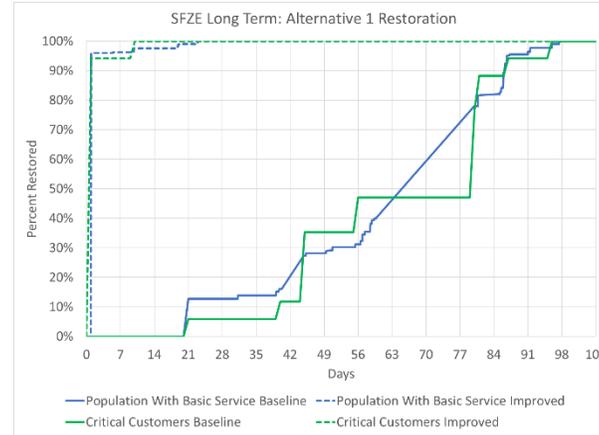
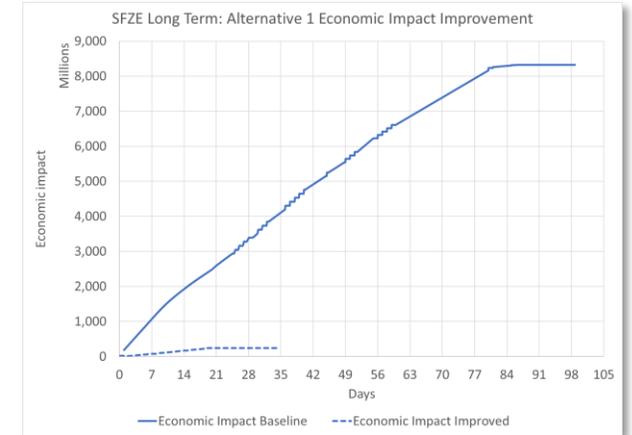
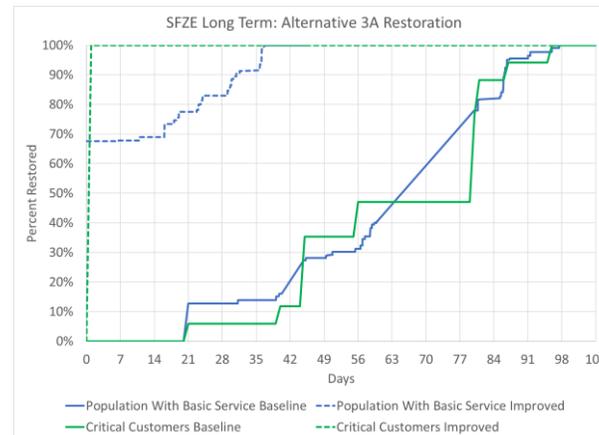
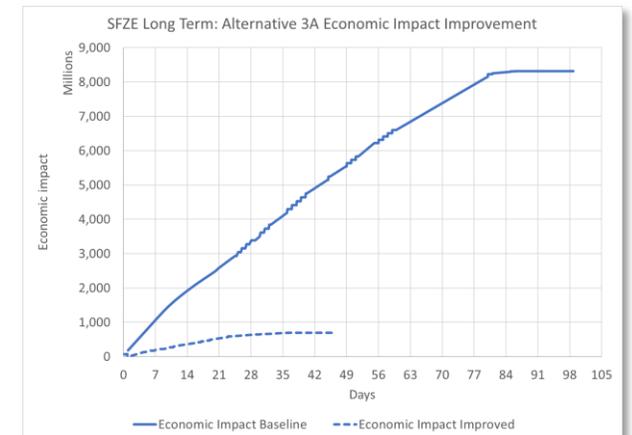
# SFZE Long Term Restoration Options – PE-LOS and Economic Benefit

Alt.	Supply Improvements	Pipe and Facility Upgrades	Relative Cost
L1	SPU Supply Resilience Improvements	Hardening Systemwide	\$\$\$\$\$
...	...	...	...
L3A	Emergency Well Supplies, SPU Supply available in 7 days	Key Pressure Zone Hardening, Partial Resilient Backbone	\$\$\$
...	...	...	...
