Using GIS to Assess Water Main Risk & to Develop Capital Projects

PNWS – AWWA 2019
May 3, 2019

CITY OF
Vancouver
WASHINGTON

Eugene Durshpek, GIS Supervisor
Tyler Clary, Water Engineering Program
Manager

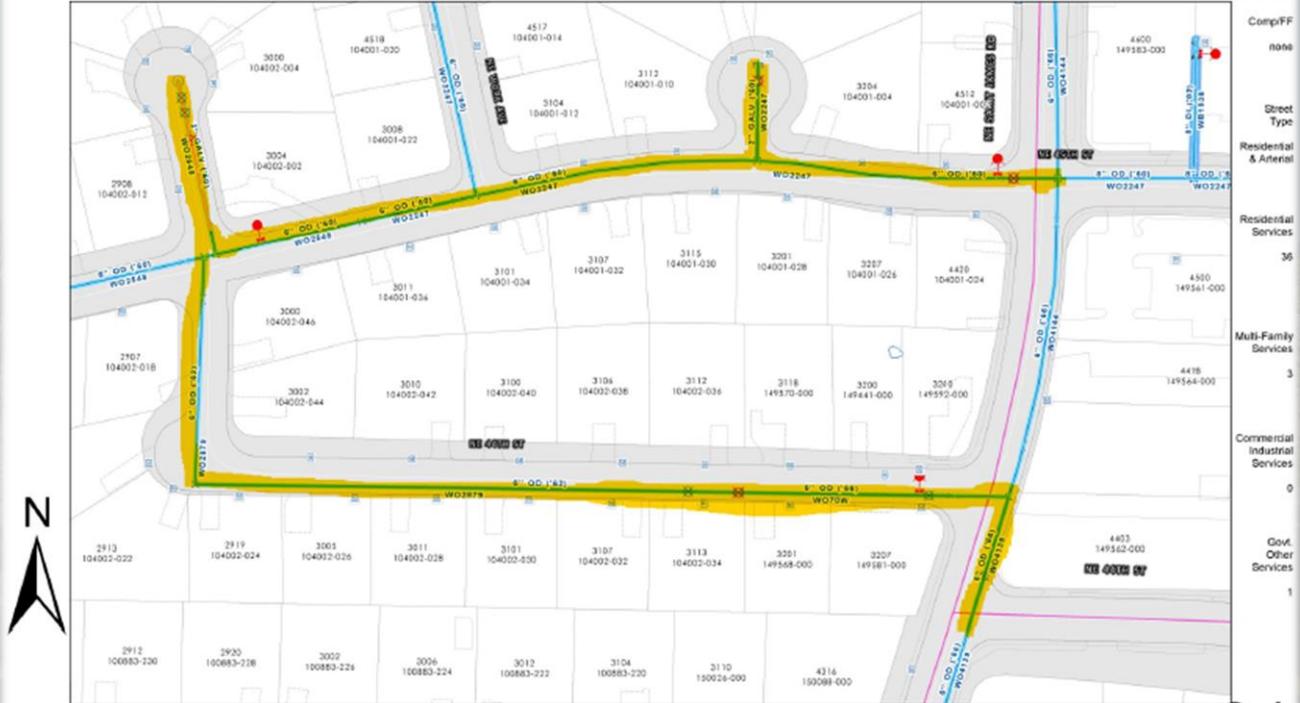
Historic Approach – Sample Data: Proj Map

NE 45th ST
& NE 44th ST

10 Leaks
6" OD
2" GALV

2200 LF
1960-1969

- Comp/FF none
- Street Type Residential & Arterial
- Residential Services 36
- Multi-Family Services 3
- Commercial Industrial Services 0
- Govt. Other Services 1

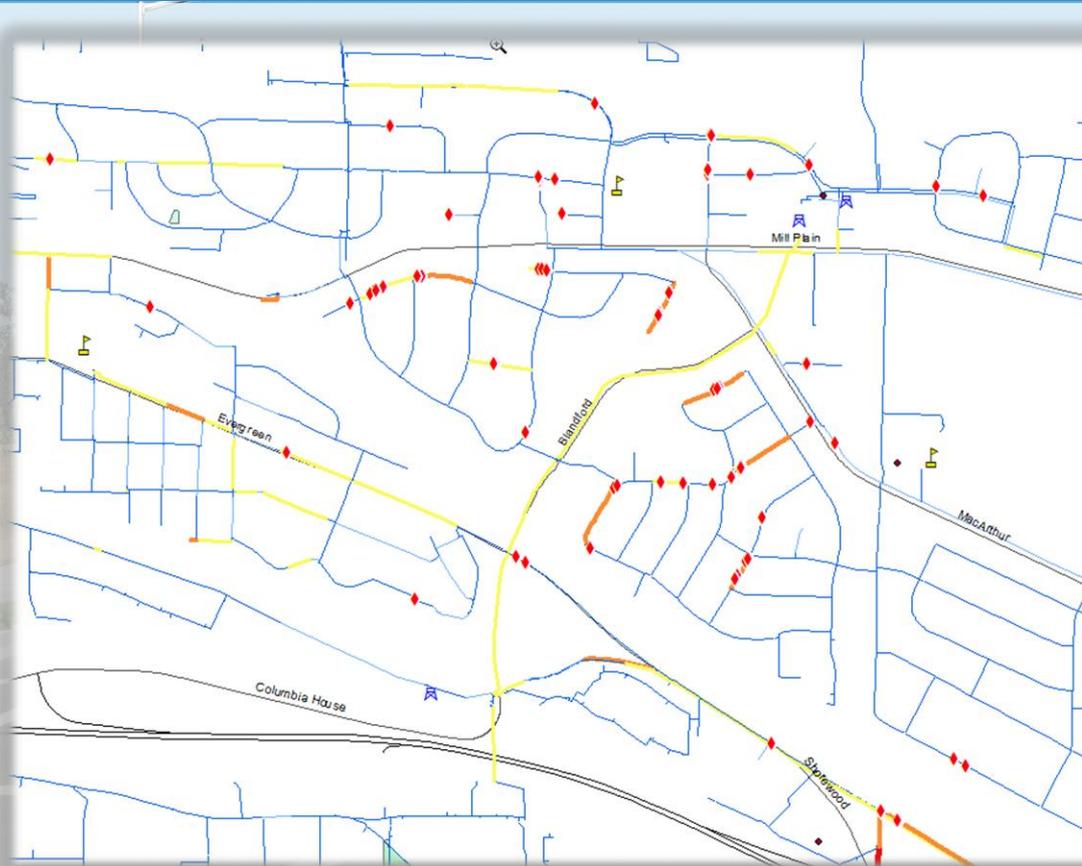
Water Mains By Risk Grading

- 1 - Negligible Risk
- 2 - Low Risk
- 3 - Medium Risk
- 4 - High Risk
- 5 - Extreme Risk

- Facility Analysis
 - Pressurized Main CapPlan
 - Consequence of Failure (COF)
 - wMain_COF1, Pipe Size
 - wMain_COF2, Pipe Material
 - wMain_COF3, Dead Ends/Redundancy

- wMain_COF4, Arterials
 - wMain_COF5, Highways
 - wMain_COF6, Laterals/LF
 - wMain_COF7, Consumption/Pipe(with meters only)
 - wMain_COF8, Consumption/Pipe(All Pipes)

- wMain_COF9, Schools
 - wMain_COF10, Hospitals
 - wMain_COF11, Dialysis Patients
 - Likelihood of Failure (LOF)
 - wMain_LOF1, Pipe Size
 - wMain_LOF2, Pipe Material

- wMain_LOF3, Install Year
 - wMain_LOF4, Leaks/LF
 - wMain_LOF5, Liquefaction
 - wMain_LOF6, Cast Iron 1938-1945
 - wMains_LOF4a, Leaks/LF(2 Leaks or Greater)

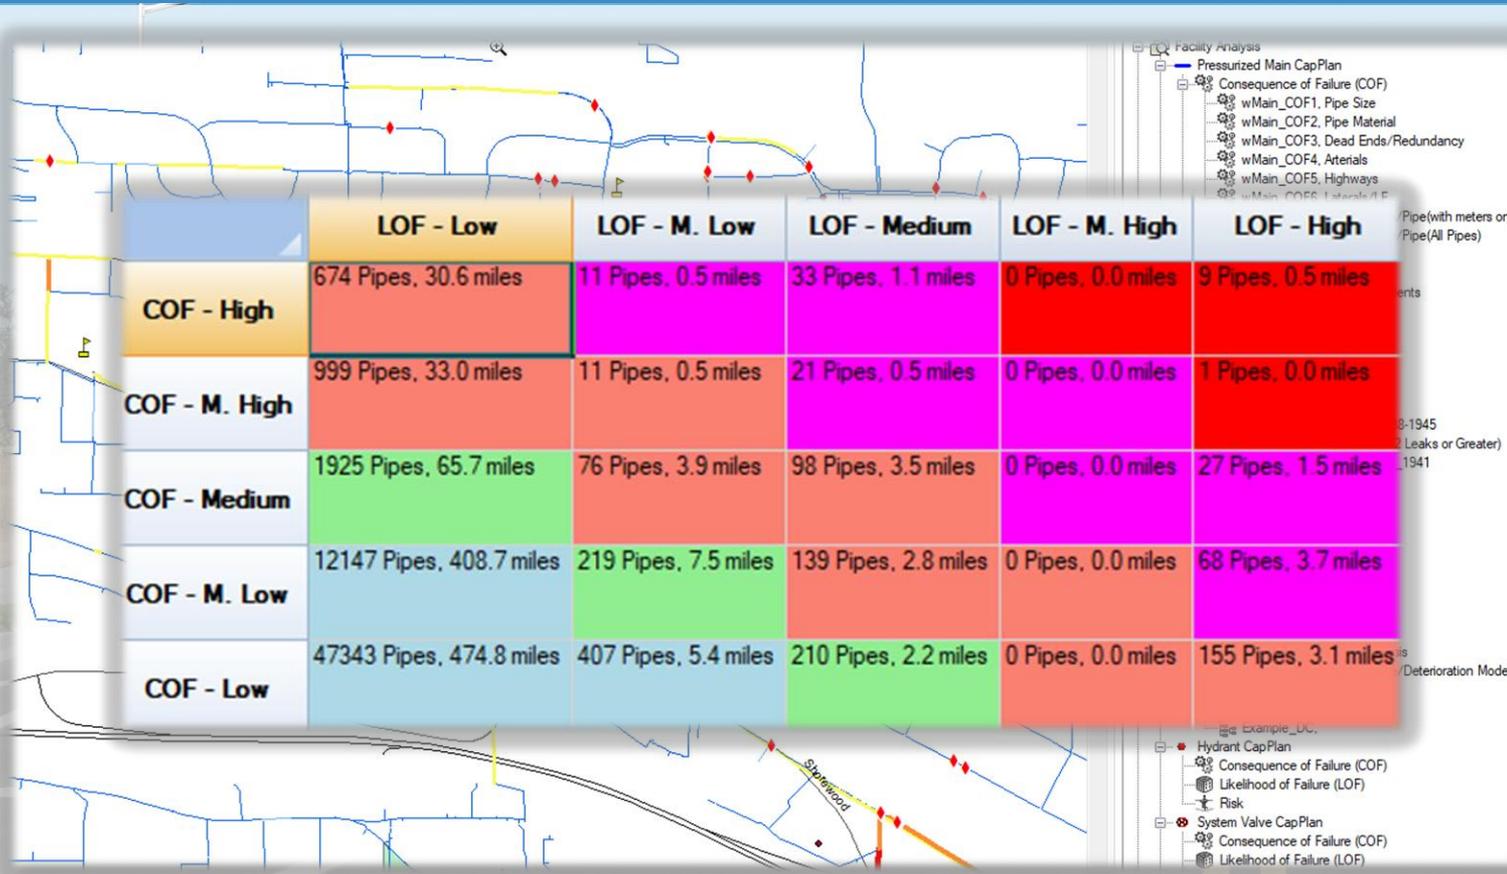
Water Mains By Risk Grading

- 1 - Negligible Risk
- 2 - Low Risk
- 3 - Medium Risk
- 4 - High Risk
- 5 - Extreme Risk

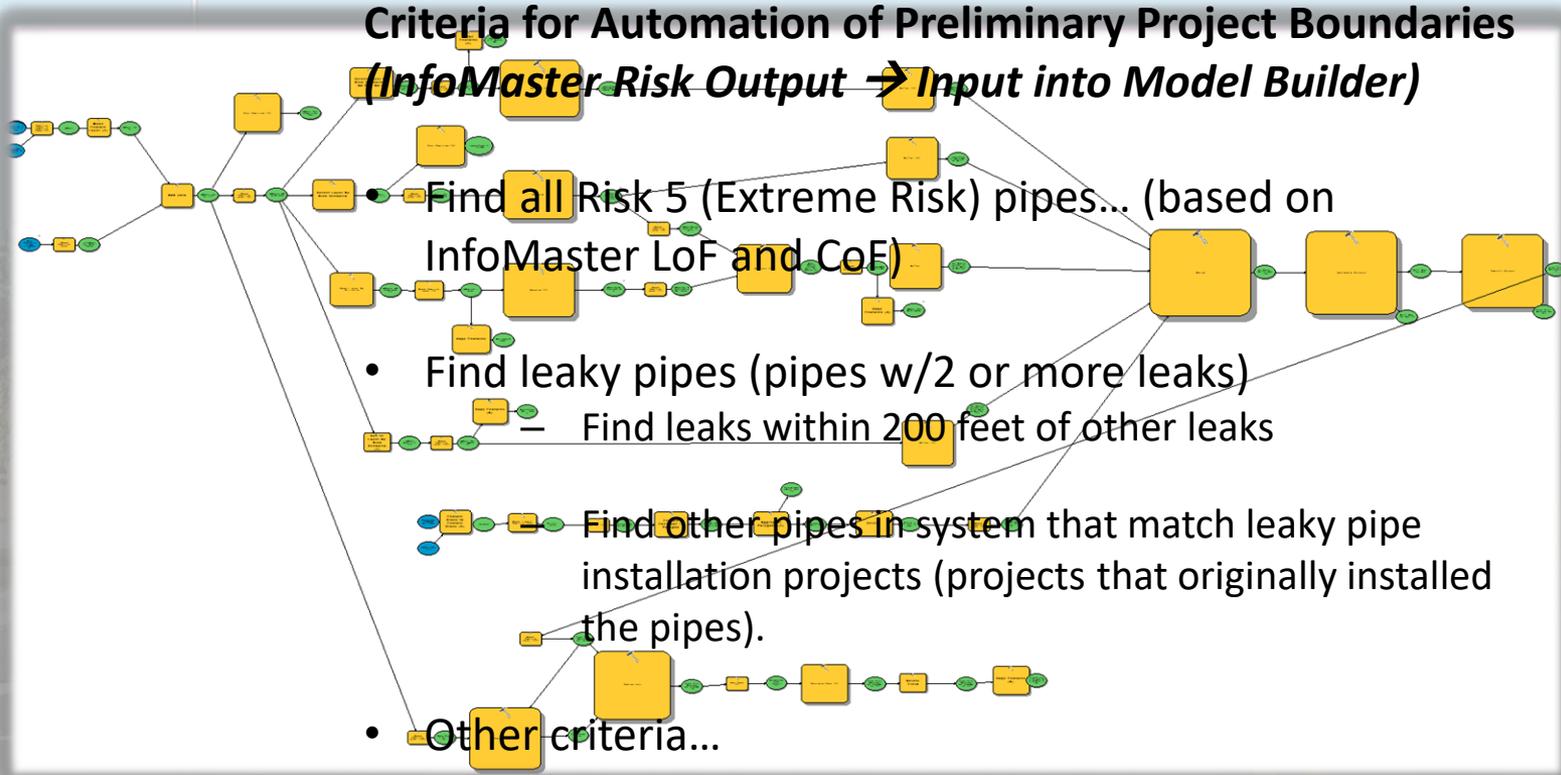
GIS Approach – Creation of Project Boundaries

Criteria for Automation of Preliminary Project Boundaries

(InfoMaster Risk Output → Input into Model Builder)
