Retrofitting your old Concrete Water Tank

CONCRETE TANK SERVICES

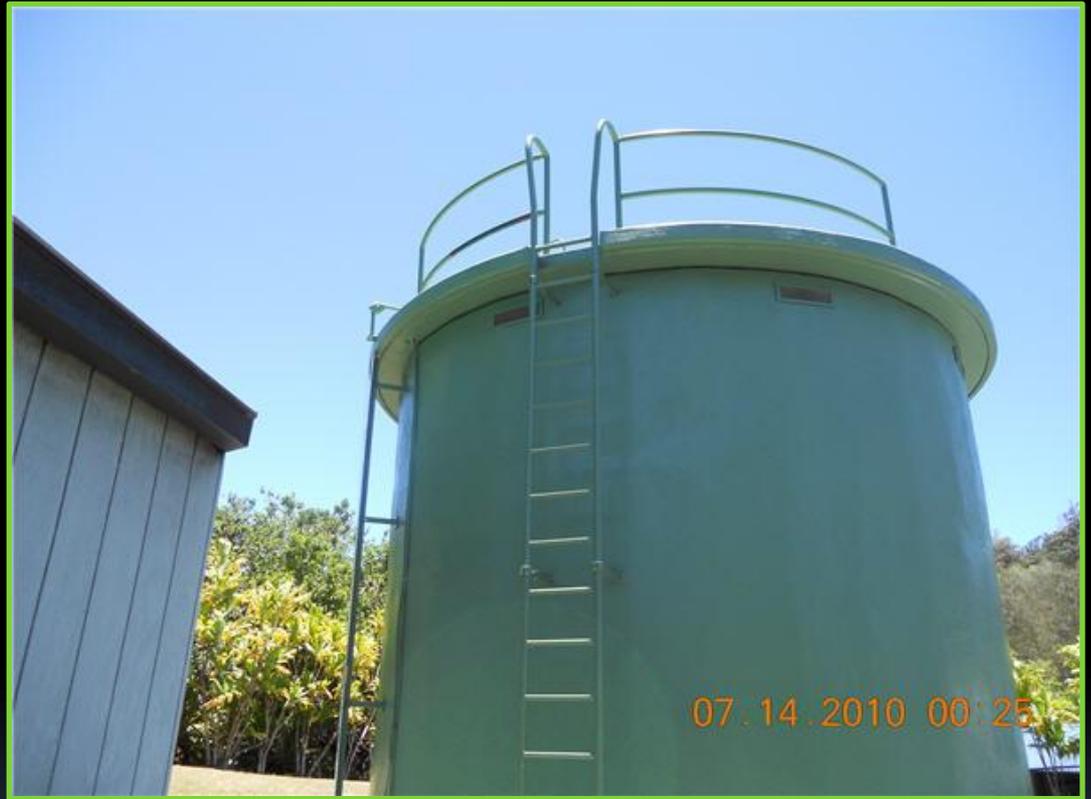
Finished reservoir after newly applied exterior paint.
