# Whack-A-Mole

## Waterproofing a 100-year-old Clear Well

for The City of Albany, Oregon

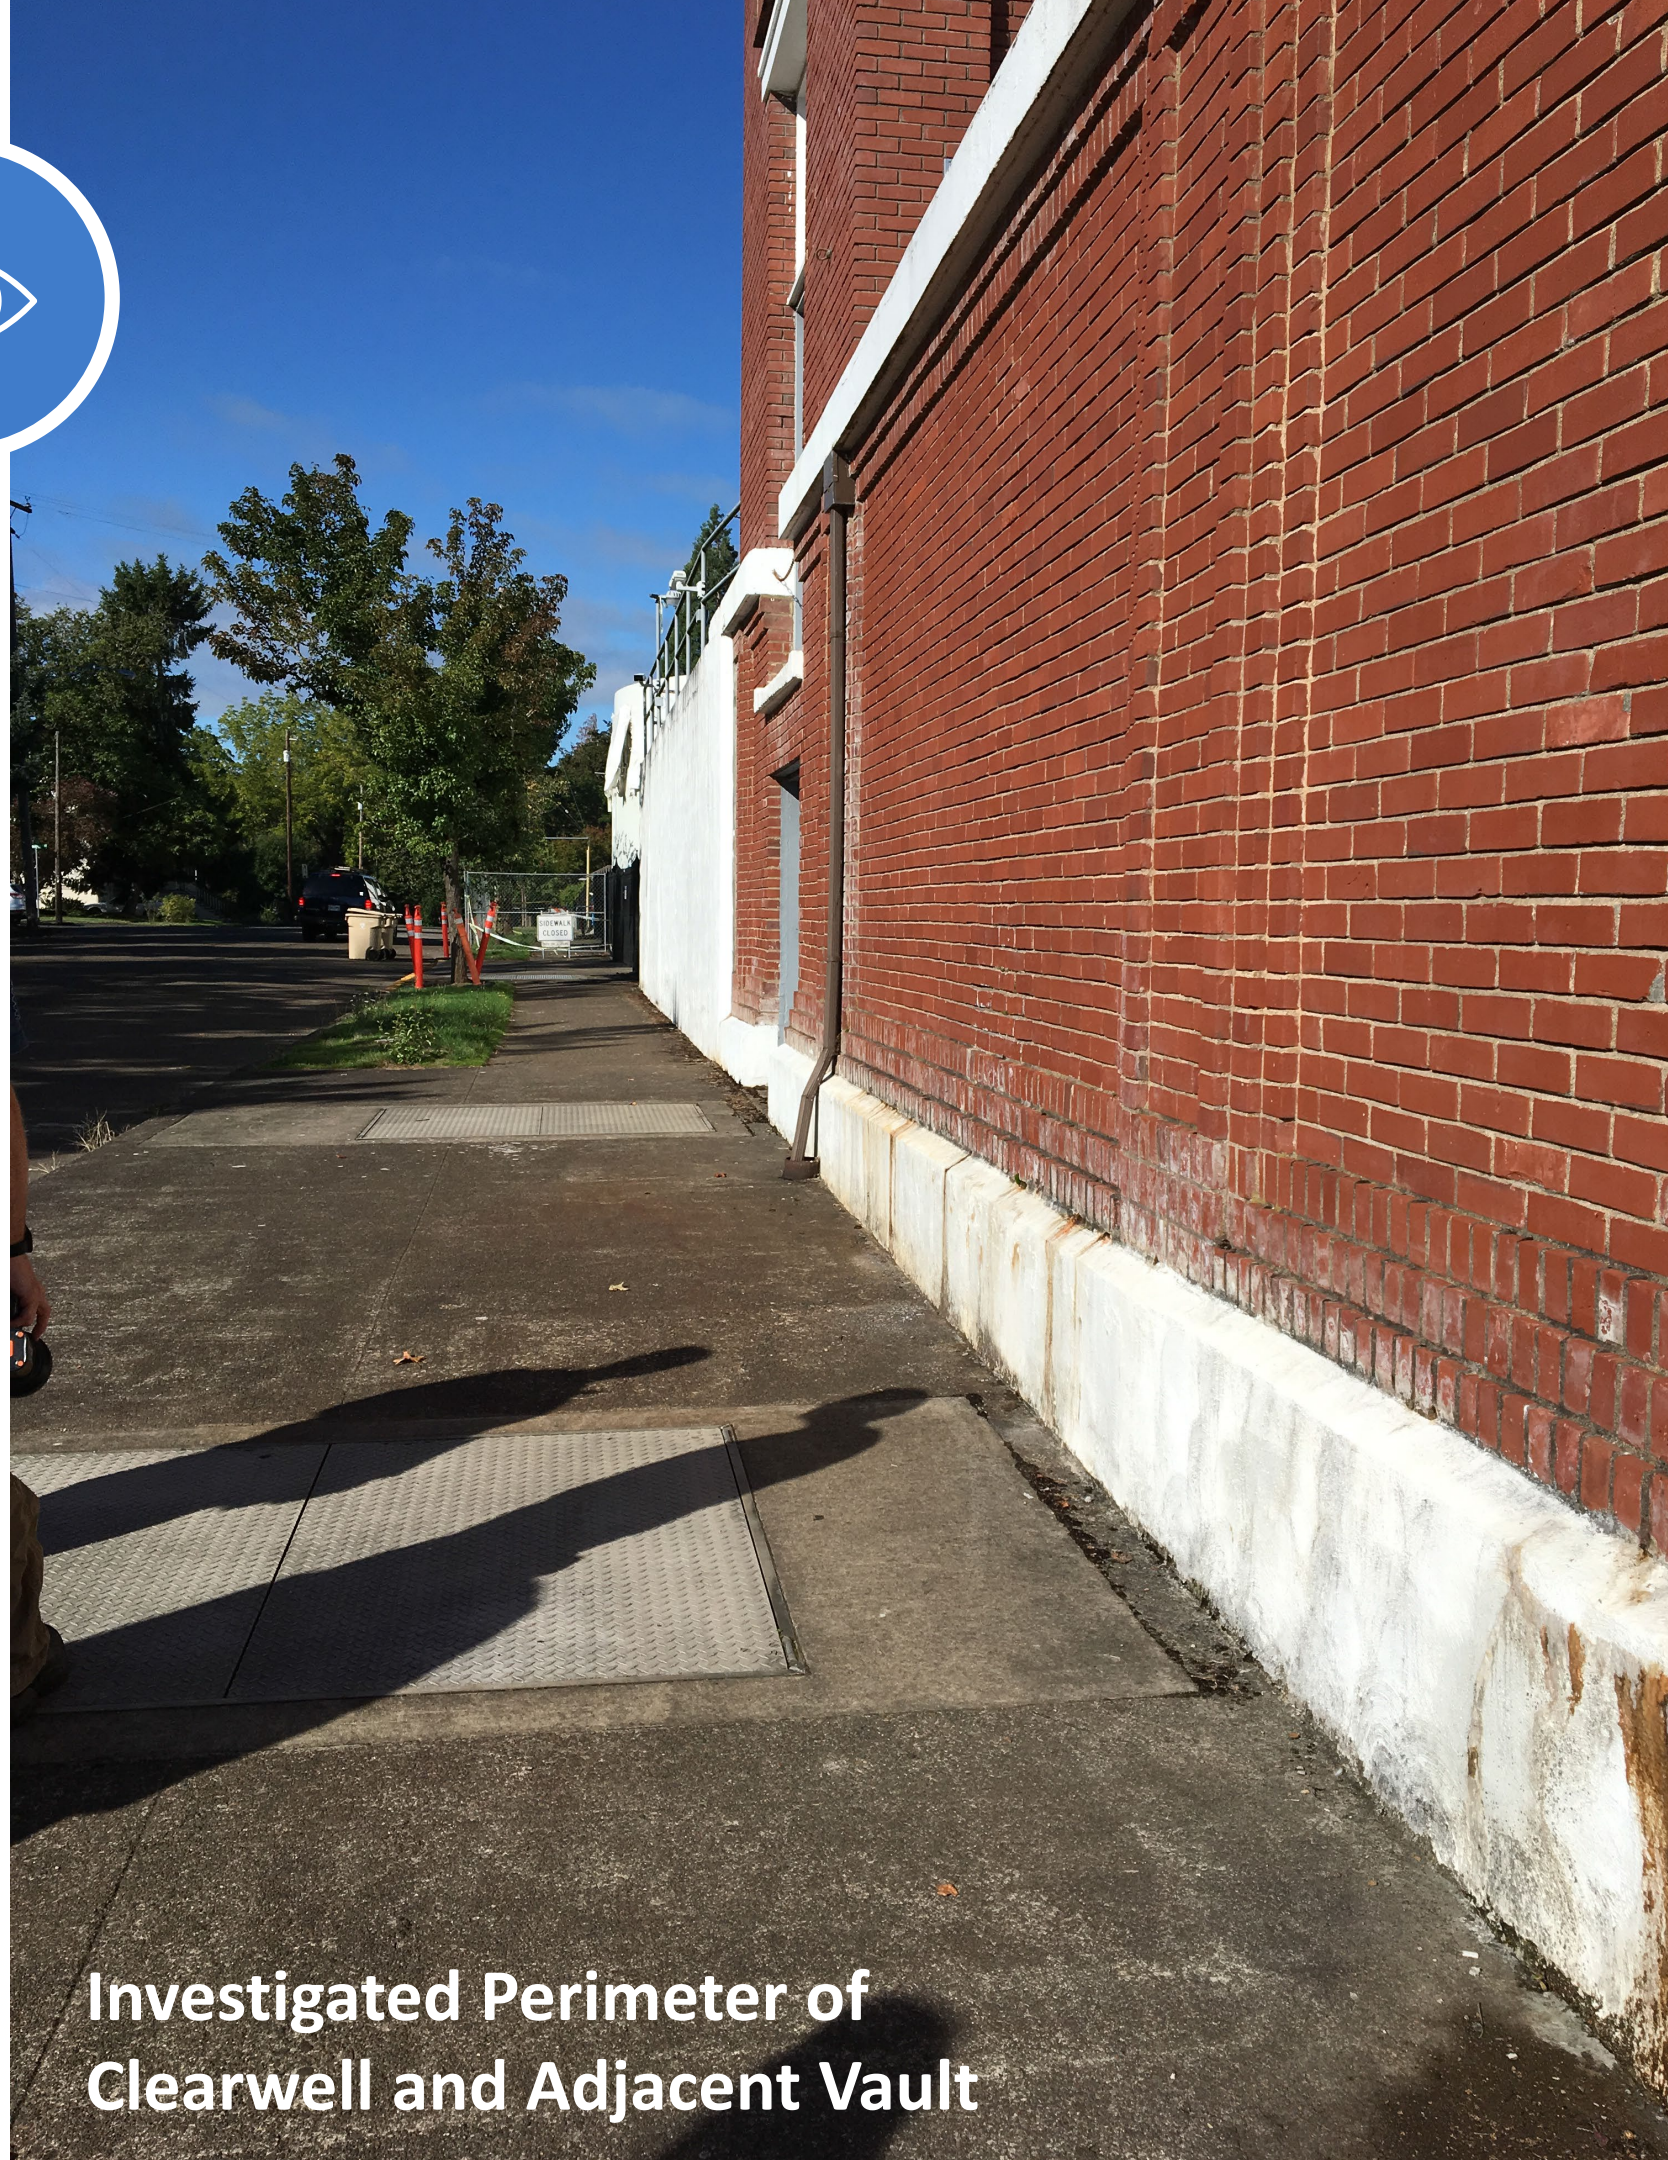
Investigated Perimeter of  
Clearwell and Adjacent Vault

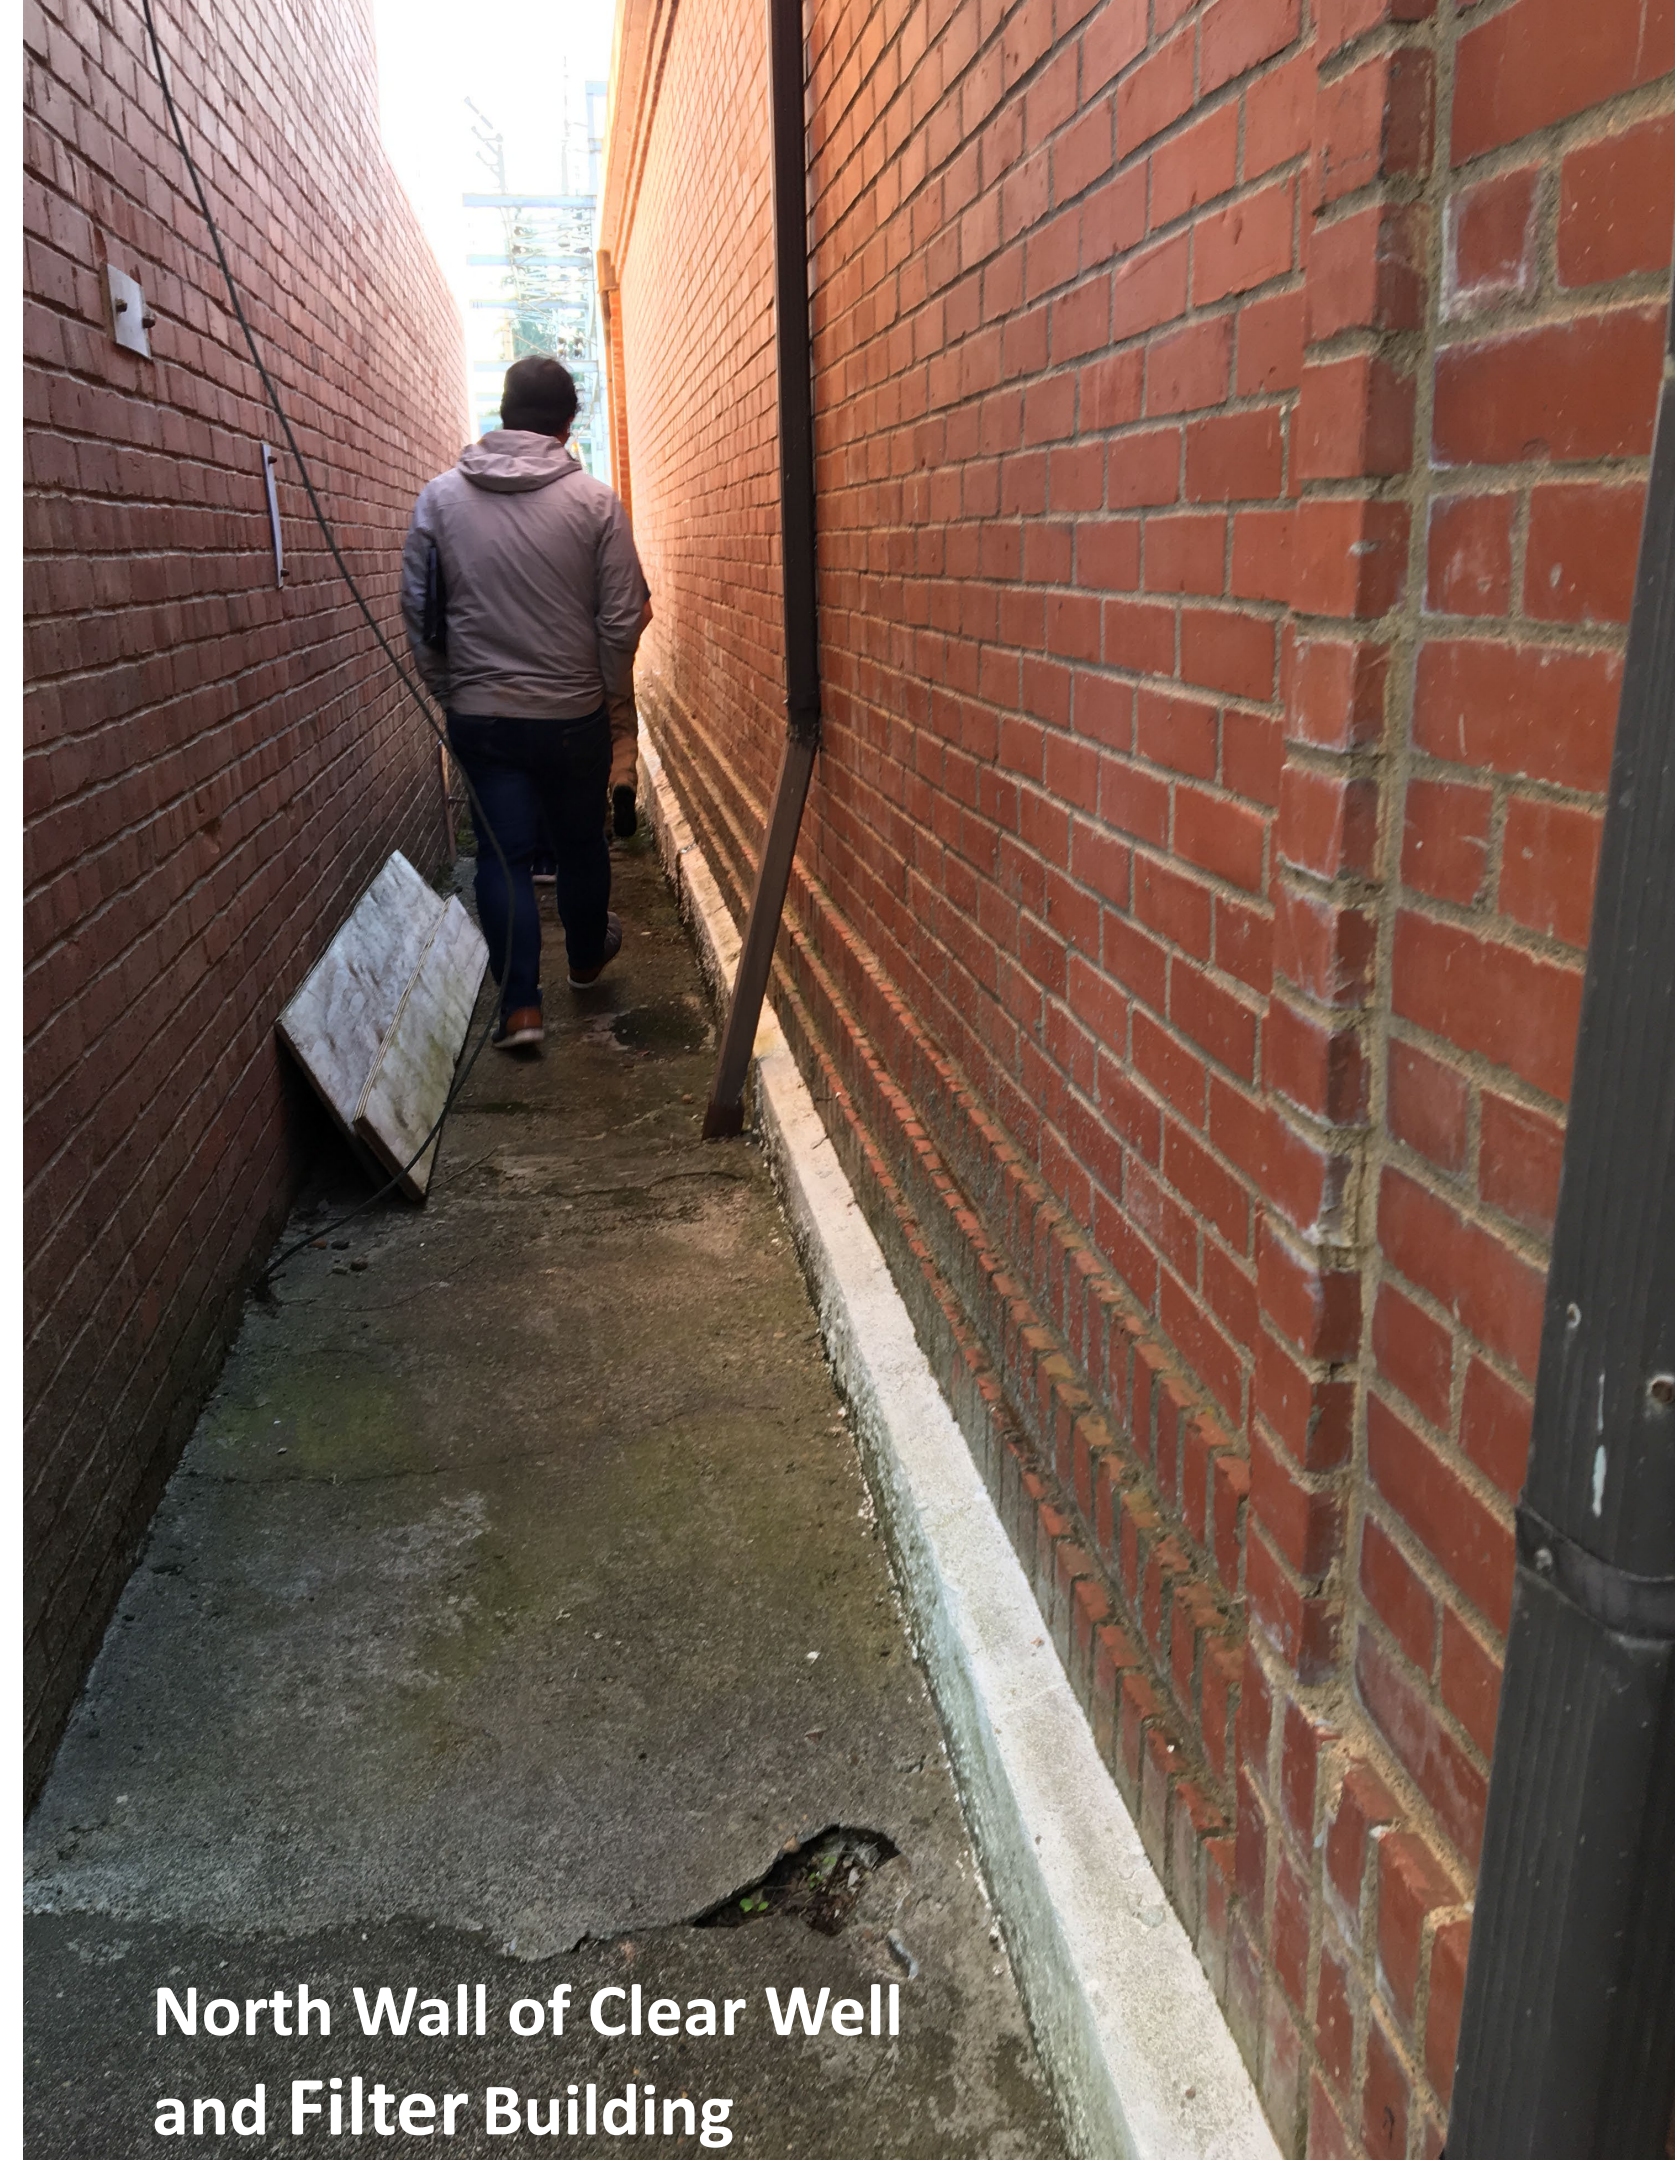
North Wall of Clear Well  
and Filter Building

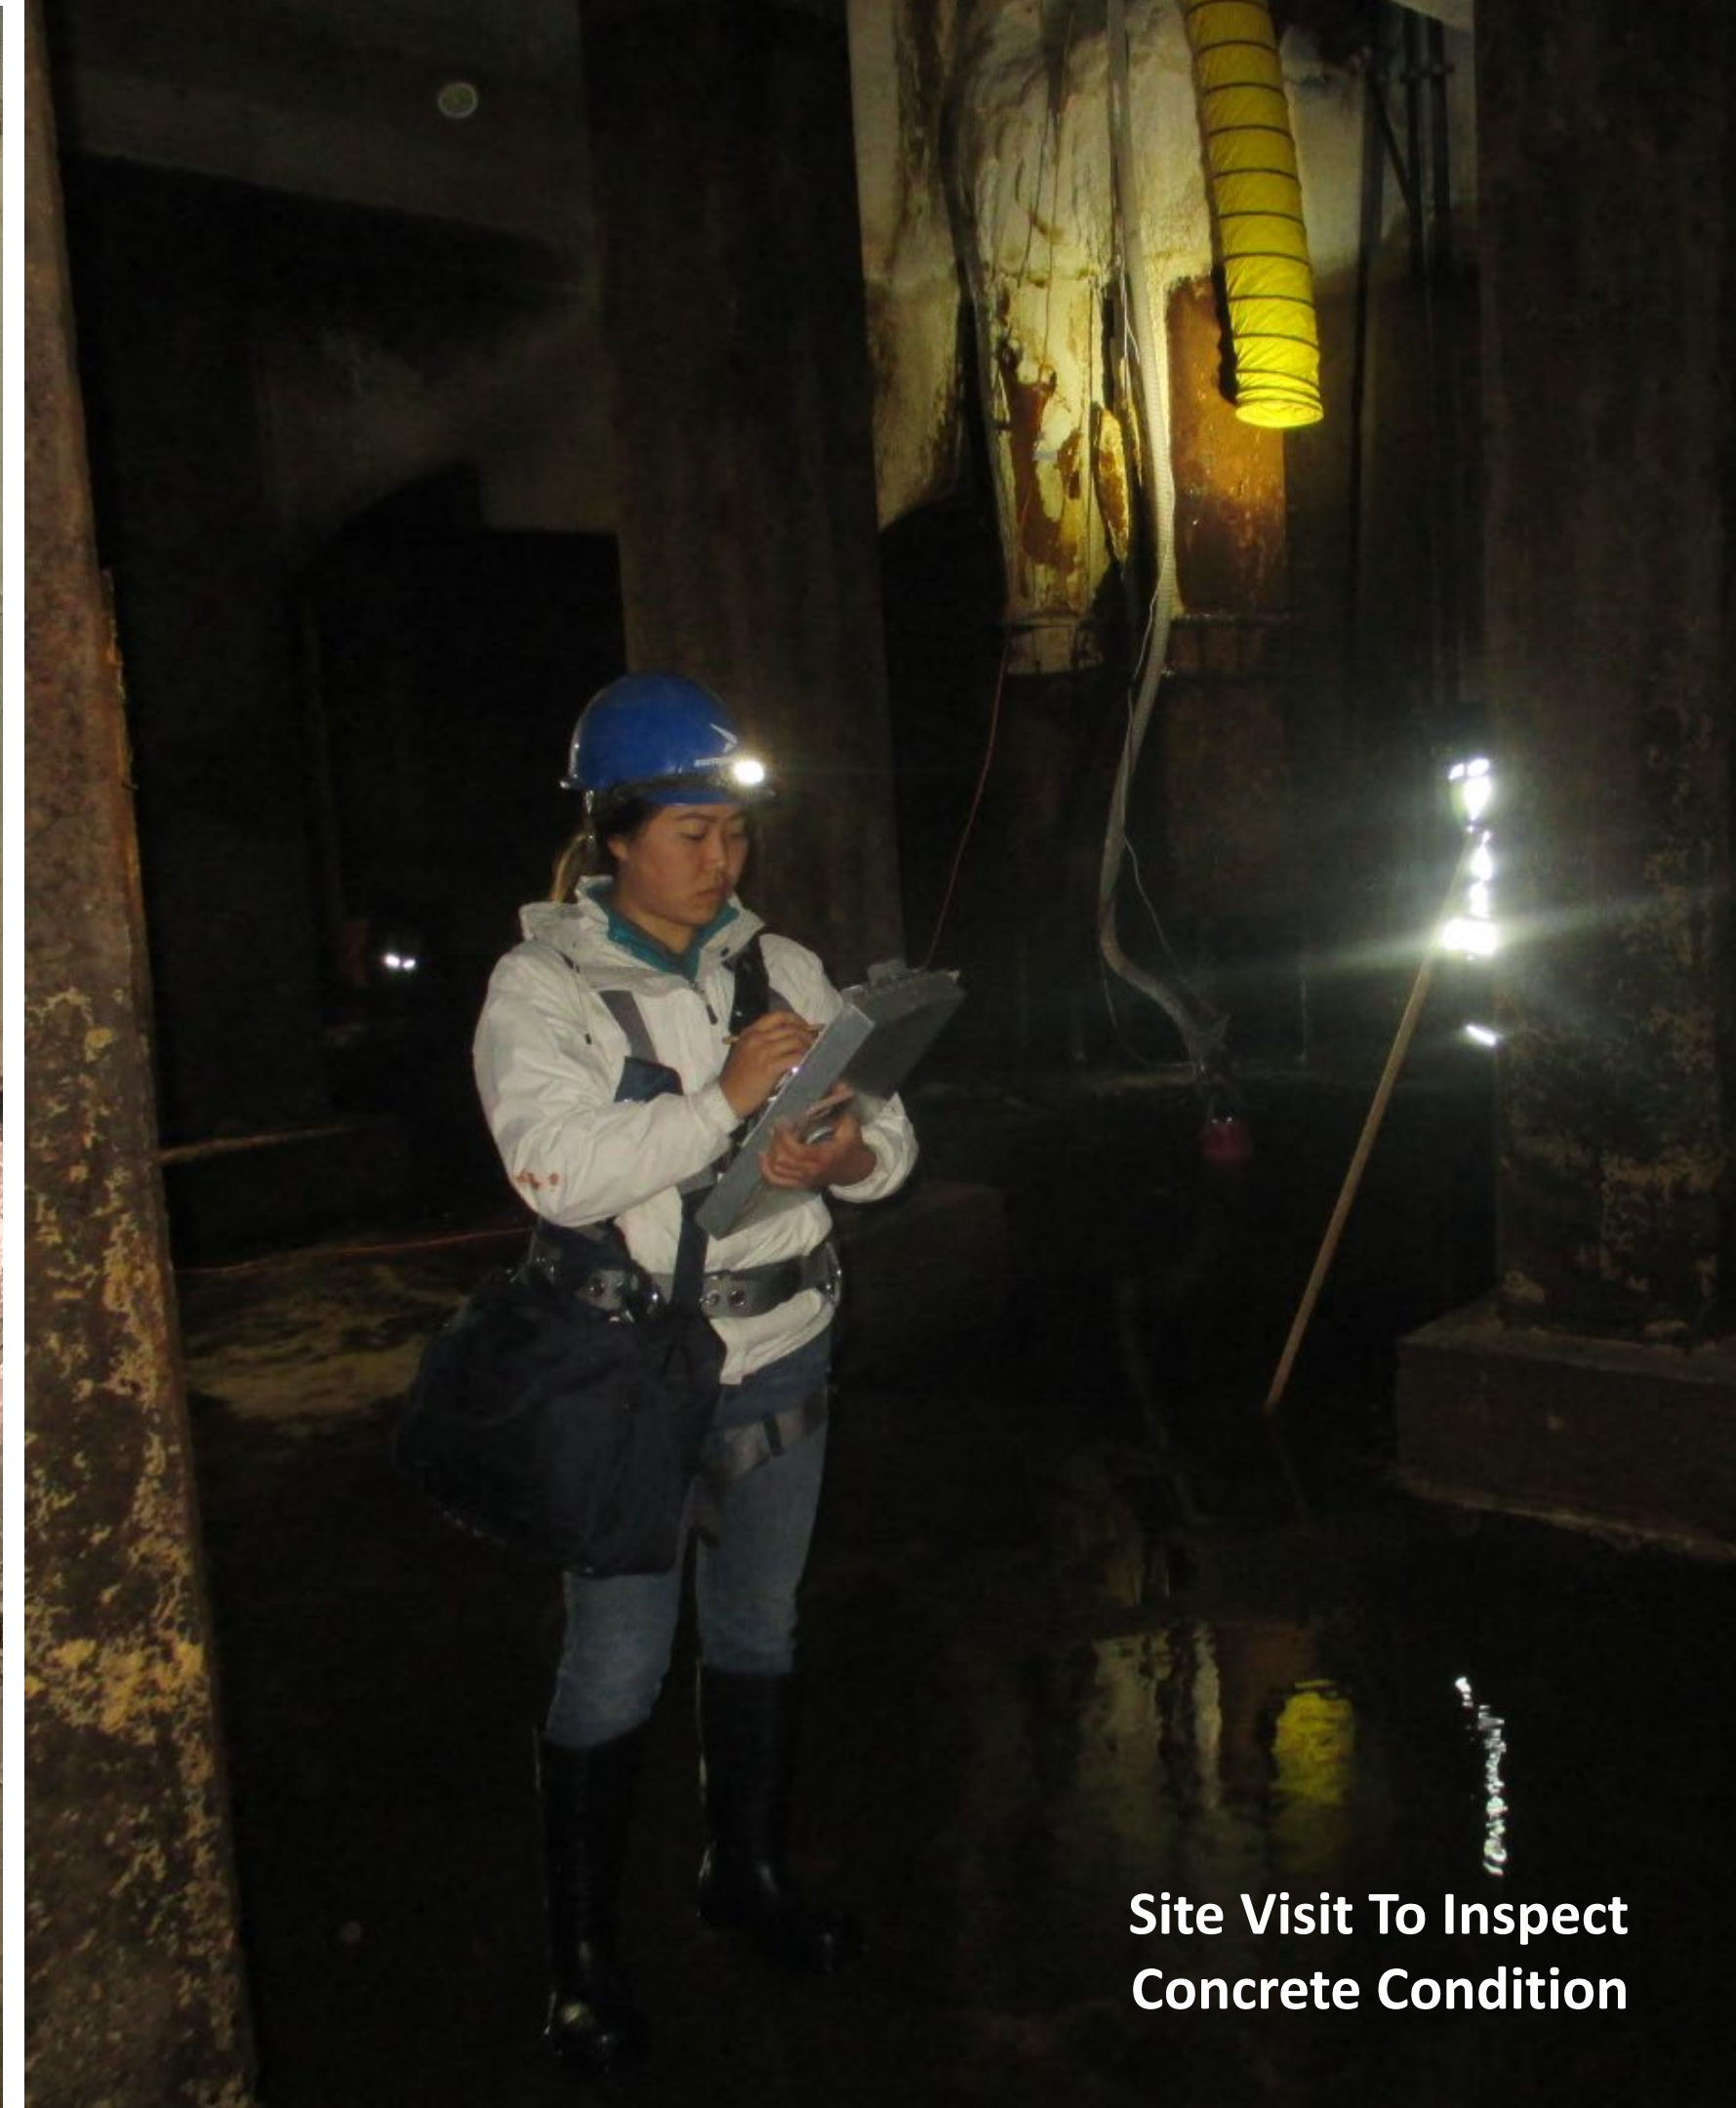
Site Visit To Inspect  
Concrete Condition
